Ashland Watershed Assessment & Action Plan

December, 2007

BEAR CREEK
Watershed Council

**Funded by the Oregon Watershed Enhancement Board
OWEB Grant #204-281**

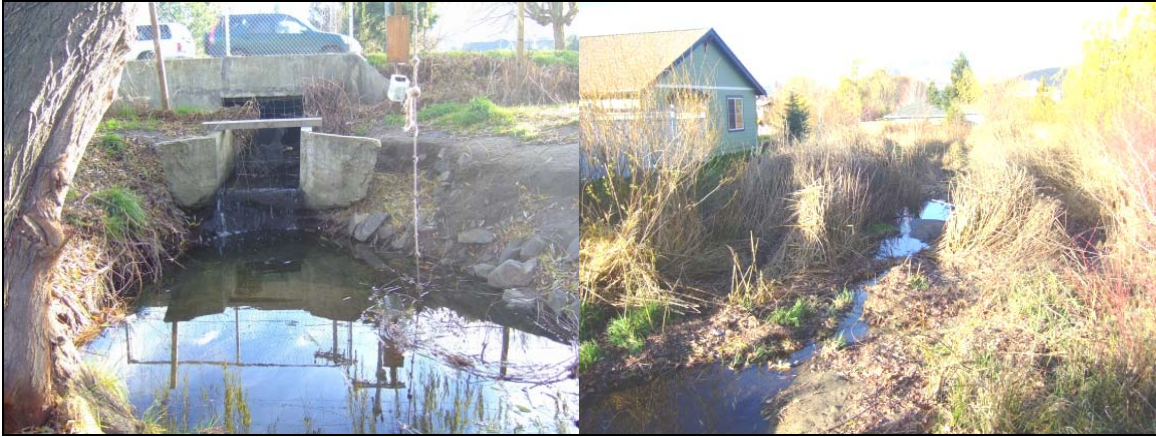
Figure IX-26: Roca Creek, downstream of East Main Street. Left: Roca Creek exits an underground pipe below East Main. Right: After exiting the pipe, the stream flows through a constructed wetland filled with cattails and other wetland vegetation. The wetland filters and cleans the stream water and also traps a large amount of granitic sand and fine silts; residents are concerned that the stream may damage their properties. Photos © Jeannine Rossa, December 2007.

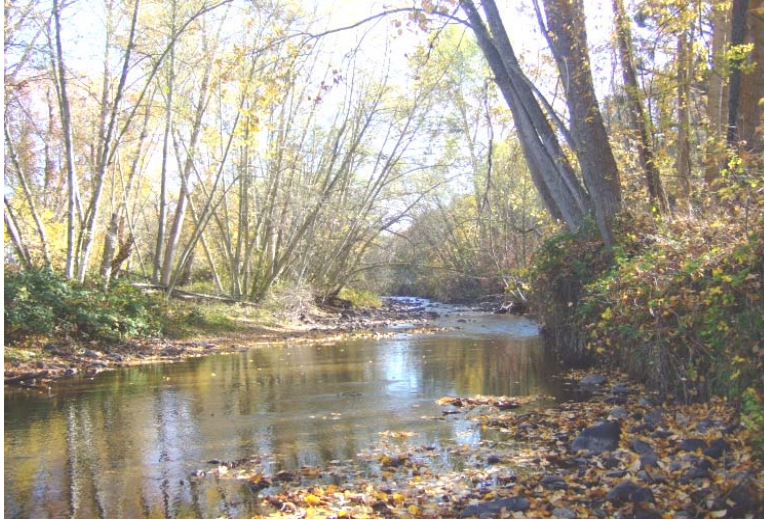
Figure IX-27: Bear Creek just upstream of its confluence with Clay Creek, October 2007. Photo © Jeannine Rossa, November 2007.

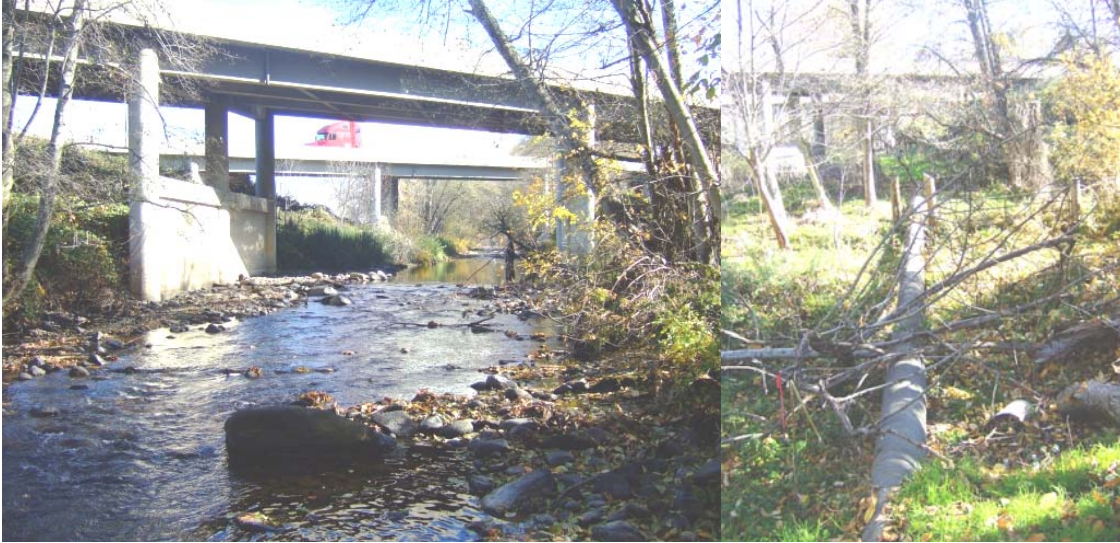
Figure IX-28: Left: Bear Creek looking upstream underneath the Interstate-5 bridges. A large, vegetated berm is visible behind the bridge abutment in the left of the photograph. Right: Part of the sewer pipe system for the City of Ashland. Most of the sewer pipe is underground. The Interstate-5 bridge over Bear Creek is visible in the background. Photos © Jeannine Rossa, November 2007.

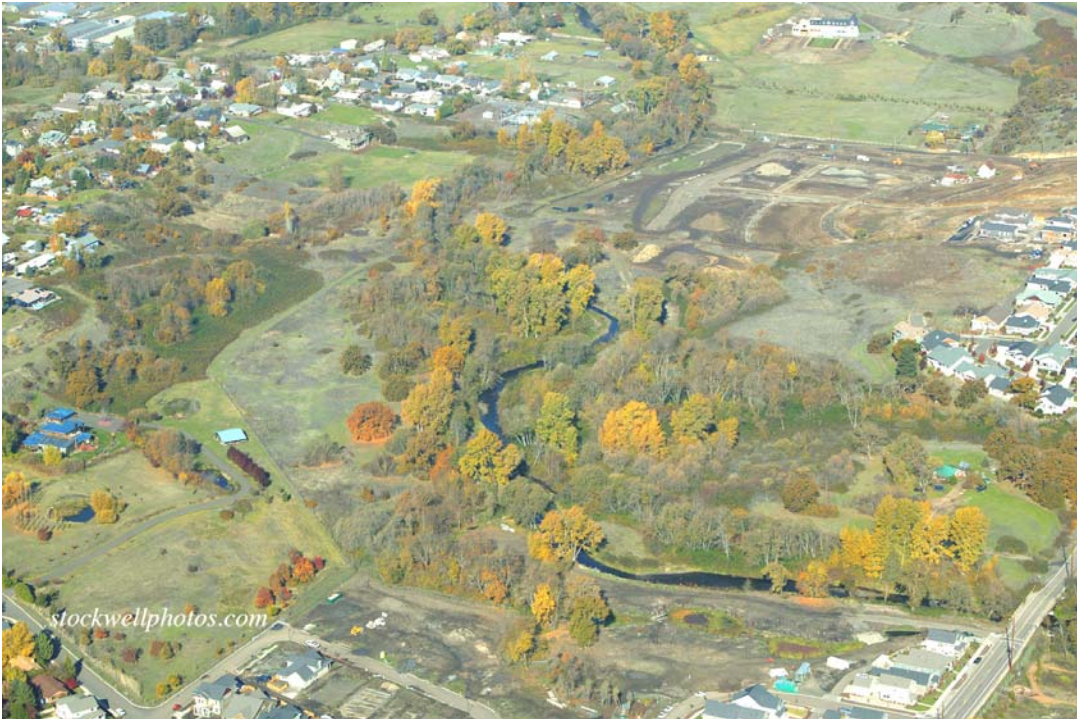
Figure IX-29: Floodplain development near Bear Creek. The grey and white houses in the lower right-hand corner have been constructed on historic old side channels. The dirt and short roads in the background are a newer development off of North Mountain Avenue. The cluster of houses in the right of the photo is located on the hill, and the development is in the flat historic floodplain. Photo © Fred Stockwell, Stockwell Photography.

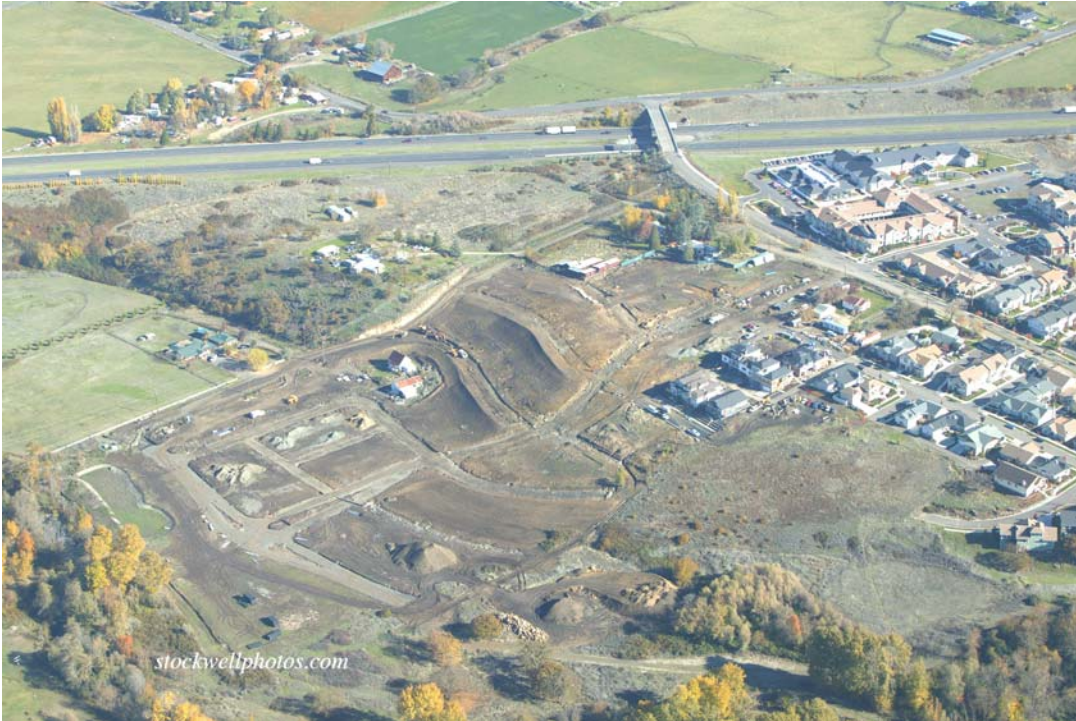
Figure IX-30: Floodplain development off of North Mountain Avenue. One can see the edge of Bear Creek's historic floodplain at the line of trees and bushes at the edge of the flat pasture. Beyond that line, the foothills rise in elevation. Bear Creek's active channel crosses the photo in the lower left-hand corner. Photo © Fred Stockwell, Stockwell Photography.

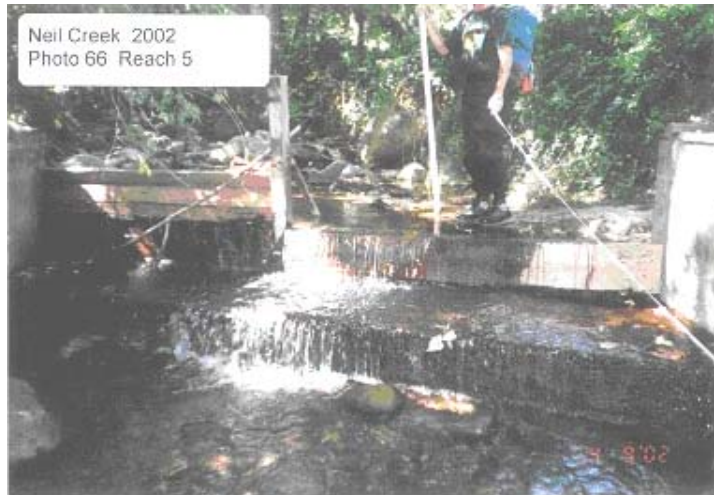
Figure IX-31: Concrete irrigation diversion in Neil Creek.
Photo: Siskiyou Research Group, Sept. 2001 (SRG 2002a).

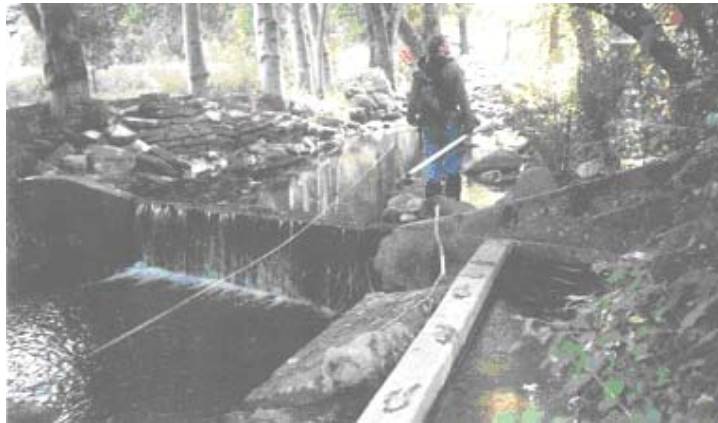
Figure IX-32: Three-foot high irrigation diversion structure on Ashland Creek just upstream of Nevada Street. Photo: Siskiyou Research Group, August 2000 (SRG 2001).

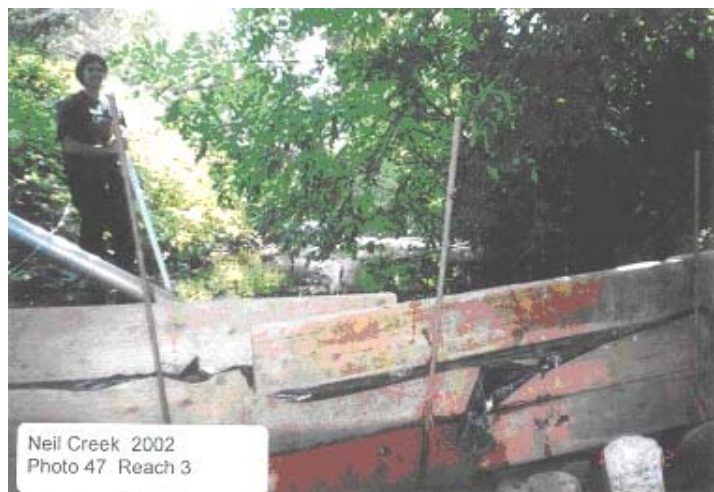
Figure IX-33: Irrigation diversion structure made out of boards, rocks, and plastic in lower Neil Creek along Hwy. 66. Photo: Siskiyou Research Group, September 2001 (SRG 2002a).

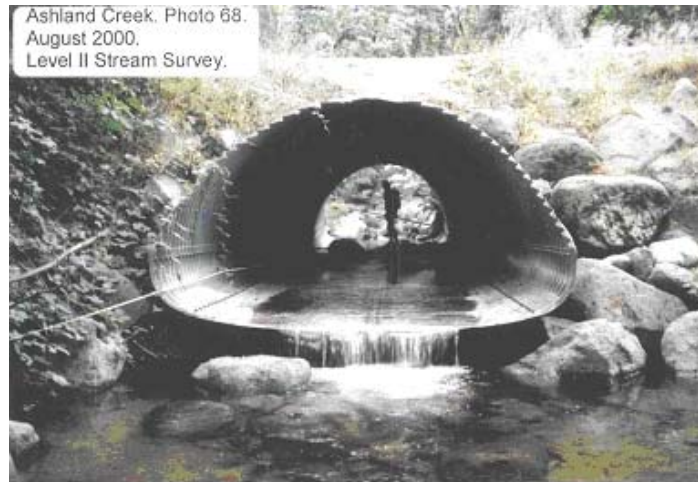
Figure IX-34: Ashland Creek passing under upper Granite Street. Photo: Siskiyou Research Group, Aug. 2000 (SRG 2001).

- d. @ East Side Diversion ditch
5. Begin conversation with City of Ashland about removing fish barrier at Granite Street dam on Ashland Creek to open up potential habitat up to Hosler Dam.

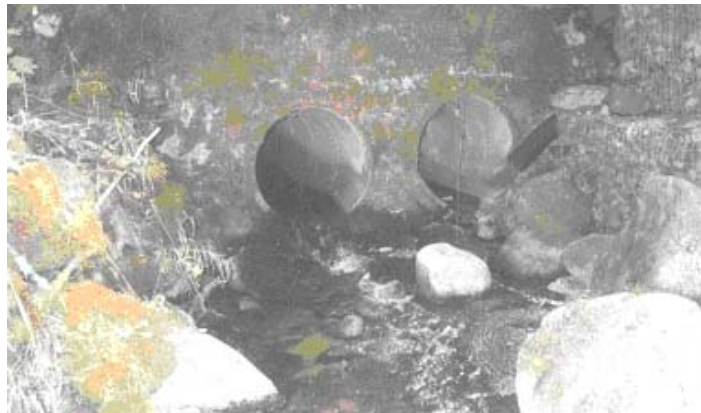
Figure IX-35: Culverts at Ashland's drinking water treatment plant. Photo: Siskiyou Research Group, Aug. 2000 (SRG 2001).

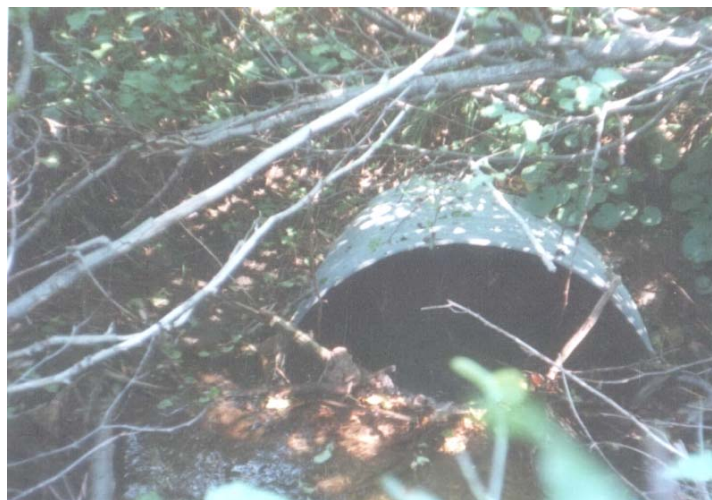
Figure IX-36: Neil Creek culvert blocked by granitic sand and debris, far upstream in T40s-R1e-Sec. 23. Photo: Ecosystems Northwest, September 1999 (ENW 2000).

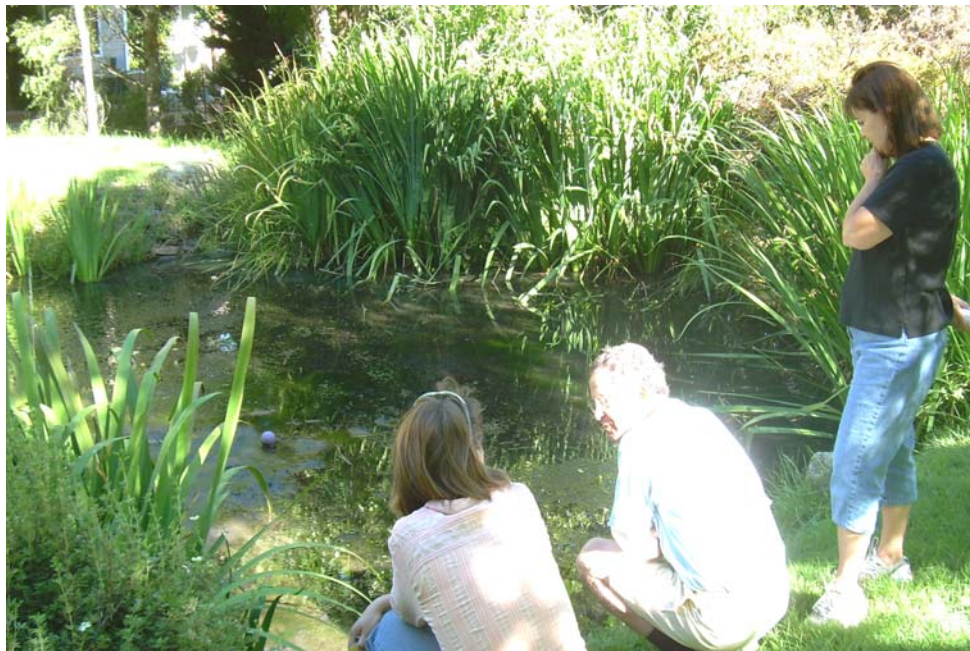
Figure XII-1: Upper Roca Creek constructed pond site needing sediment removal, weed eradication (Yellow Flag).

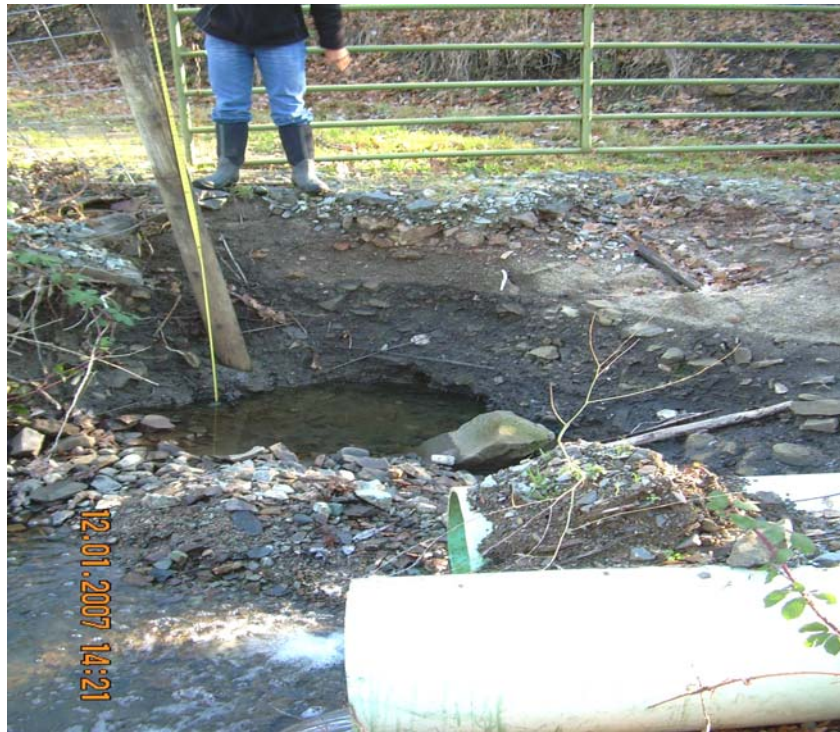
Photo XII-2: Clay Creek near Bear Creek at potential project site. See [Map 16](#), Action Plan Sites, Δ 1.

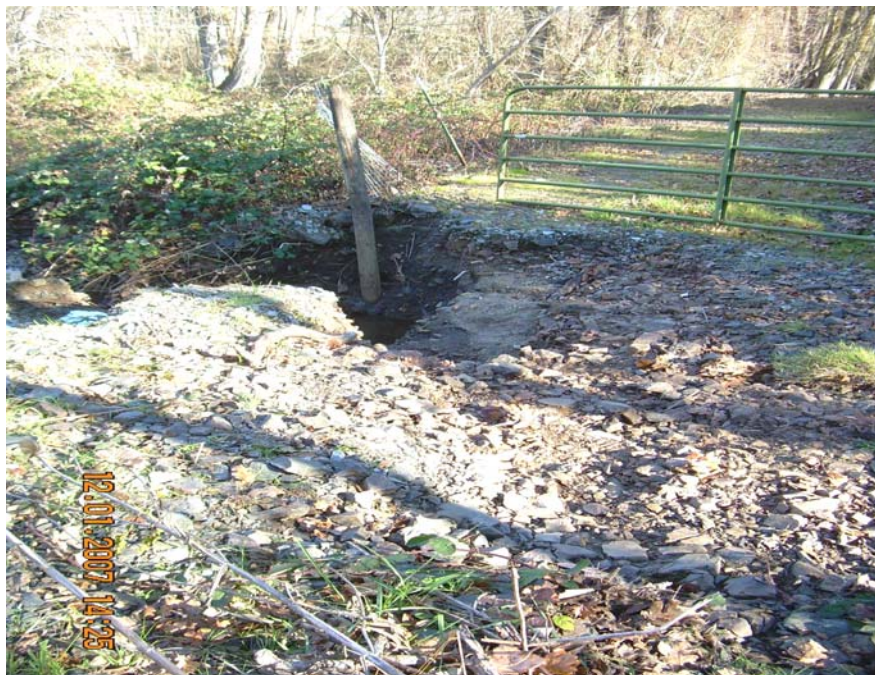
Photo XII-3: Clay Creek at potential project site, view from access road over PVC pipes in photo XII-2. Note same pipe gate and post in both photos.

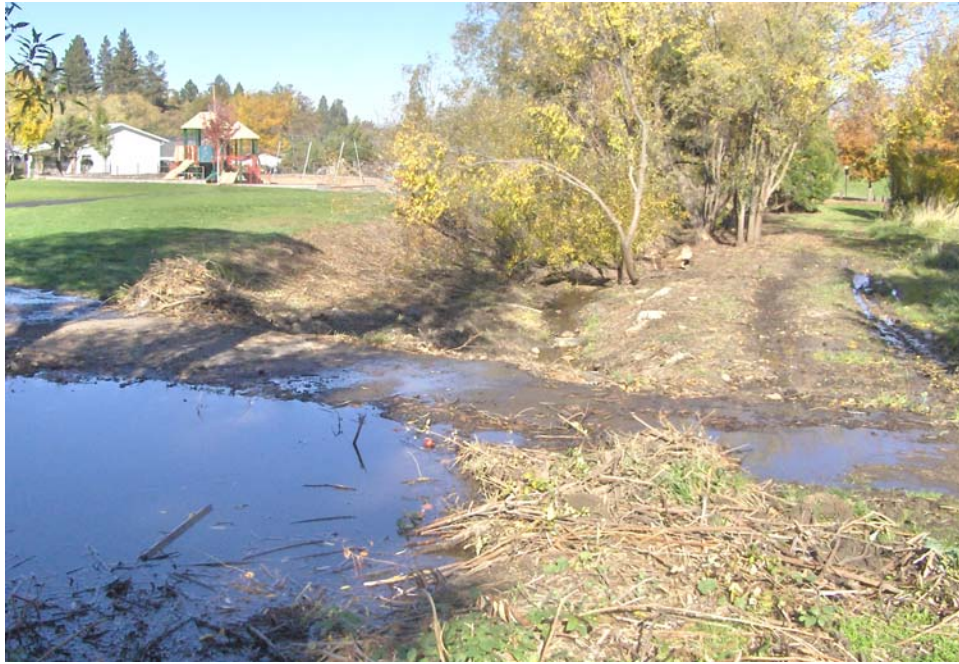
Figure XII-4: Clay Creek at Clay Creek Park. Culvert under path blocked.

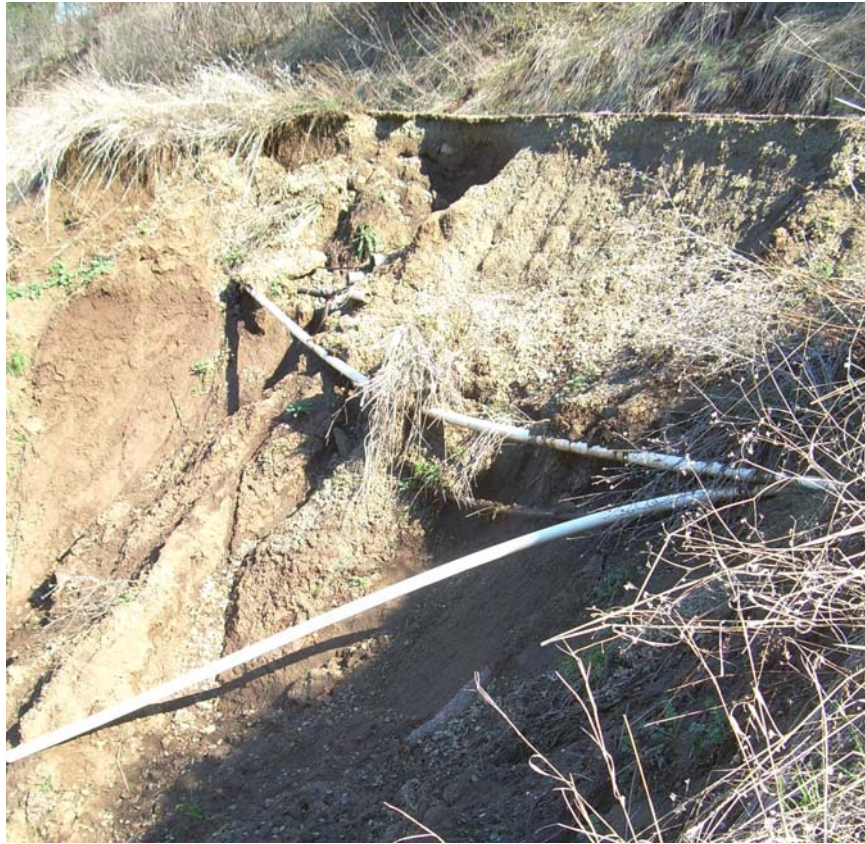
Figure XII-5: Failing road prism in Sec. 31, 38-1East (above Butler Ford).

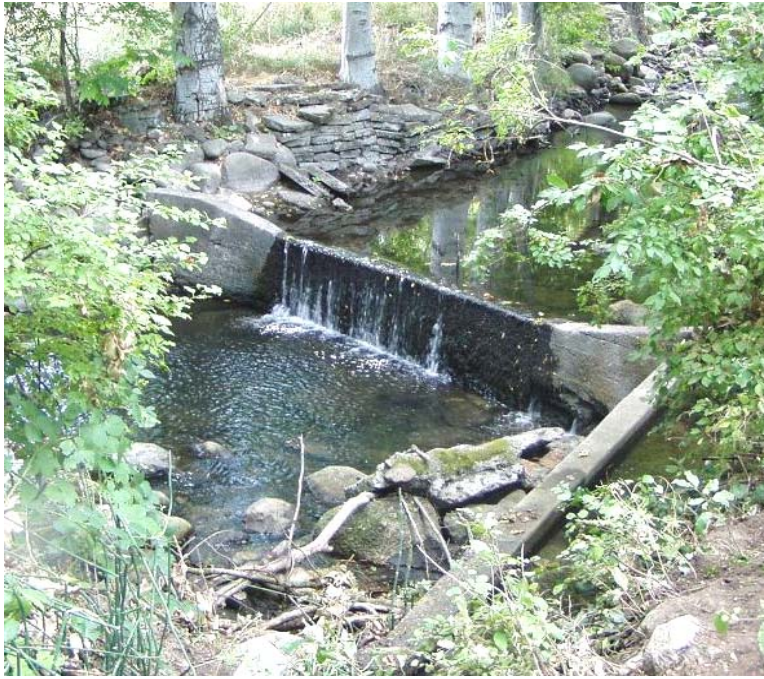
Figure XII-6: Fish barrier on Ashland Creek at Smith/Meyer/Roper diversion, August 2007.
