BRIDGE CREEK WATERSHED ASSESSMENT

Resource Specialists INC.

Wheeler Soil and Water Conservation District

December 2013

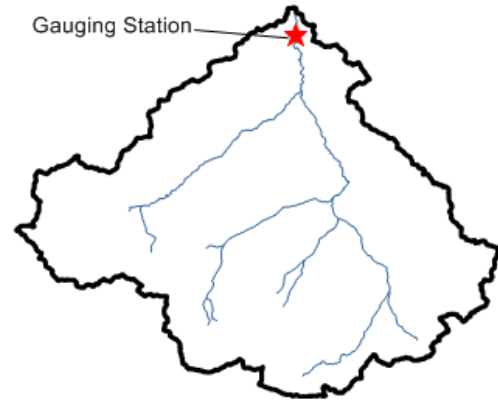
FIGURE 1 - LOCATION OF USGS GAUGING STATION

A USGS gauging station (14046778) at the lower end of Bridge Creek (Figure 1) has data available going back to water year 2008, providing six full years of useable data. The average daily flows from the past six water years are plotted in Figure 2. Exceedance flows at the 5%, 50%, and 95% are provided within the figure.

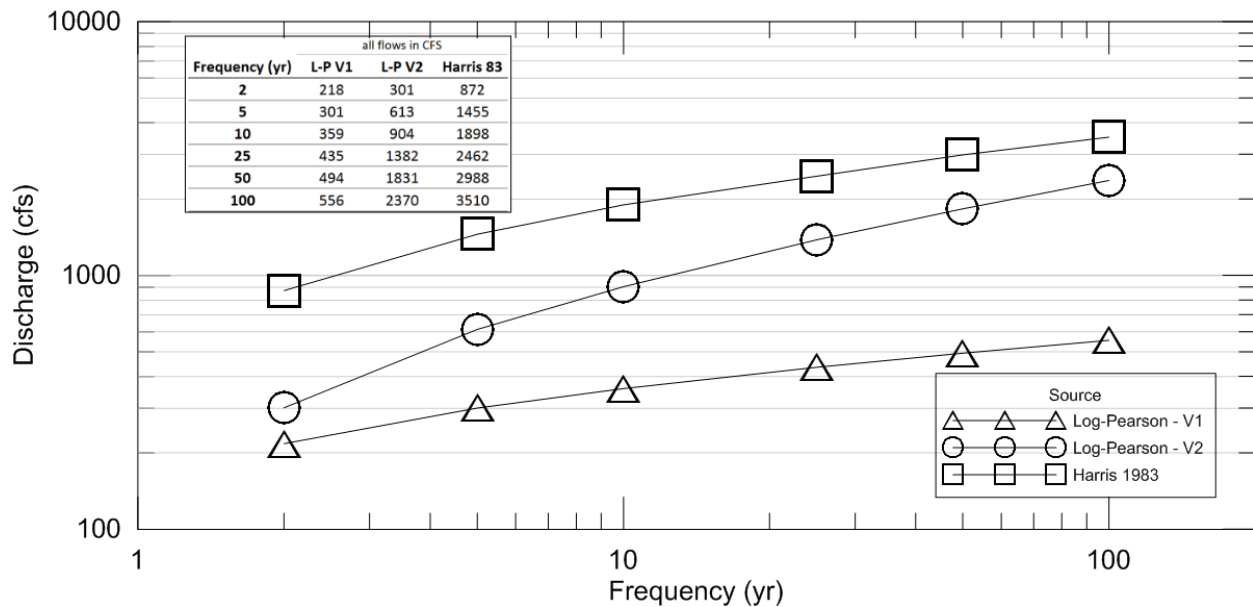
FIGURE 3 - PEAK FLOW ESTIMATES FOR BRIDGE CREEK NEAR THE USGS GAUGING STATION

If the data from August 1, 2009 is disregarded, the second highest peak flow for water year 2009 was only 182 CFS. Both of these values were used to build a set of two peak flow estimates; Version 1 (V1) with the 182 CFS value, and Version 2 (V2) with the 1400 CFS value. Peak discharge information was determined using a log-Pearson Type III distribution with a skew value of 0.2. Peak flows estimates were also calculated using the methodology outlined in "Magnitude and Frequency of Floods in Eastern Oregon" (Harris, 1983). This methodology uses the watershed characteristics of drainage area, percent forested land, average annual precipitation, and average minimum January temperature in a series of exponential calculations for the determination. All three estimates are tabulated and graphed in Figure 3.

The short period of record produces high standard deviations with the Log-Pearson approach, especially when a singular high value (such as 1600 CFS) is introduced into the calculations. The equations from Harris (1983) produced much higher results than either of the Log-Pearson approaches, which has been typical of other similar hydrologic analysis performed in the Wheeler County area.

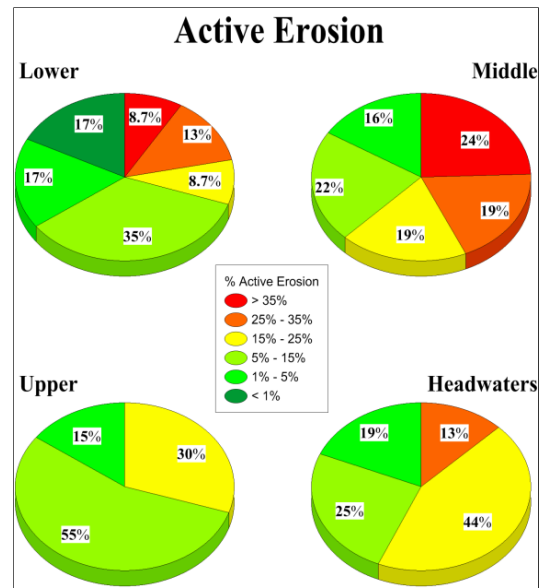
FIGURE 7 - REACH AVERAGED EROSION DISTRIBUTION

Each unit was assigned a value for percent active erosion determined by the amount of bare soil present along the stream bank. Due to stream dynamics, active erosion was typically only observed on one side of the stream. If active erosion was deemed present on one side of an entire unit, but none on the other, the percent active erosion was recorded as 50%. The formula for determining the total active erosion for a quarter mile reach is as follows:

The formula takes into account the relative length of each unit in determining the overall measure of the total active erosion. The spatial breakdown of shading for the four respective HUC 6 watersheds is shown in Figure 7. The distribution of Total Active Erosion values for Bridge Creek is shown in Figure 8. Maps of active erosion are provided for the lower (Figure 9) and upper (Figure 10) watersheds. The areas with the highest degree of active erosion were concentrated between RM 4 and RM 10. This corresponds to the large private ranch located at the confluence of Bridge Creek and Bear Creek and the portion of Bridge Creek that borders the Painted Hills National Monument. There is a small portion of high erosion in the upper reaches (RM 21) but the remainder of the surveyed stream reach does not have any significant erosional issues. The area with the lowest active erosion was the three mile section just above the confluence with the John Day River. This section is very well vegetated and has had very little cattle pressure.

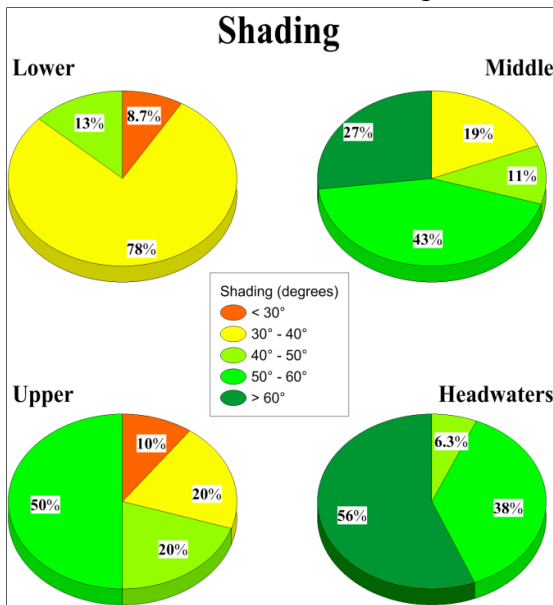
FIGURE 11 - REACH AVERAGED SHADING DISTRIBUTION

The distribution of the total shading metric is shown in Figure 11 and Figure 12. The spatial distribution of the total shading metric is shown in Figure 13 and Figure 14. The areas of poor shading are predominantly in the lower watershed with the lowest five river miles having the poorest ratings. There are areas of poor shading scattered through RM 8 - RM 17 with the majority of reaches showing good shading upstream of RM 17. Much of Bridge Creek between RM 5 and RM 8 shows a high degree of shading; but this may not indicate desirable stream conditions. Wheeler SWCD is currently working on a large scale multi-phase project in this reach that involves removal of Russian olive. Russian olive is an invasive species that was widespread throughout the watershed. Large-scale removal efforts have left this private landholding near the confluence of Bridge and Bear Creek as the last remaining stand of Russian olive in the watershed. Once the Russian olive trees are removed the shading through this segment will initially decrease, but eventually native vegetation will proliferate, resulting in increased shading and a more natural stream system.
