Tenmile Lakes Delta Building Study

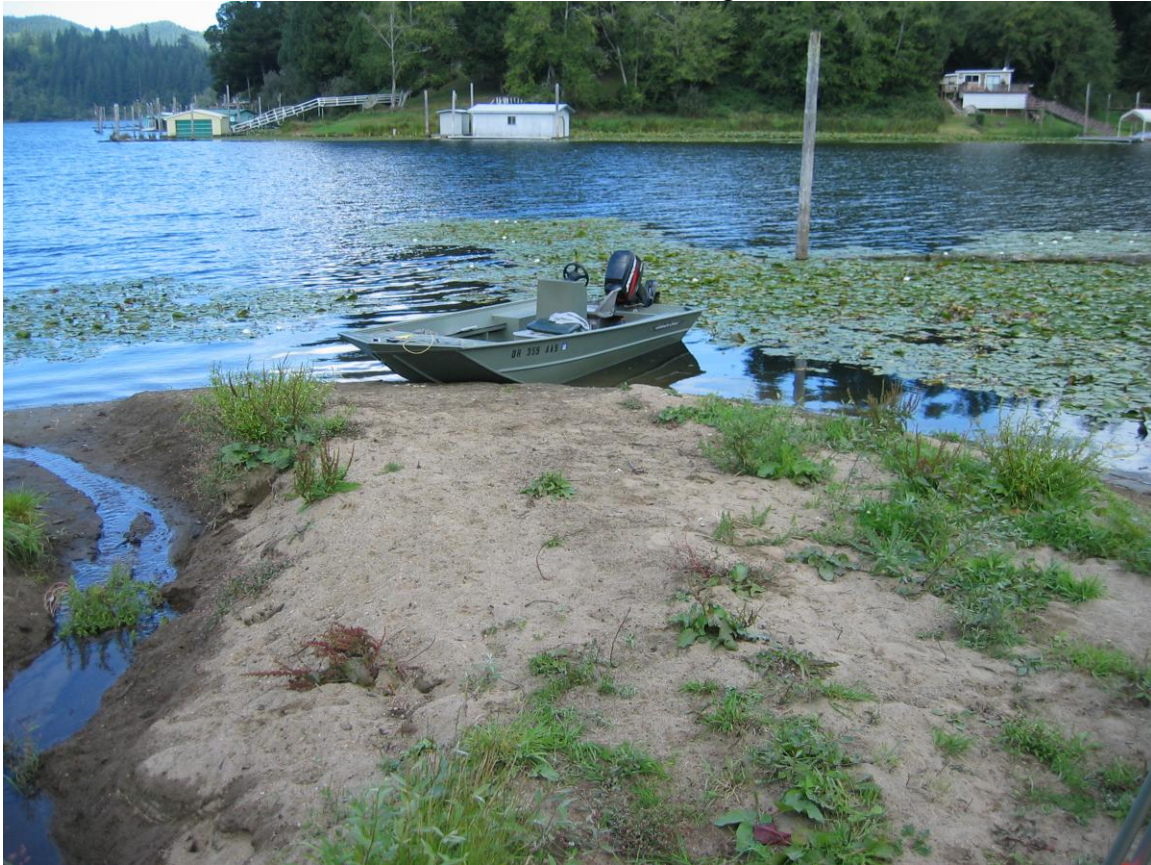
Sunlake Delta 9-14-04

5': 7' 7" East, 7' 6.5" Center, 7' 8" West. Width: 23' 4"

15': 7' 7.25" East, 5' 4"-9ft in, 5' 1.25"-4ft 6inches east of center, 7' 7" Center, 6' 7"-4ft 6inches west of center, 6' 10.25"-9ft from west water edge, 7' 7.75" West. Width: 40' 3"

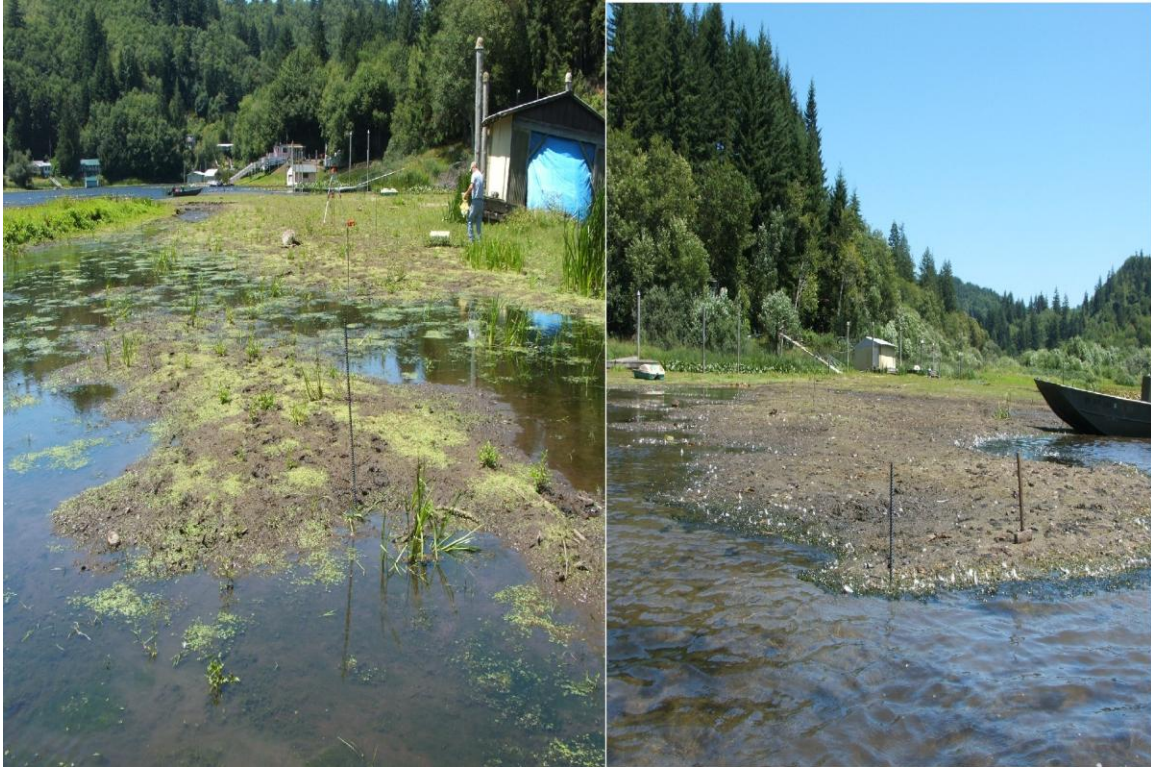
Big Delta 7-27-2007

1. 0': 6'3.5" center. No width
2. 50': 6'3.5" left, 5'10.5" Center, 6'4" right, Width: 49'6"
3. 100': 6'3.75" left, 5'11" Center, 6'2.5" right, Width: 105'
4. 150': 6'4.75" left, 5'7.5" Center, 6'3.25" right, Width: 135'4"
5. 200': 6'1.75" left, 5' 10" Center, 6'3.25" right, Width: 118'7"
6. 250': 6' left, 5'8.5" Center, 6'4.75" right, Width: 109'6"
7. 300': 5'11.75" left, 5'11.5" Center, 6'.5" right, Width: 70'2"
8. 350': 5'10.25" left, 5'.75" Center, 5'11.25" right, Width: 59'6"
9. 387': 5'9.25" left, 5'4.5" Center, 5'1.75" right, Width: 33'
10. 420': 5'9" Center. No width

All rebar was capped with 4"x4" safety caps.

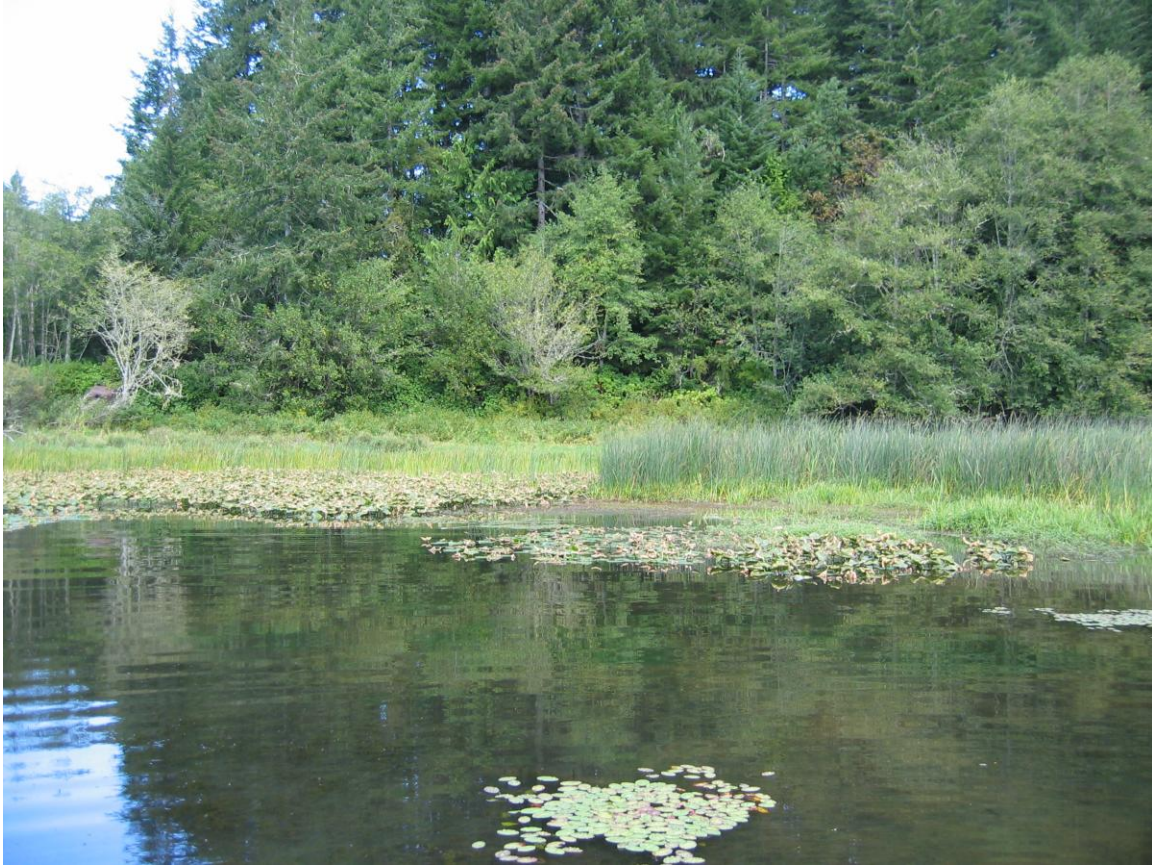
Murphy 9-14-2004

2004- No delta was visible.

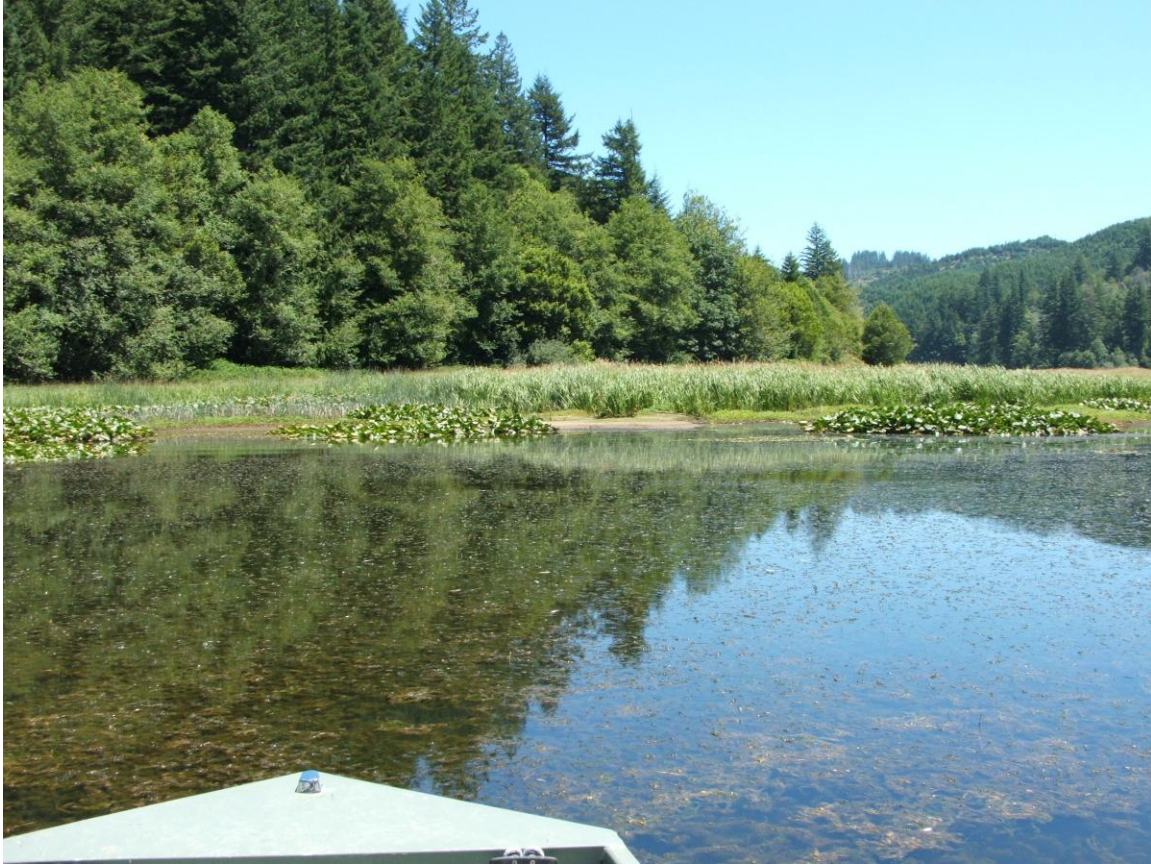
Murphy Delta 7-20-2006

2006- Delta was observed, but the potential site to place the survey instrument and marker was on private land, and permission to access this spot could not be obtained.
