Indian Creek Aquatic Restoration

Oregon Wildlife Heritage Foundation

Narrative Summary:

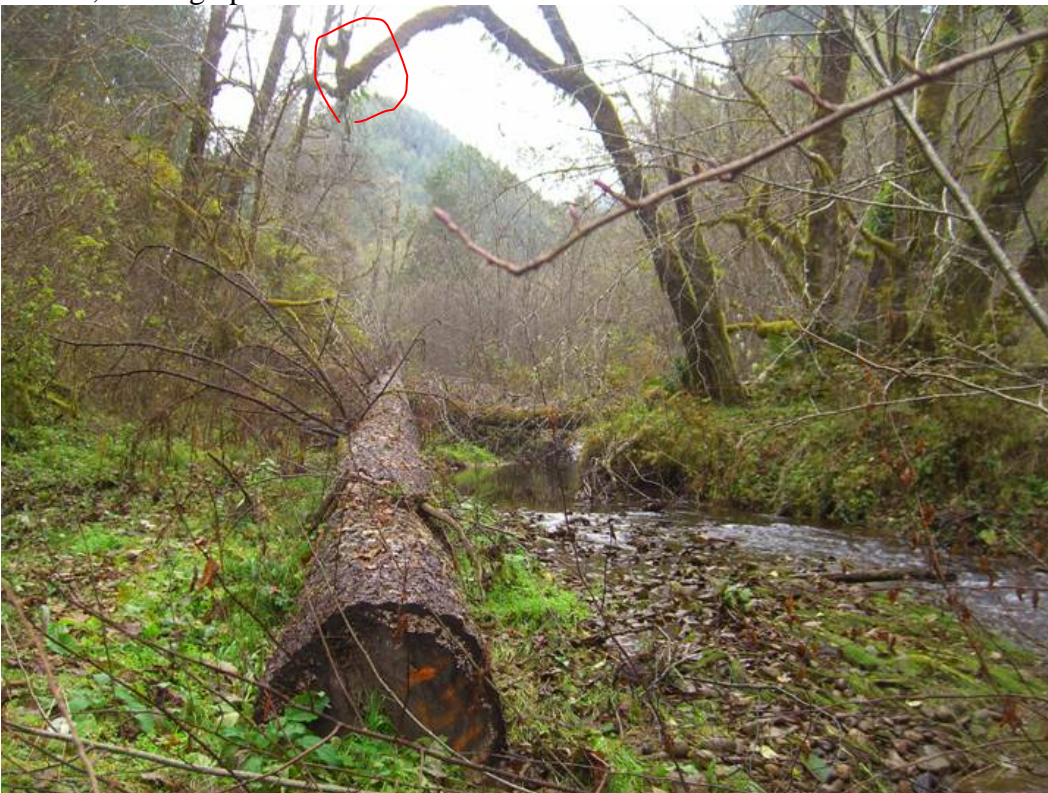
Site #4, looking upstream – 2007

New Comments: The structure has affected the channel enough to develop a point bar at the downstream end of this structure, causing the stream to become more sinuous.

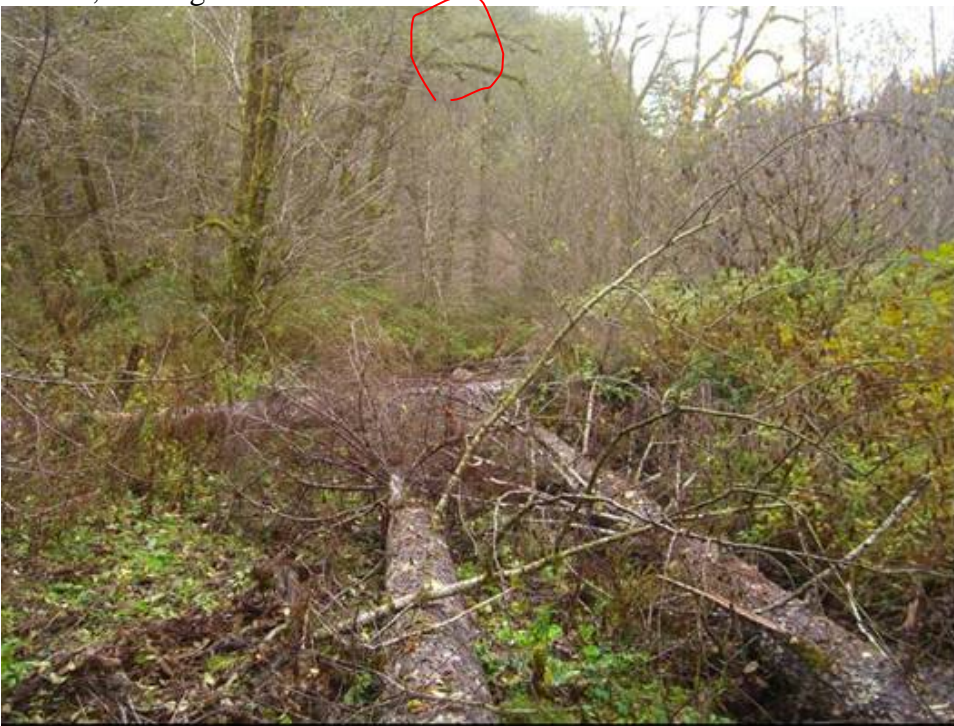
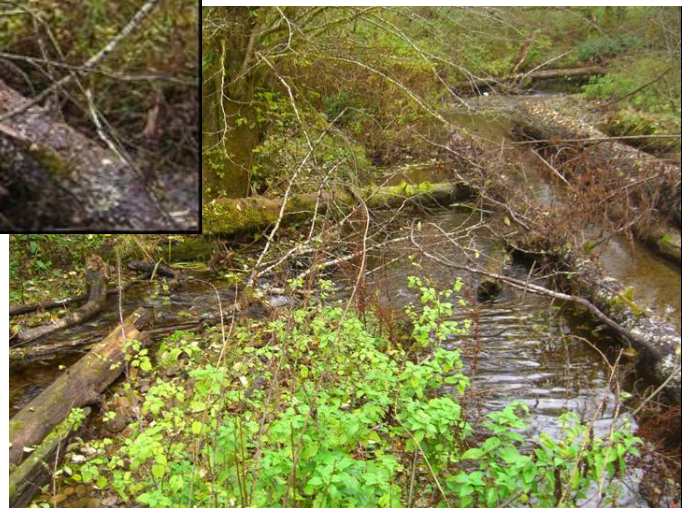
Site #5, looking downstream – 2007

New Comments: The trees have changed the stream dynamics significantly by collecting sediment and creating a side channel. The photo on the right shows the area right where the channel splits.

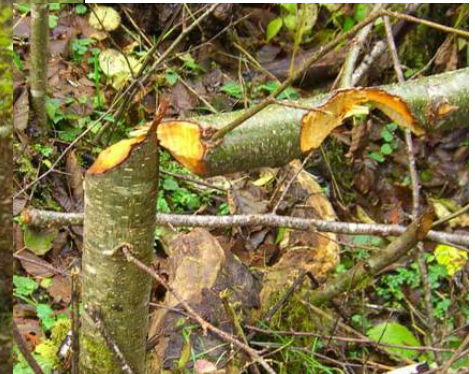
The photo above shows the 6 inch DBH alder that the eager beaver munched down right below this structure site.

New Comments: The structure is helping the water seep out into the low-level floodplain zone (covered with small alders) during high water events. It's also adding various scour depths in the channel unit.

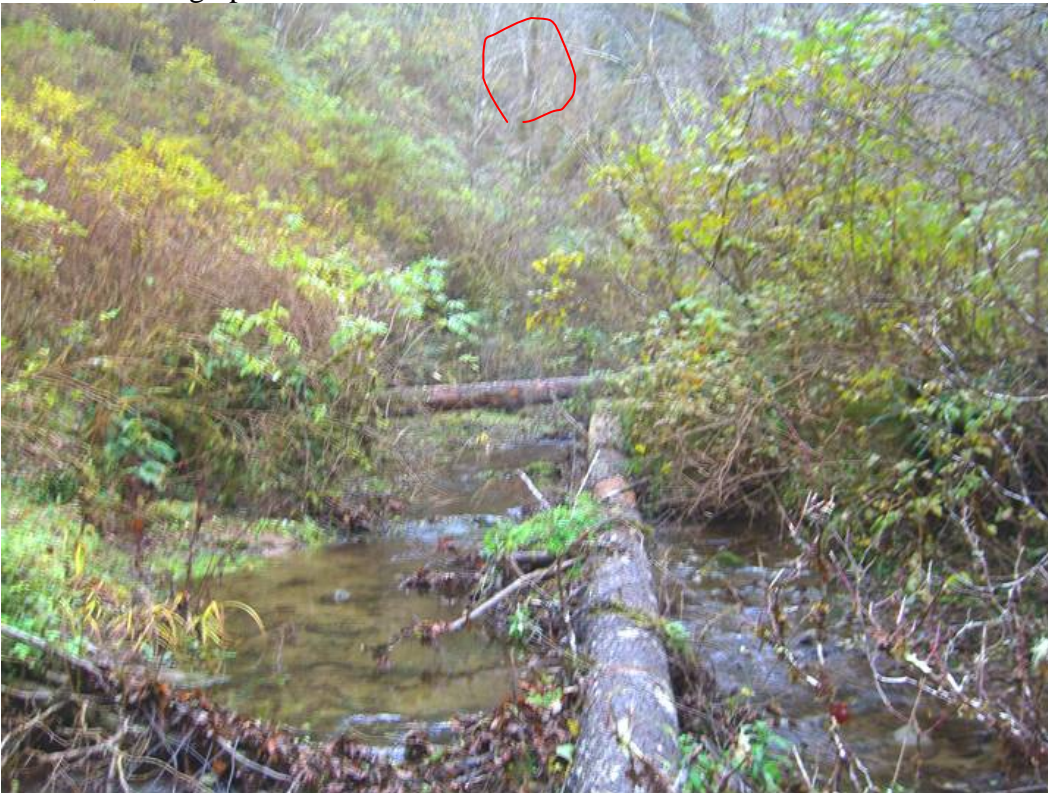
Site #9, looking upstream – 2007

New Comments: There was small woody debris collected around the new trees in addition to some beaver cuttings that were scattered in here. There is tributary that comes in on the left side, so we look forward to see future debris collection at this site.

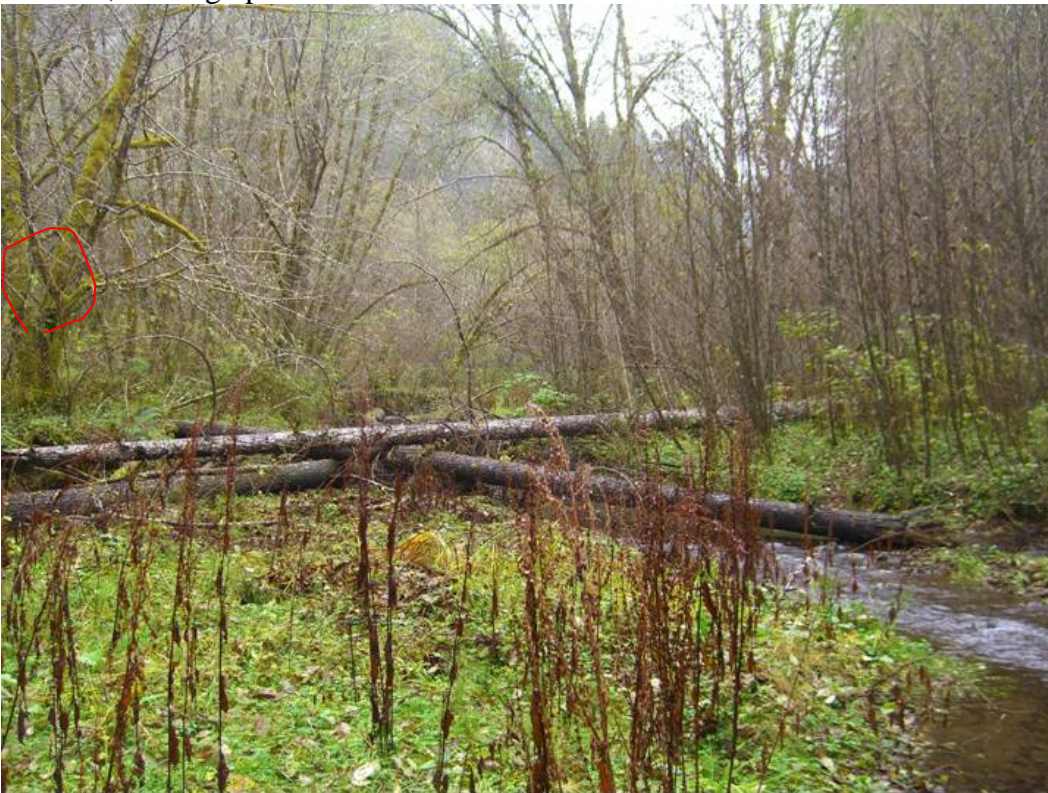
Site #25, looking upstream – 2007

New Comments: The structure is helping regain the floodplain interaction by causing the high flow water to move into the low-level floodplains on both side of the bank.

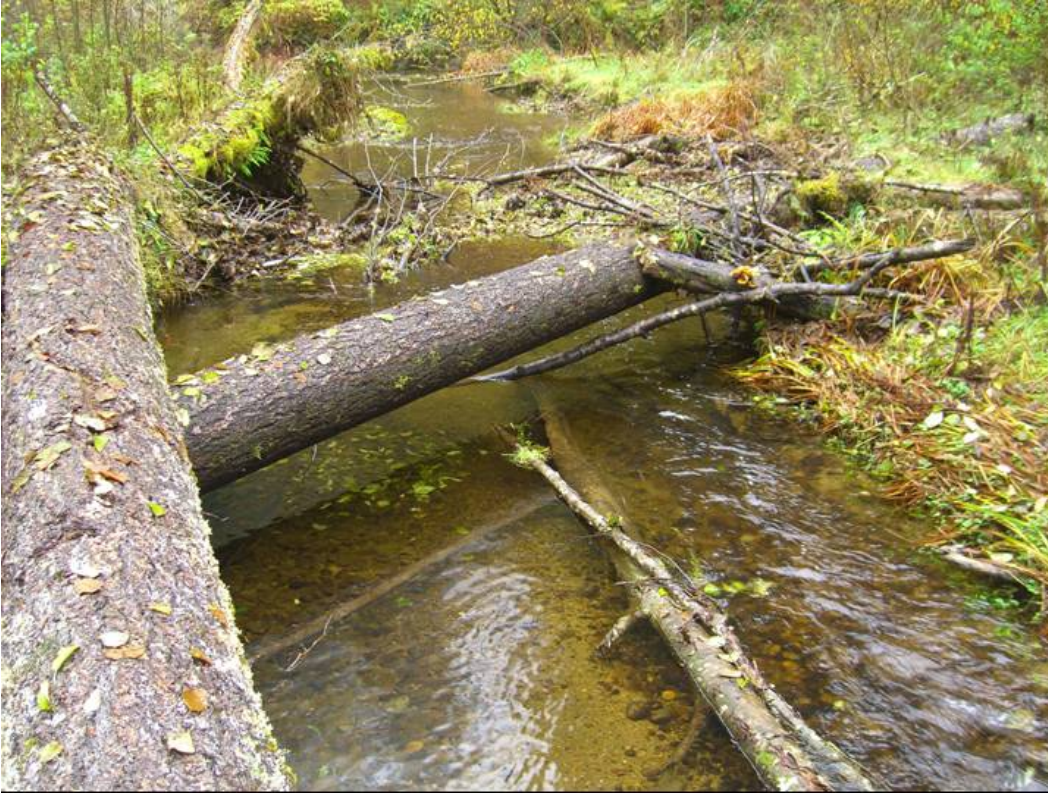
Site #27, looking downstream from the bottom end of the structure – 2007

New Comments: The photo above shows the deep scour pool created in this channel unit. The photo below shows how the upstream end tree is encouraging the formation of a pronounced point bar.

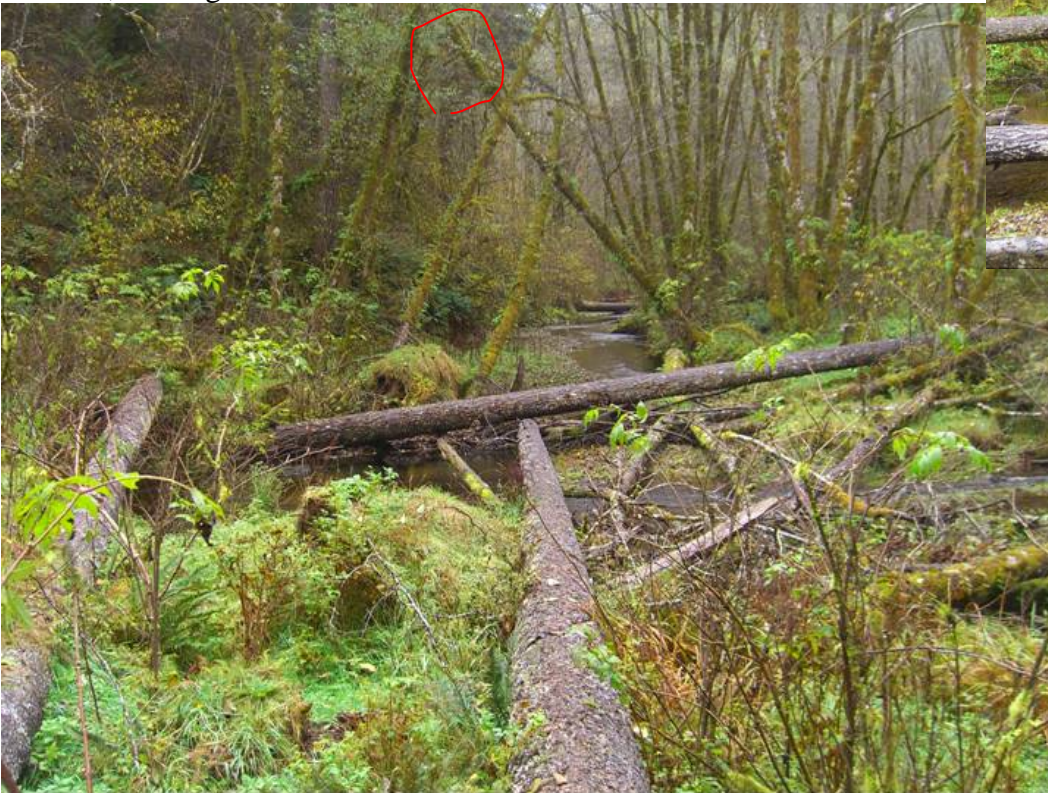
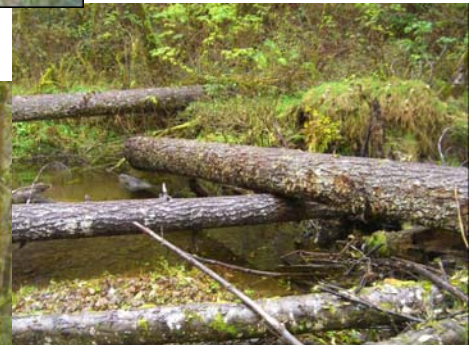
Site #28, looking downstream – 2007

This photo above shows the wood that are helping scour the deep pool.

New Comments: There is a mid-channel island that is forming under the right hand tree and the deep pool under the left hand tree is maintaining and increasing its depth as a result of the wood scouring.

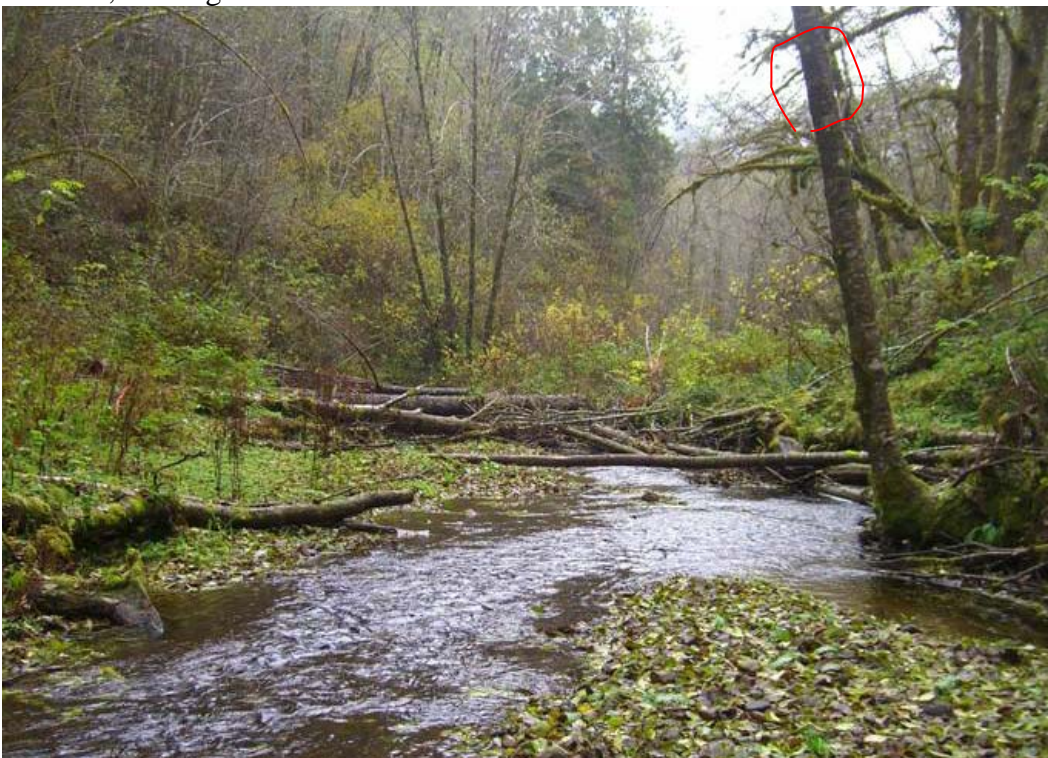
Site #30, looking downstream – 2007

New Comments: the channel seems to be encouraging the formation of the mid-channel island and side-channels upstream as a result of slowing down the water.

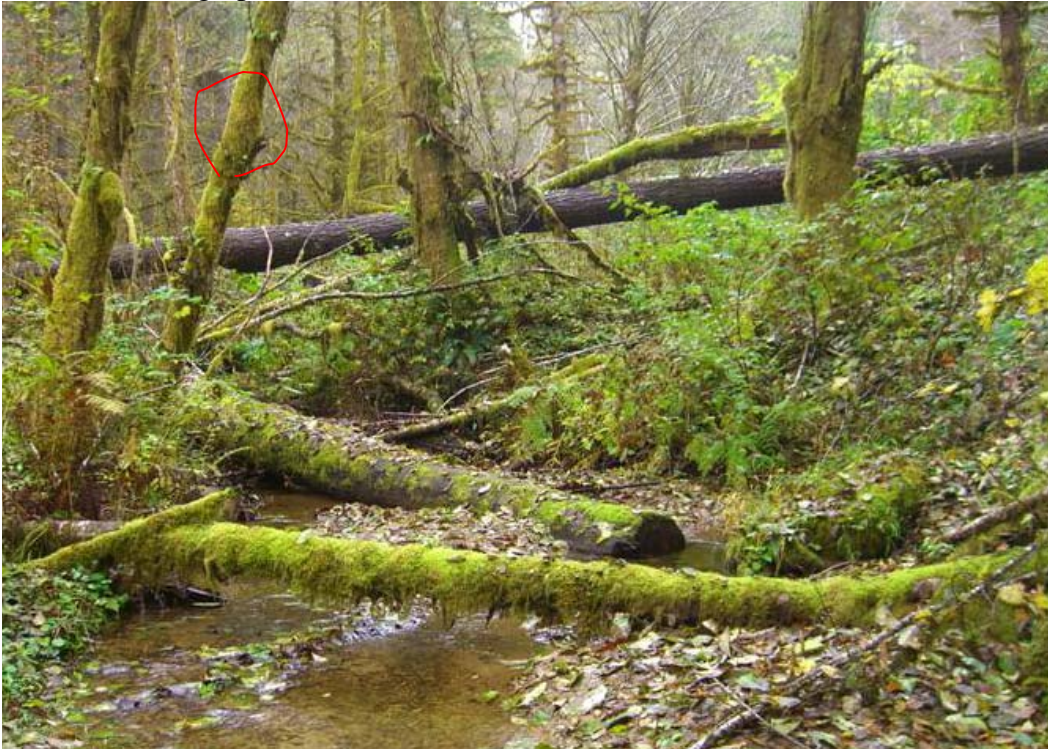
Site #11 looking upstream – 2007

New Comments: The structure is starting to collect sediment and detritus all around these trees and changing the way this site looked drastically. I almost did not recognize it was the same site.

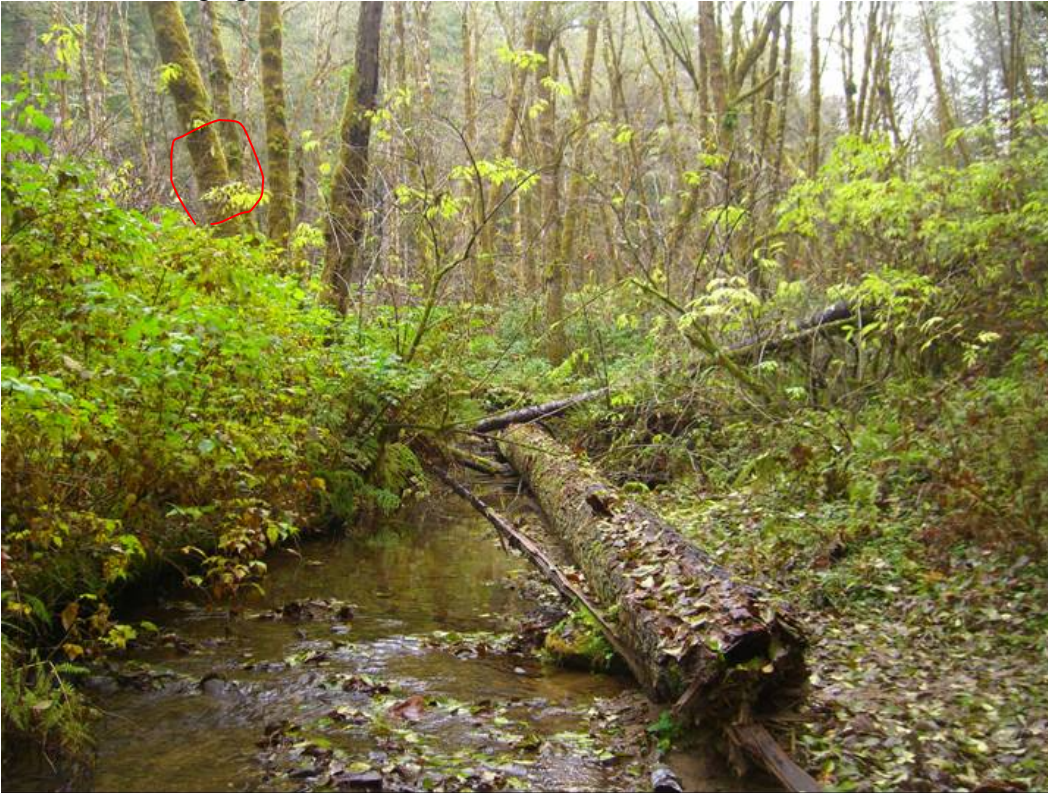
Site #13 looking upstream – 2007

New Comments: Gibson Creek seems to collect a lot of leaf litter and other coarse organic material, and as a result the structure is collecting that and sediment actively around the placed trees.
