*Lateral Channel Migration, Downcutting and Restoration Potential
of
the North Fork Siuslaw River*

A report prepared for the Siuslaw River Watershed Council

*Barbara Ellis-Sugai, PhD
Forest Hydrologist
Siuslaw National Forest*

July 2002

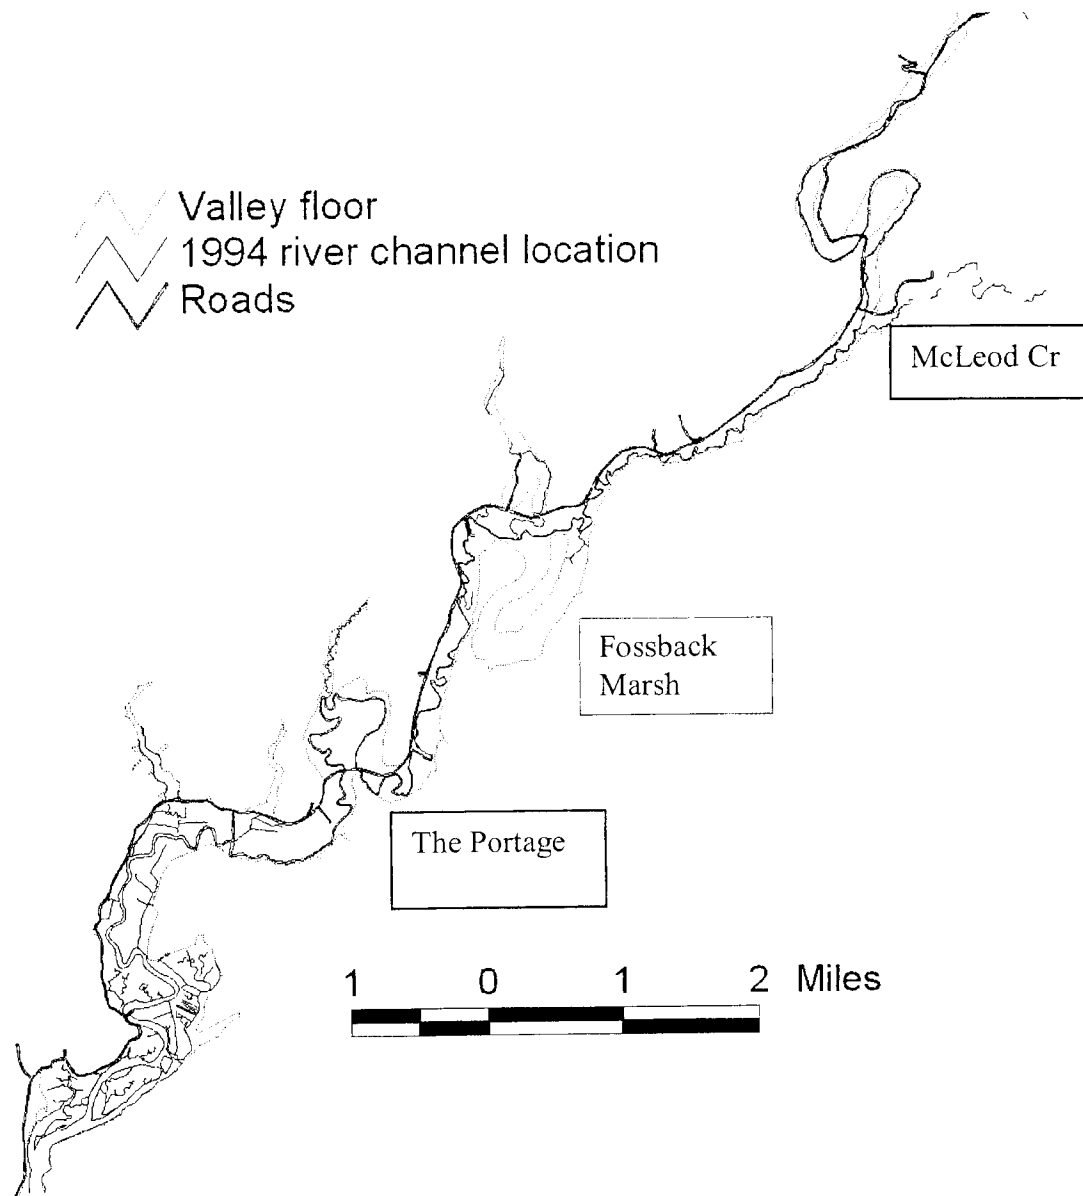
Old, large meanders that are defined by the valley floor are present in the landscape upstream of McLeod Creek, at Fossback Marsh, and the Portage (Figure 3). Fossback Marsh is an abandoned meander. At some time in the past, the river cut a new channel across the meander. Abandoned meanders are not uncommon in the Oregon Coast Range. Similar abandoned meanders are found along the Yaquina River (Boone and Nute Sloughs) and along Five Rivers (Swamp Creek).

Figure 3: Large ancient meanders in the North Fork Siuslaw watershed. The large meanders in the valley floor are located north of McLeod Cr, at Fossback Marsh, and at the Portage. Fossback Marsh occupies an ancient meander that has been cut off from the mainstem of the North Fork Siuslaw River.

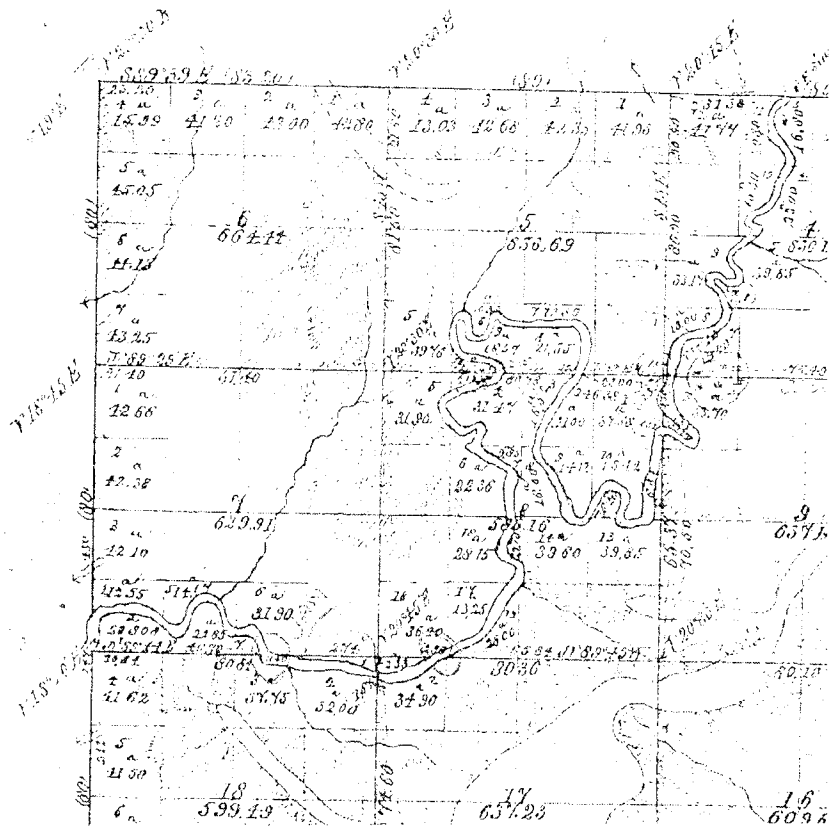
Figure 4a: 1879 GLO MAP

The notes and the accompanying map (Figure 4) show that the river around the Portage, and just downstream (T18S, R11W, Sections 7 and 8) has not changed much since the surveys were done. Also, the notes show that the river channel was north of Fossback Marsh in 1879, and that the marsh had been cut off from the mainstem of the river by then.

Information on the amount and location of large wood in the river channel is sketchy. Because the survey was conducted by walking section lines, only the logjams that occurred on a traverse would have been noted and recorded. A large logjam was recorded below the Portage between river mile 5 and 6 (see Figure 4). The jam had buried one bank under wood, and was big enough for the surveyors to walk across. Other logjams and large wood were probably present in the river, but were not recorded in the survey notes. As with other streams and rivers in the Coast Range, there would have been periodic deposition of logjams, which would have captured gravels and helped to aggrade the river bottom. By 1880-1890, the river was open for navigation, which suggests that the logjams had been cleared from the river by that time (Charlie Dewberry, pers. comm.).

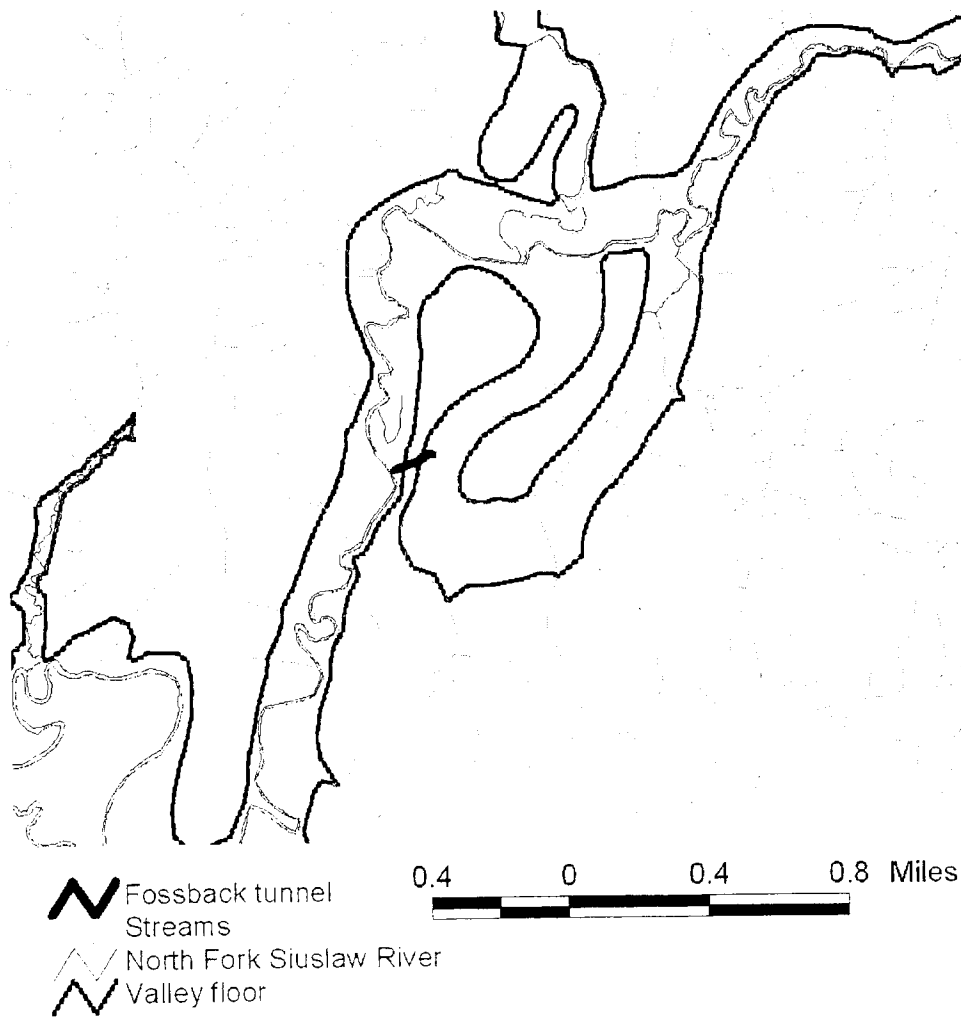
Drainage in Fossback Marsh was altered when a tunnel was dug through the ridge west of the marsh and a small, unnamed stream was routed through the tunnel to join the North Fork Siuslaw River. It is not known when the tunnel was constructed; however, its existence was noted in a 1992 stream survey. See figure 6 for the location of the tunnel.

Figure 6: Location of tunnel cut through ridge to connect Fossback Marsh to the mainstem of the North Fork Siuslaw River.

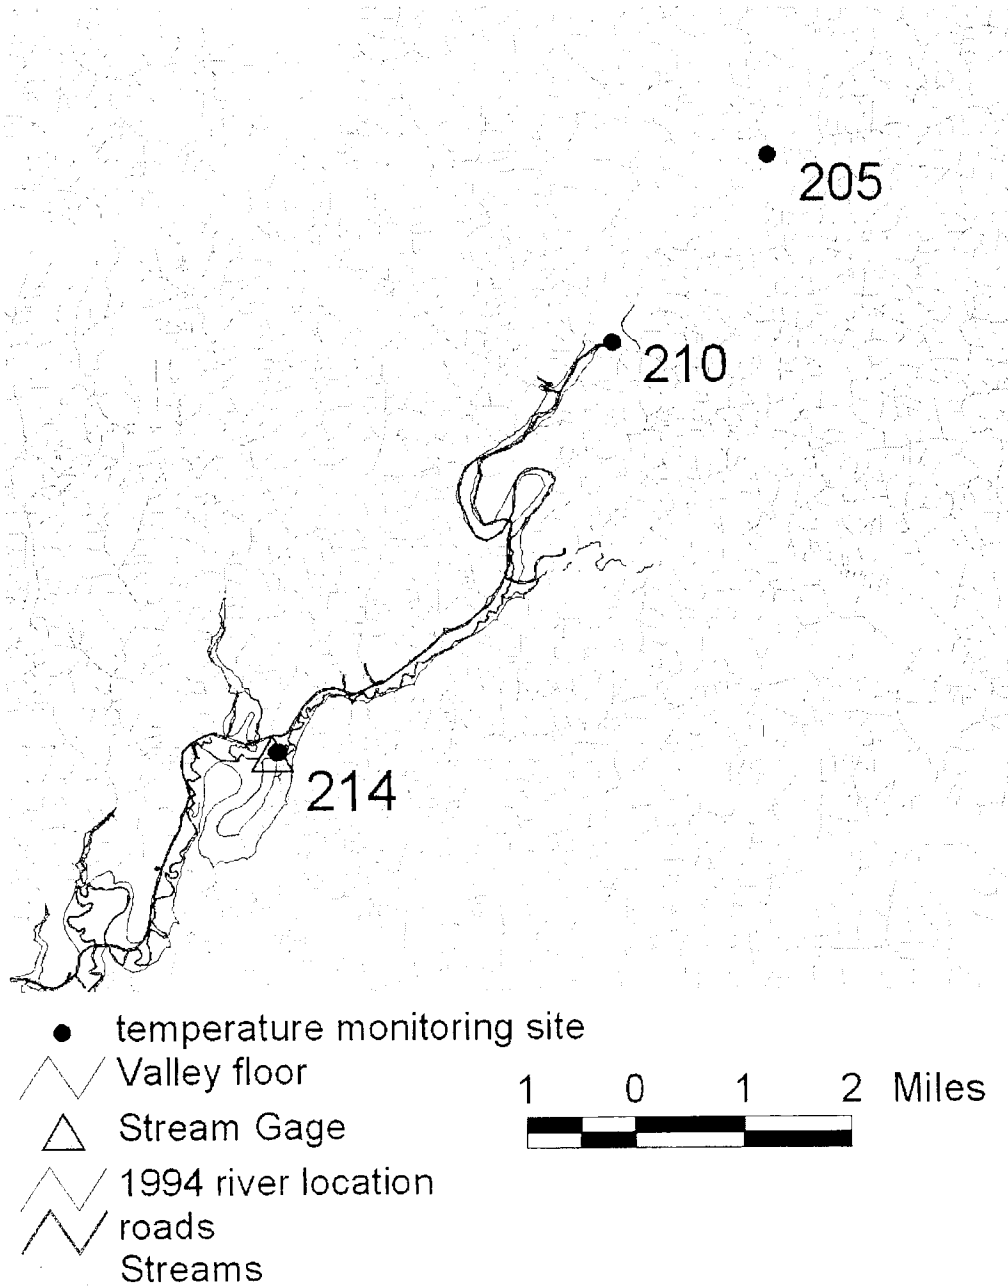
The US Geological Survey stream gage, which was in operation from 1967 to 1985 was located just upstream from Condon Creek. The location of the stream gage is shown on Figure 9. Floods in the North Fork Siuslaw watershed occurred in 1964, 1972, 1984 and 1996. Peak stream flows in 1972 and 1984 reached 2280 cfs (cubic feet per second) and 3900 cfs respectively. Unfortunately, by 1996, the stream gage was no longer in operation. For comparison, the peak flow for the 1.25 year recurrence interval for the North Fork Siuslaw River is 2230 cfs.

Stream temperatures in the North Fork Siuslaw watershed have been monitored at various locations since 1994. Data from three sites on the mainstem of the river are shown in Table 3, and the locations are shown in Figure 9. The Department of Environmental Quality has set a standard of a 64F for the maximum temperature of the running 7-day average of the daily maximum. The North Fork Siuslaw meets this standard upstream from the PAWN trailhead, but summer temperatures exceed this standard downstream, probably due to a lack of shade, and the southwest orientation of the valley.

Figure 9: Location of U.S. Geological Survey stream gage and temperature monitoring sites on the North Fork Siuslaw River.

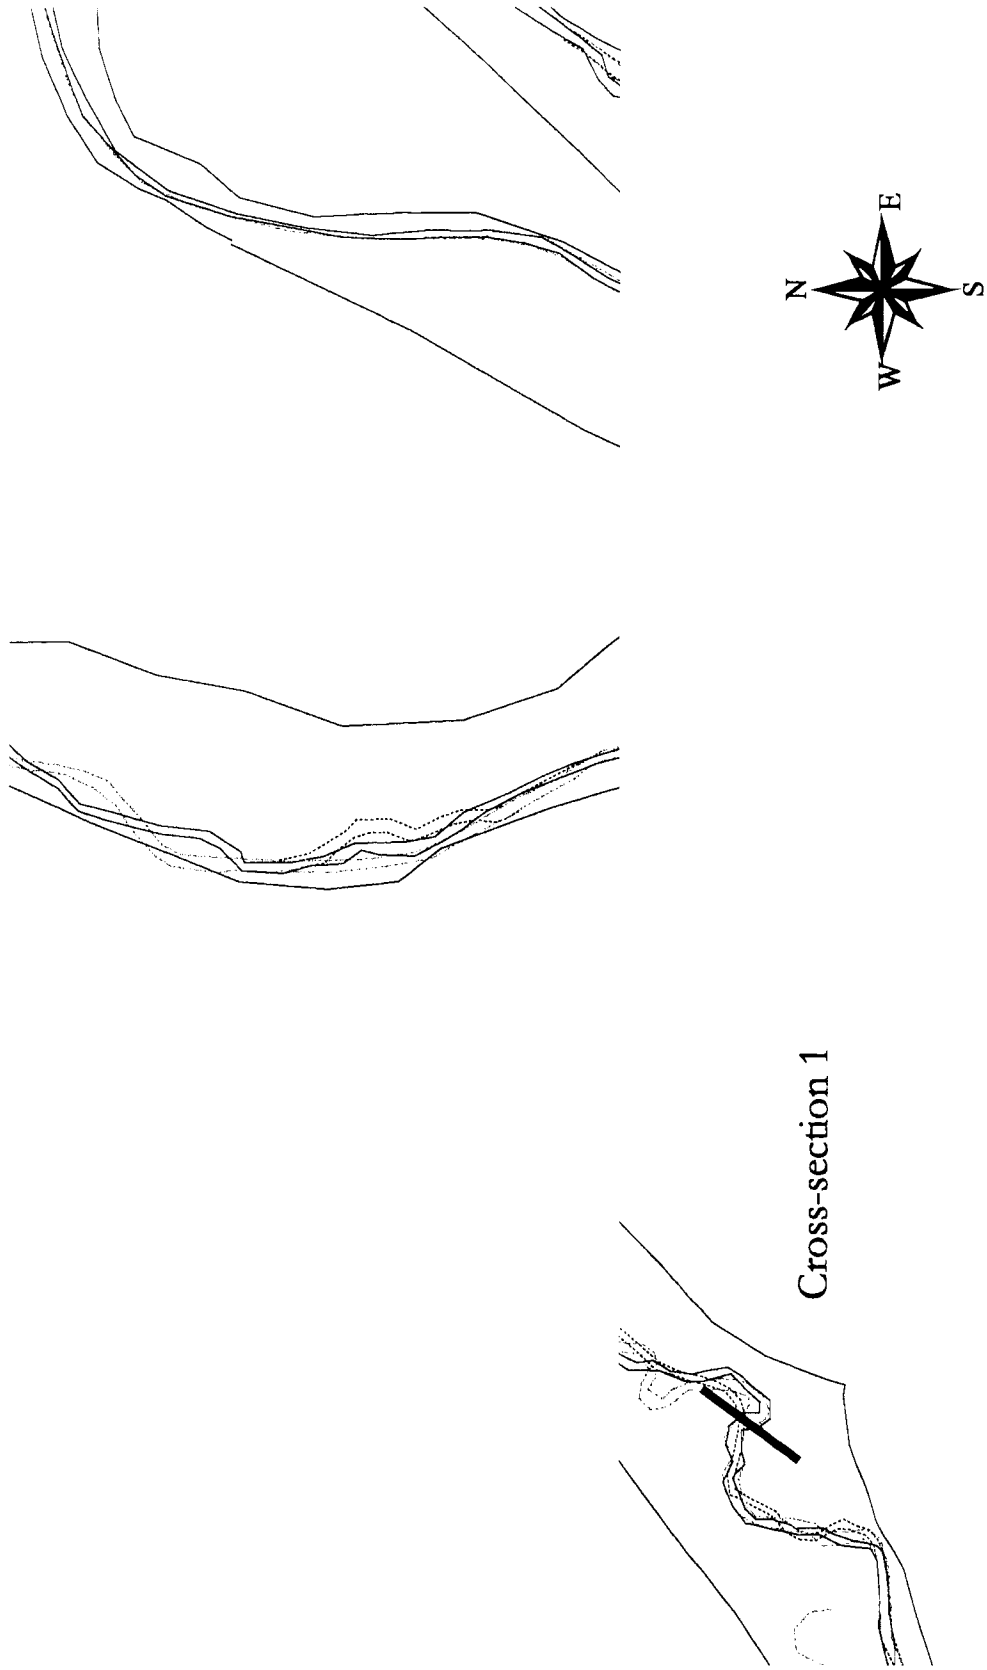
Figure 10: Location of cross-sections on the North Fork Siuslaw River.

Cross-sections were measured downstream from McLeod Creek, and were used to classify the river channel according to Rosgen’s (1996) methodology. The location of the cross-sections is shown in figure 10, and the cross-sections is shown on figure 11. Numerical data derived from the cross-sections is shown in Table 6.

The North Fork Siuslaw does not fit neatly into any one stream type. This lack of correlation suggests the stream channel may be evolving from one stream type to another. Cross-section 2 measures an abandoned channel (not shown), as well as the active channel. Assuming the abandoned channel has not been modified or filled in, the bottom of the channel is approximately 5-6 feet below the valley floor. The active channel, on the other hand, is downcut approximately 16-18 feet below the valley floor. Comparing the depths of the two channels suggests considerable downcutting into the floodplain has taken place. Based on the numerical data from the cross-sections, and the qualitative

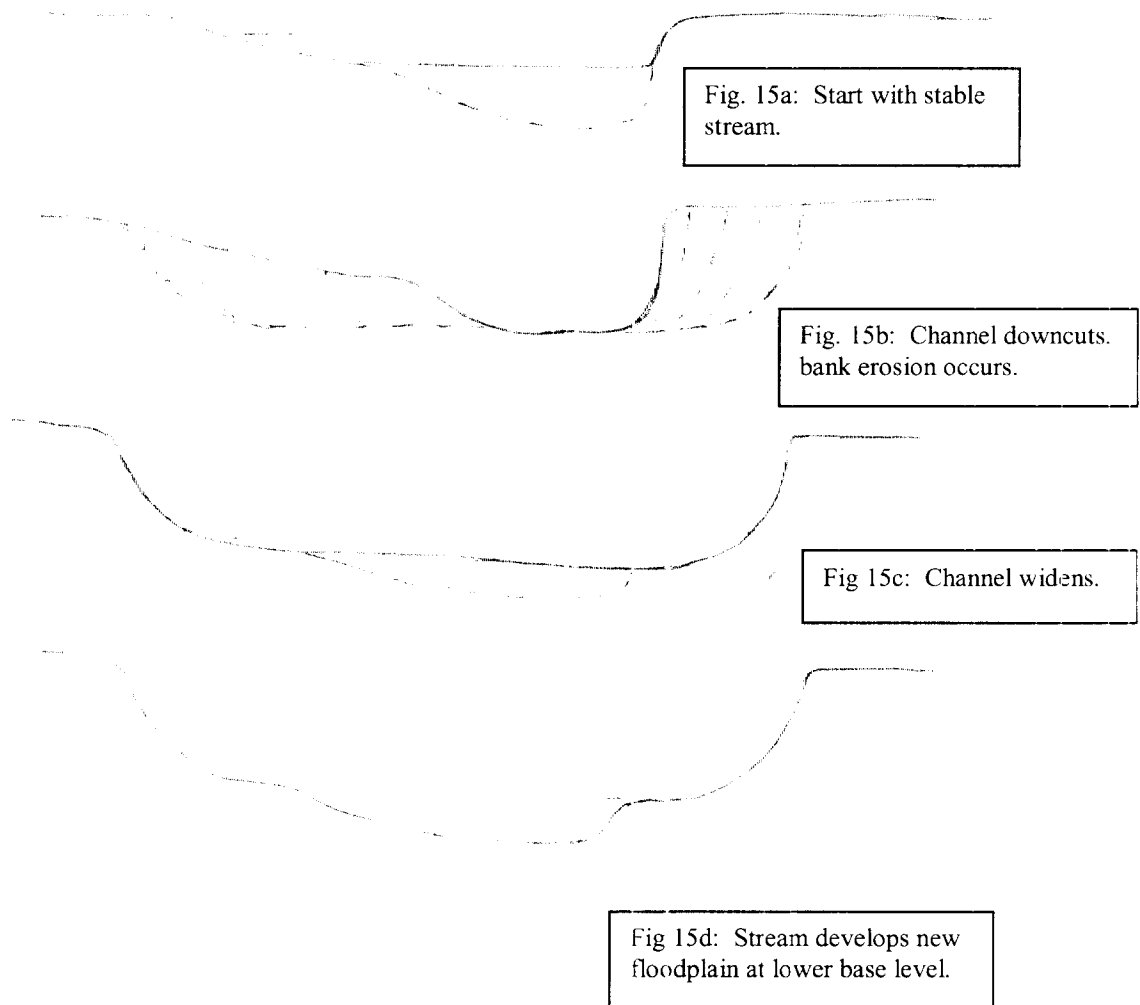
Figure 13: An example of channel evolution for a downcut stream.

Assuming the river is downcut, what is likely to happen in the future? Both Schumm (1986) and Rosgen (1994) have developed a model for channel evolution for downcut streams (Figure 13). The model starts with a stream that is stable (Figure 13a); in other words, it could be migrating laterally, but the channel dimensions are staying about the same. Something happens to disturb the system, such as channel straightening, or removing grade controls, like large wood. The channel responds to the changes by

downcutting into the floodplain (Figure 13b). After downcutting to a new base level, the stream begins to meander and the oversteepened banks are eroded. The stream channel becomes wider (Figure 13c). As the channel reaches a new equilibrium at the lower base level, it develops a new floodplain, and the old floodplain becomes an abandoned terrace (Figure 13d).
