# 2003 Restoration Project Effectiveness Monitoring Report

## Fish Passage Improvement Projects

### Summary

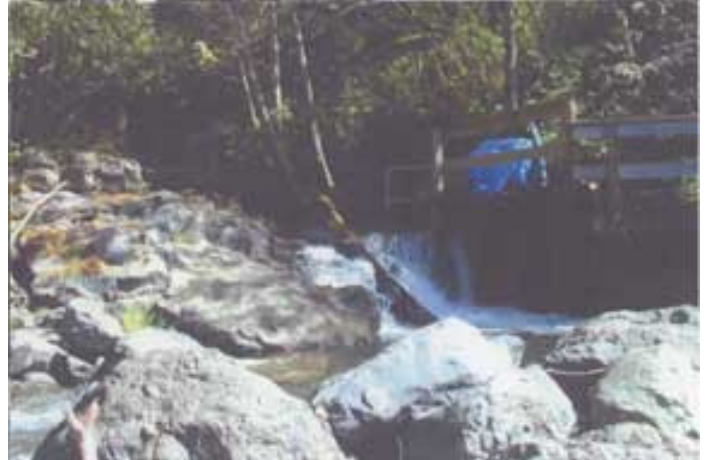
Side view of top jump over intake dam, 04/01

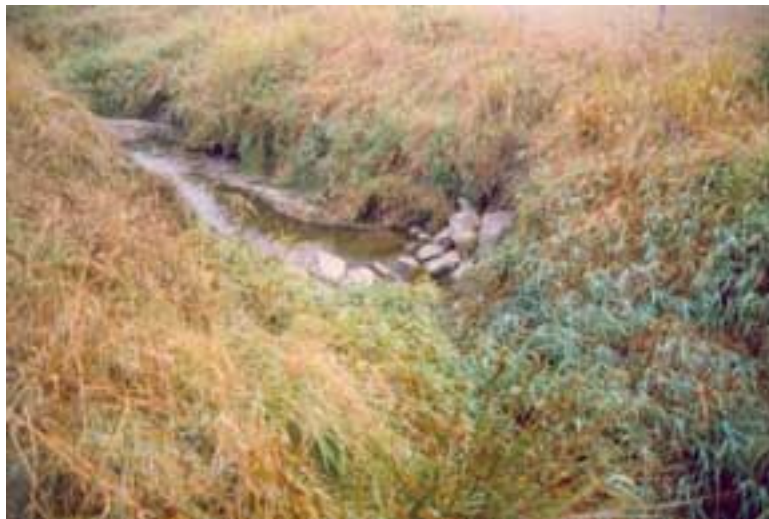
Upstream weir following construction

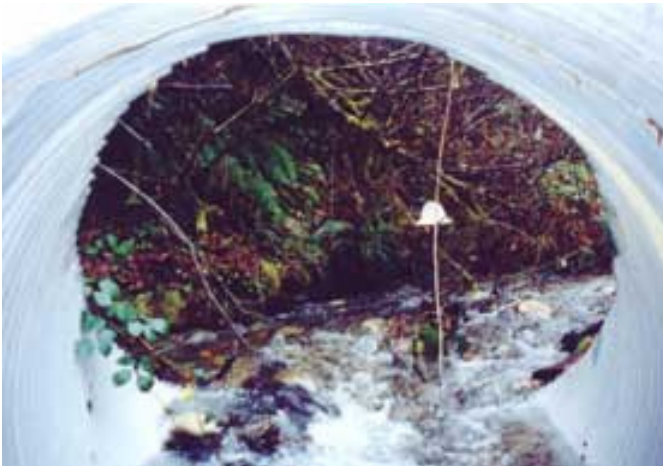
Looking upstream from inside the inlet, 01/12/00

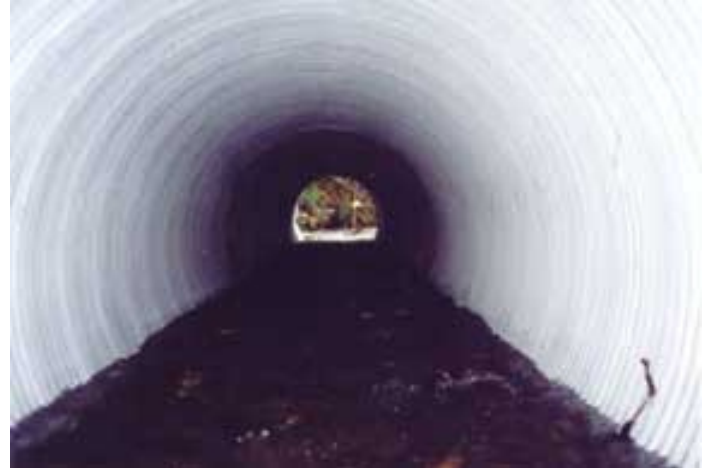
Substrate in culvert, 01/12/00

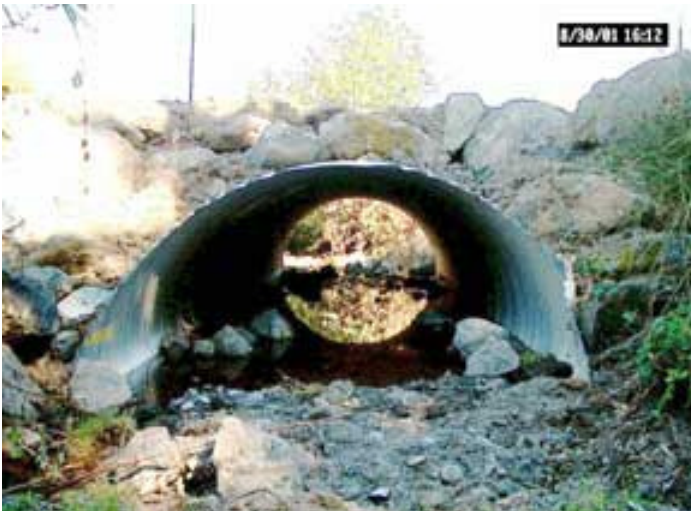
Inlet of downstream culvert following installation, 08

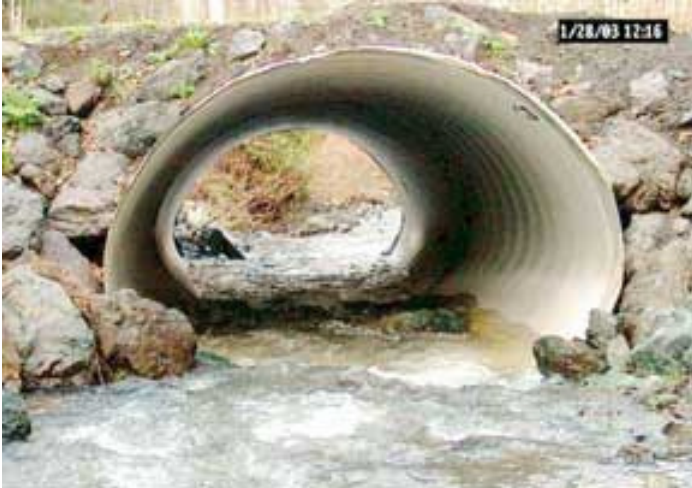
knox1 mp 1.130 Looking at inlet knox 1 mp1.130

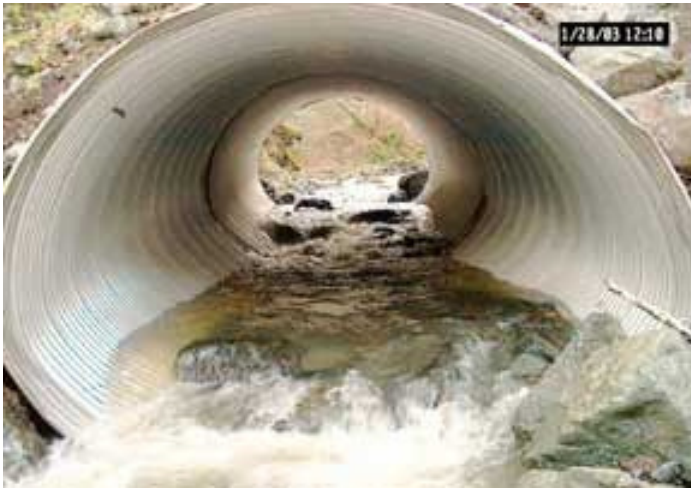
Looking at rip rap forming pools

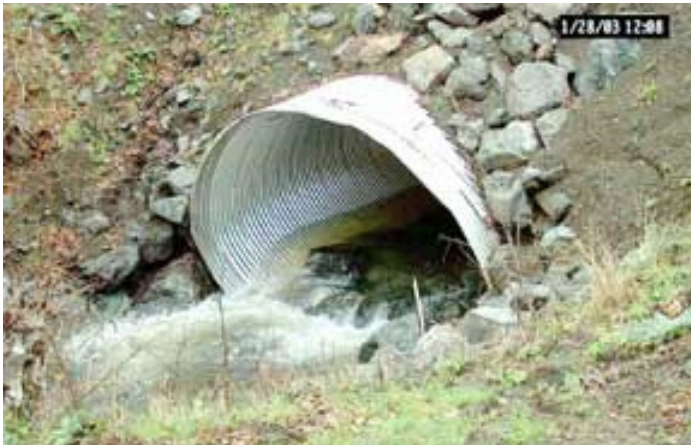
Looking through culvert at inlet knox 1 mp 1.130 Outlet

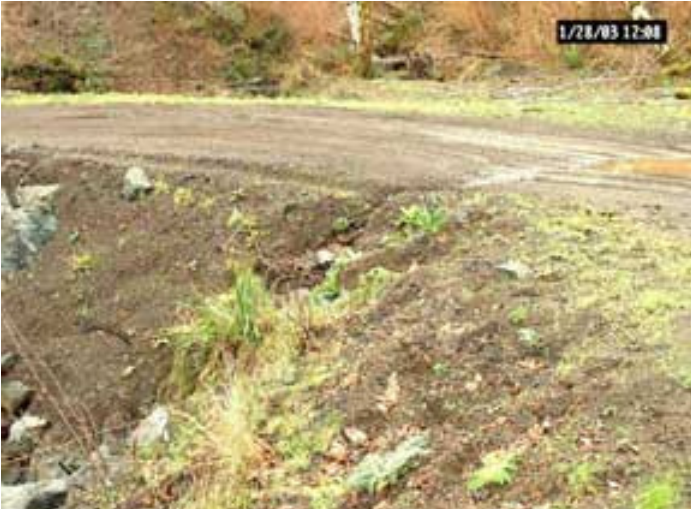
knox 1 mp 1.130 Runoff mining road fill

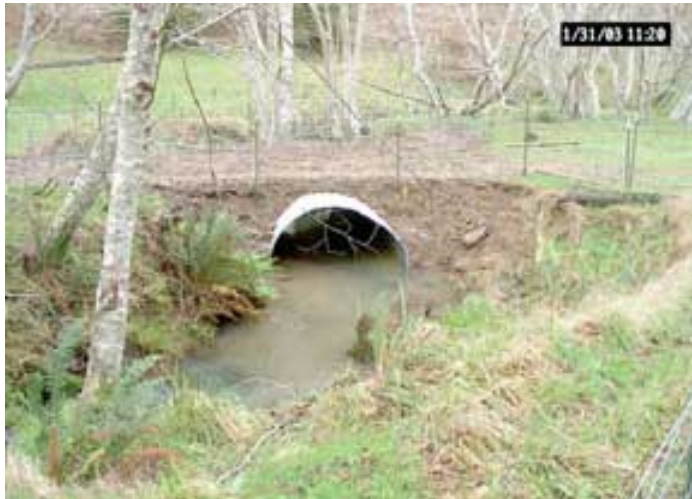
Looking downstream at the inlet following installation, 01/31/03

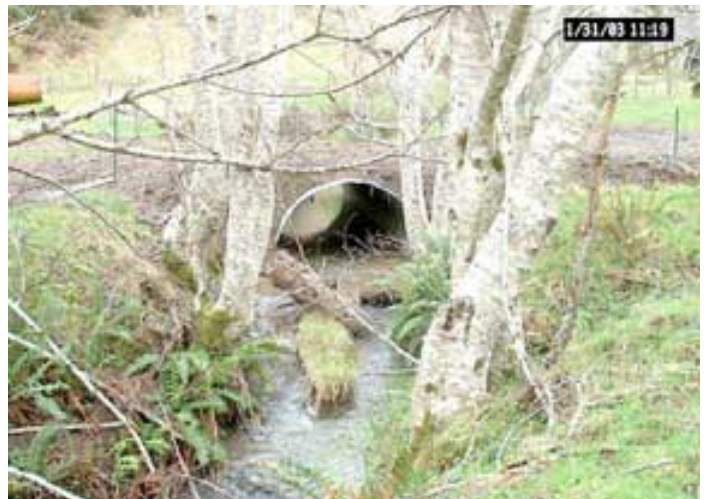
Looking upstream at the outlet following installation, 01/31/03

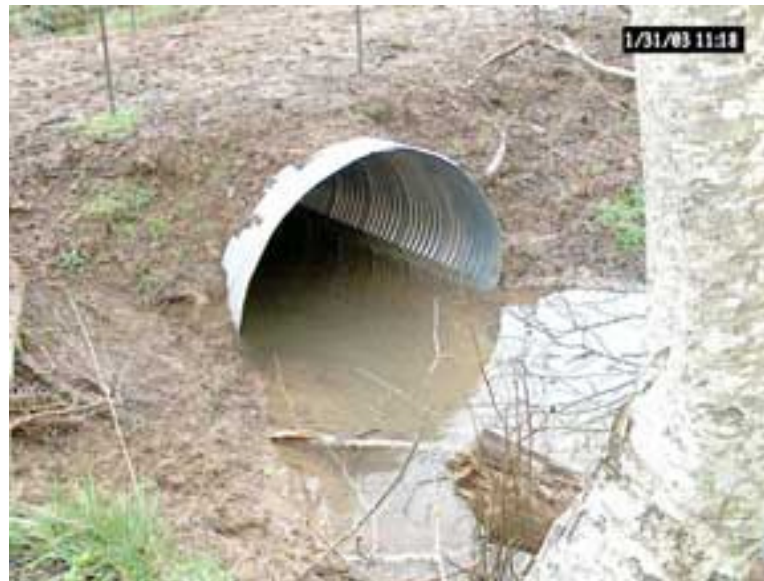
Close-up of outlet following installation, 01/31/03

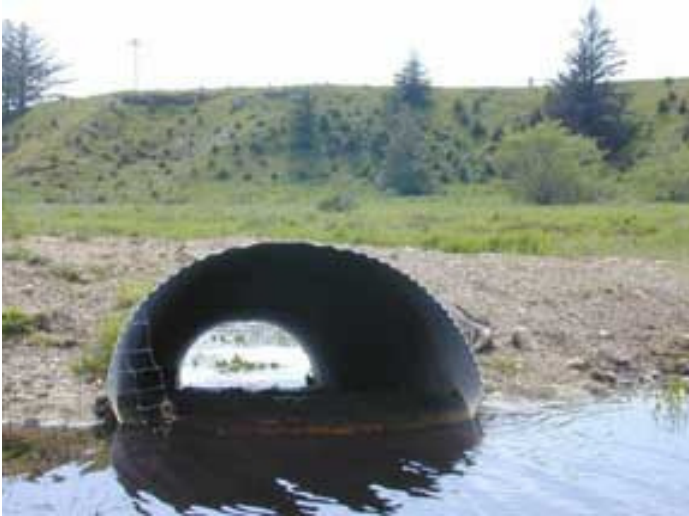
Culvert inlet at the downstream reservoir, 5/15/03

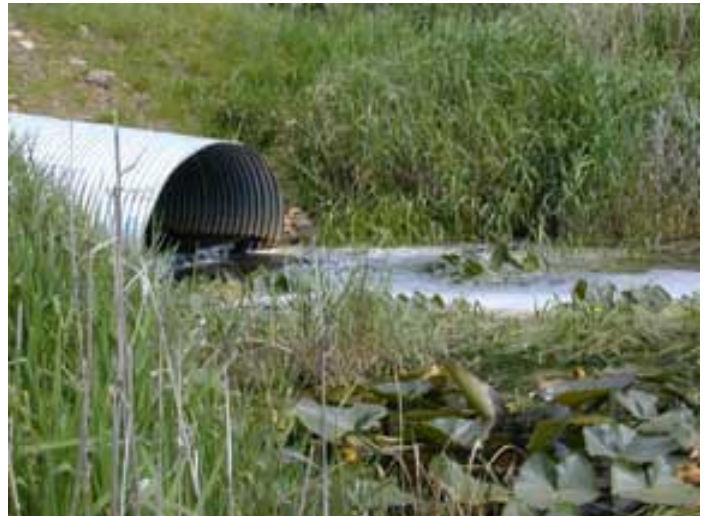
Culvert outlet at the downstream reservoir, 5/15/03

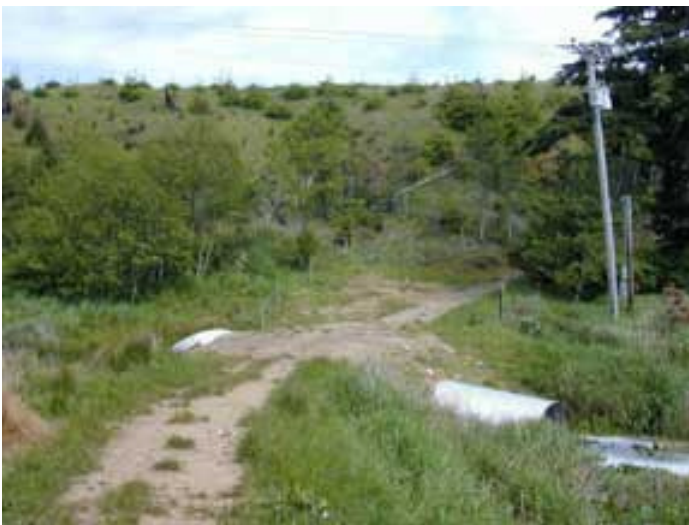
Full view of culvert placed at the downstream reservoir, 5/15/03

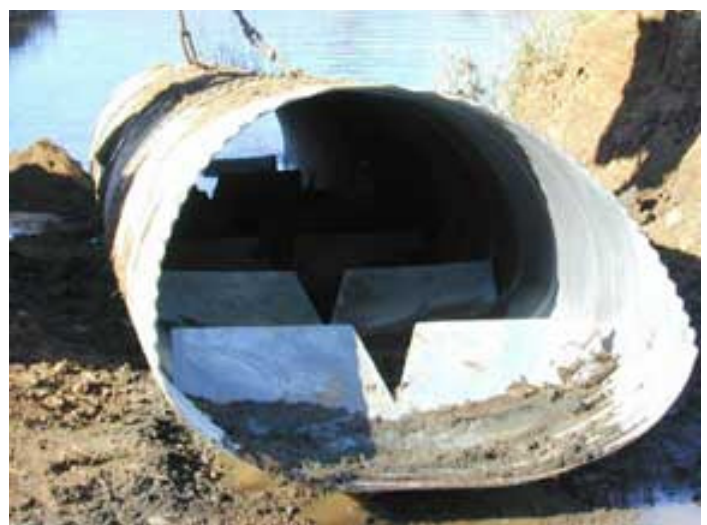
Looking upstream into the baffled culvert during installation, 2002

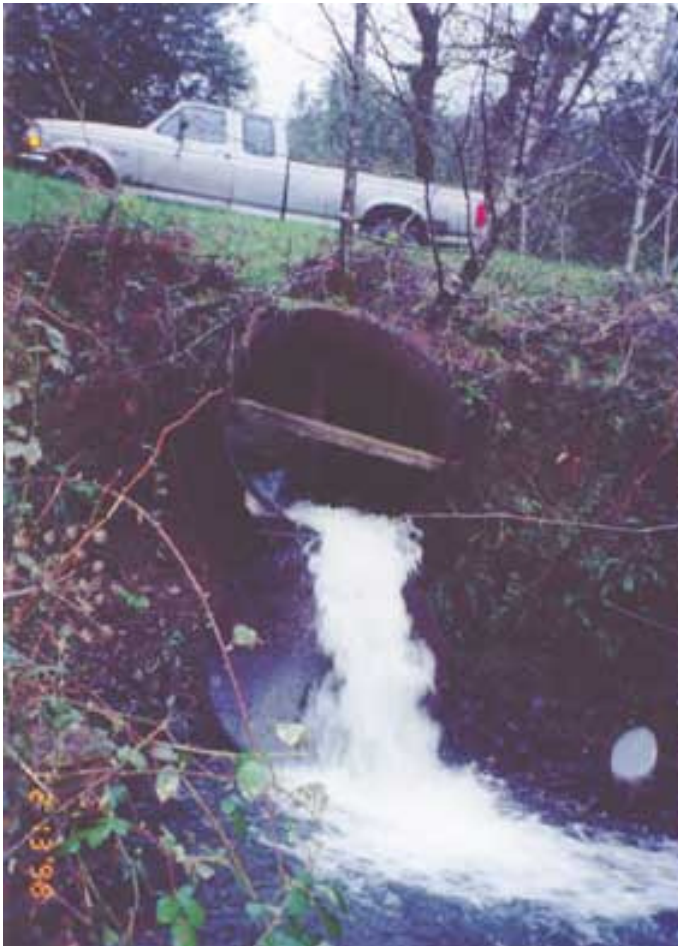
Outlet before replacement, 02/13/98

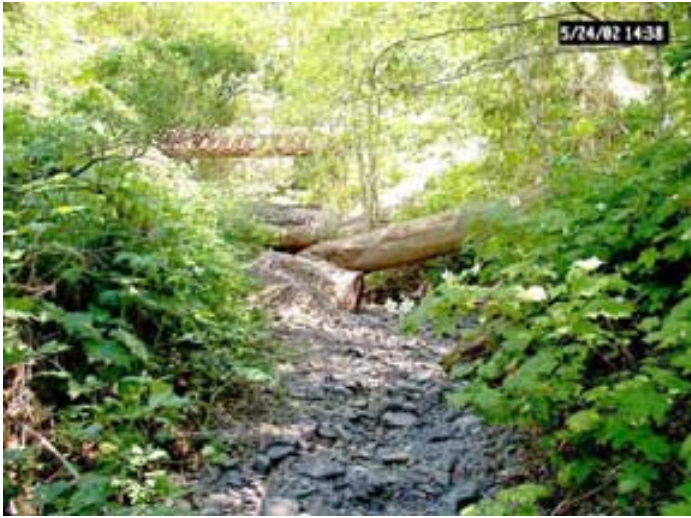
Looking upstream at wood placement, note bridge in background

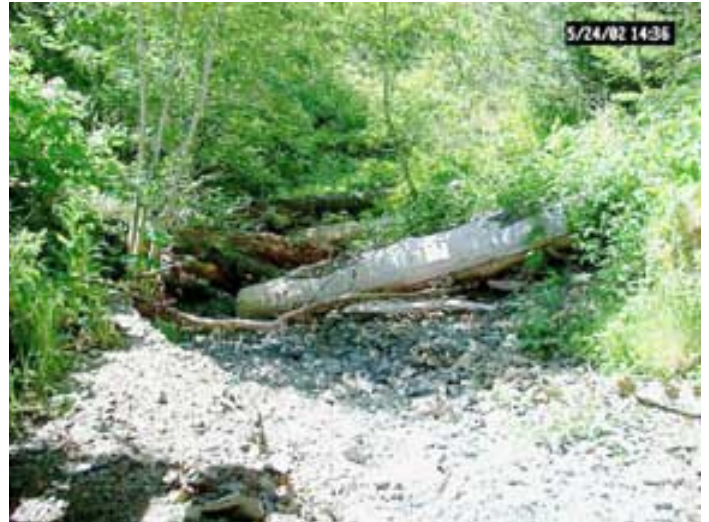
Looking downstream from beneath the bridge at wood placement

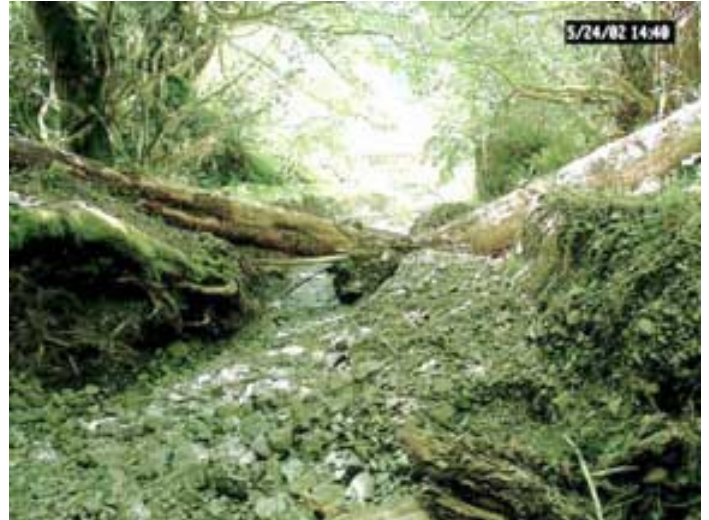
Looking downstream at wood placement, note bridge in background

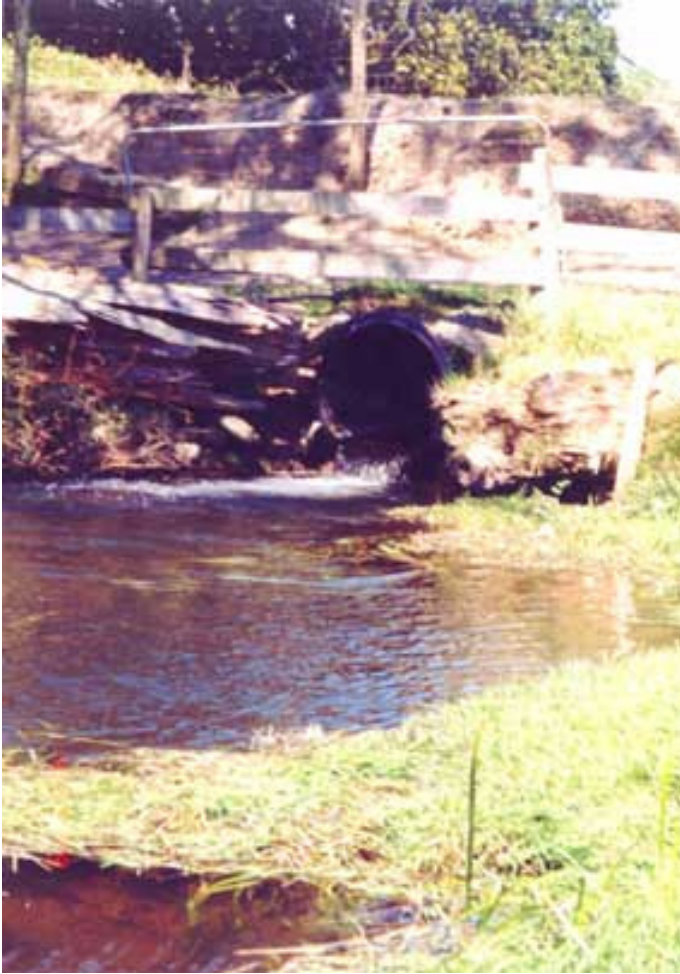
Looking upstream before installation of bridge, 04/23/99

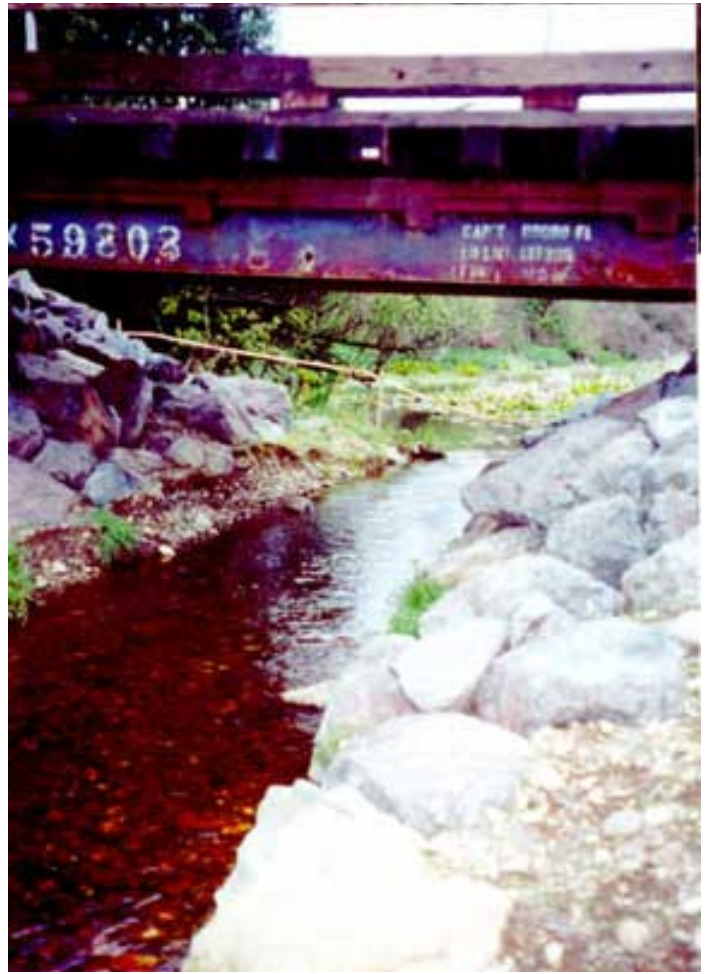
Looking upstream after installation of bridge, 03/15/00

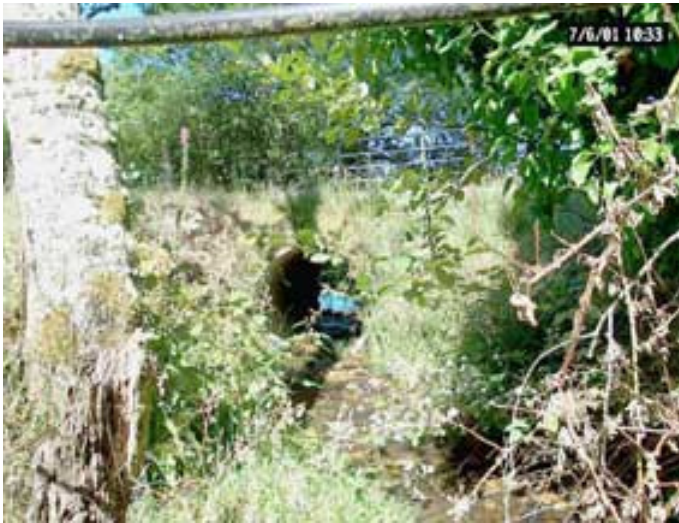
Looking at the former inlet of the lower crossing, 07/06/01

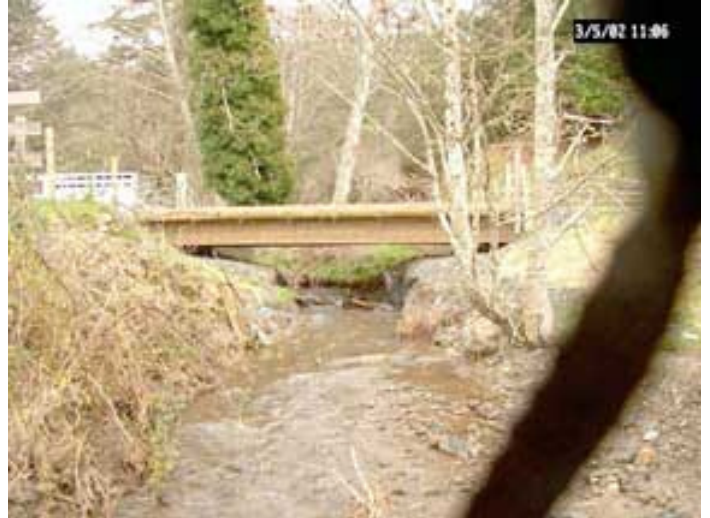
Looking upstream at the bridge placed at the lower crossing, 03/05/02

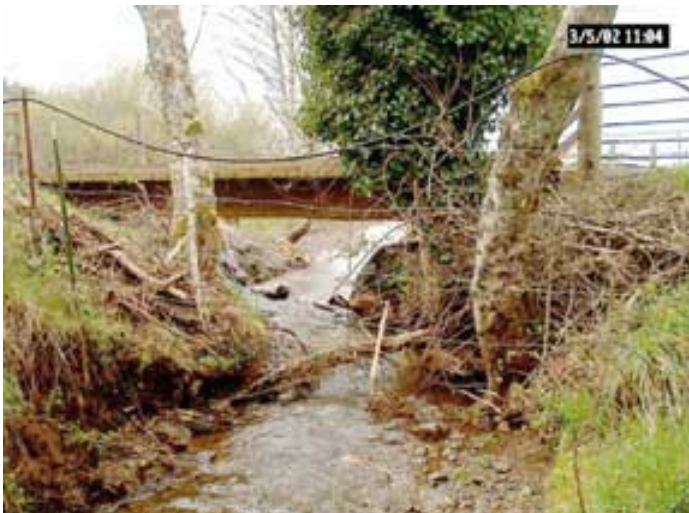
Looking downstream at the bridge placed at the lower crossing, 03/05/02

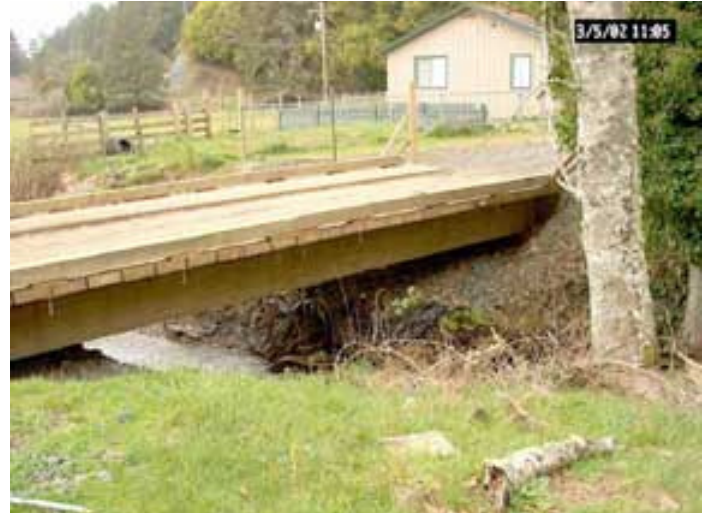
Looking from the SE at the lower crossing bridge, 03/05/02

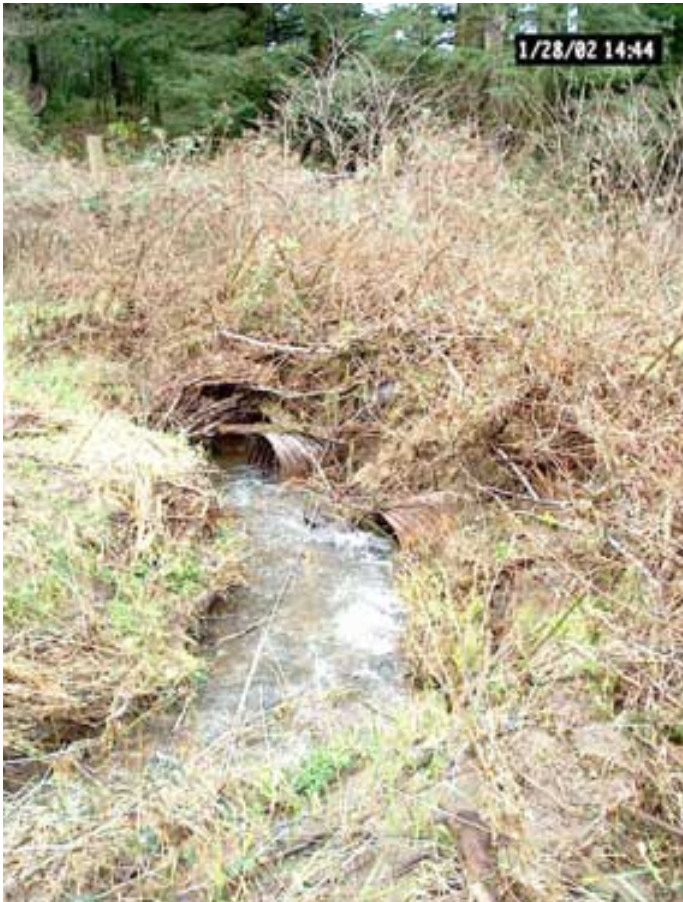
Looking at the former inlet of the lower crossing, 01/28/02

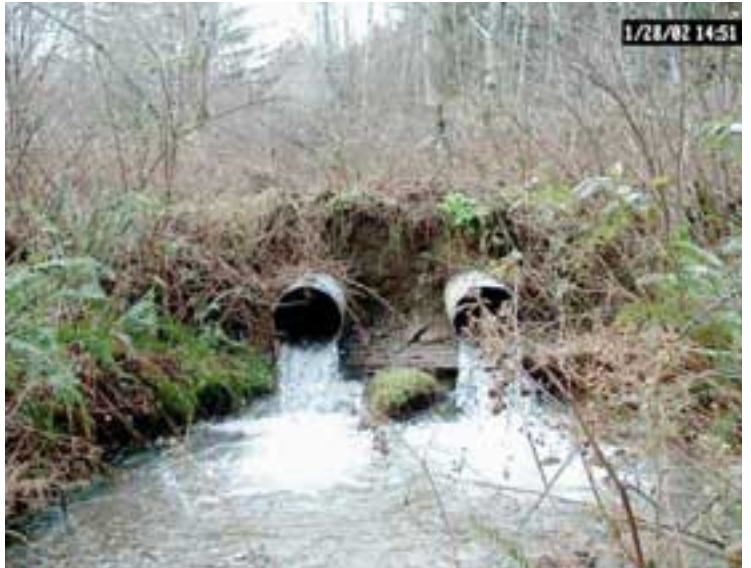
Looking at the former outlet of the lower crossing, 01/28/02

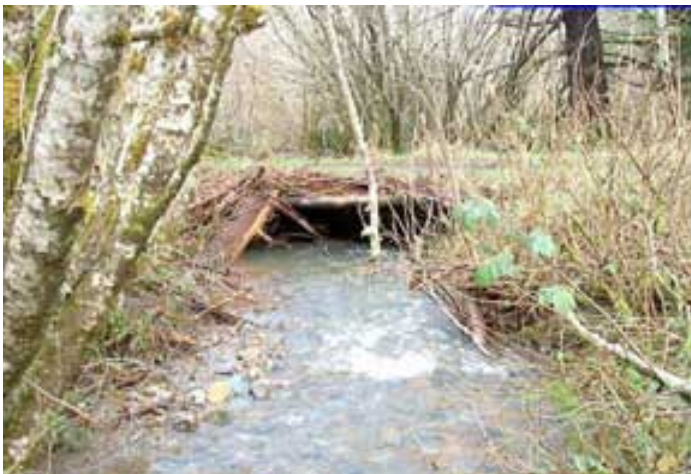
Looking at the former inlet of the upper crossing, 01/28/02

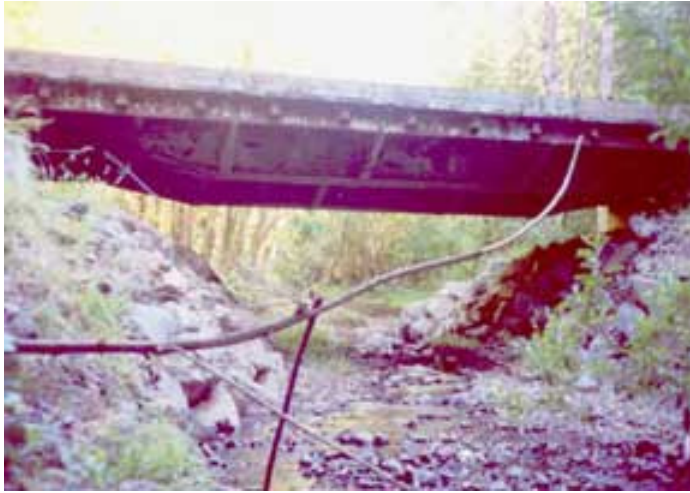
Looking upstream newly formed channel prior to the first winter, 07/31/00

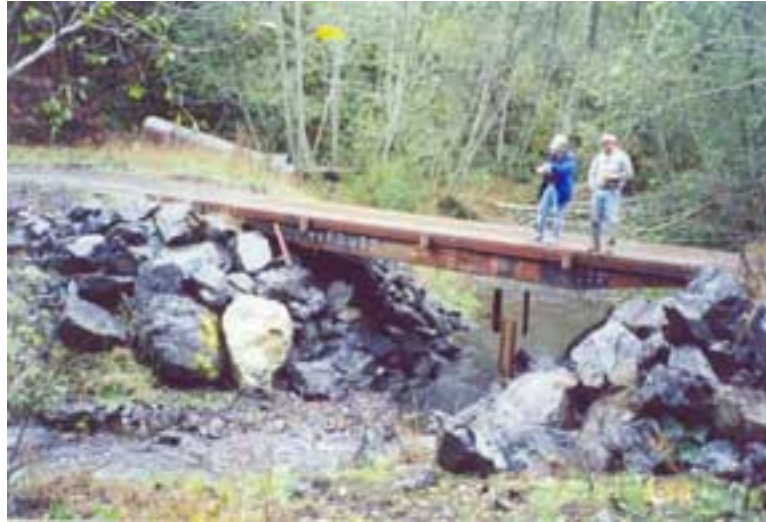
Looking downstream at the railcar bridge

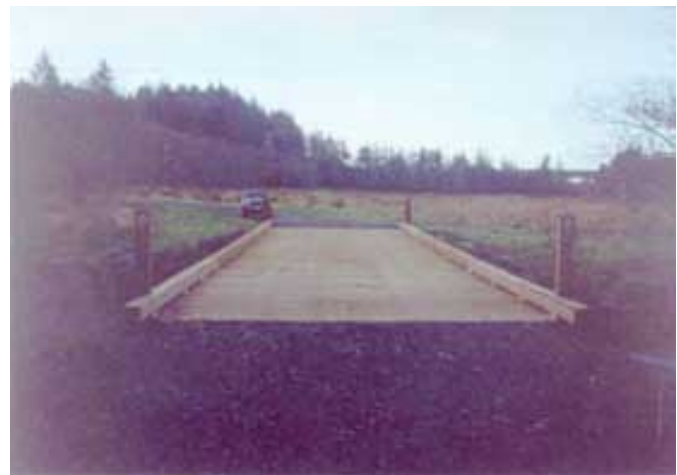
Looking at the bridge decking (notice no running boards)

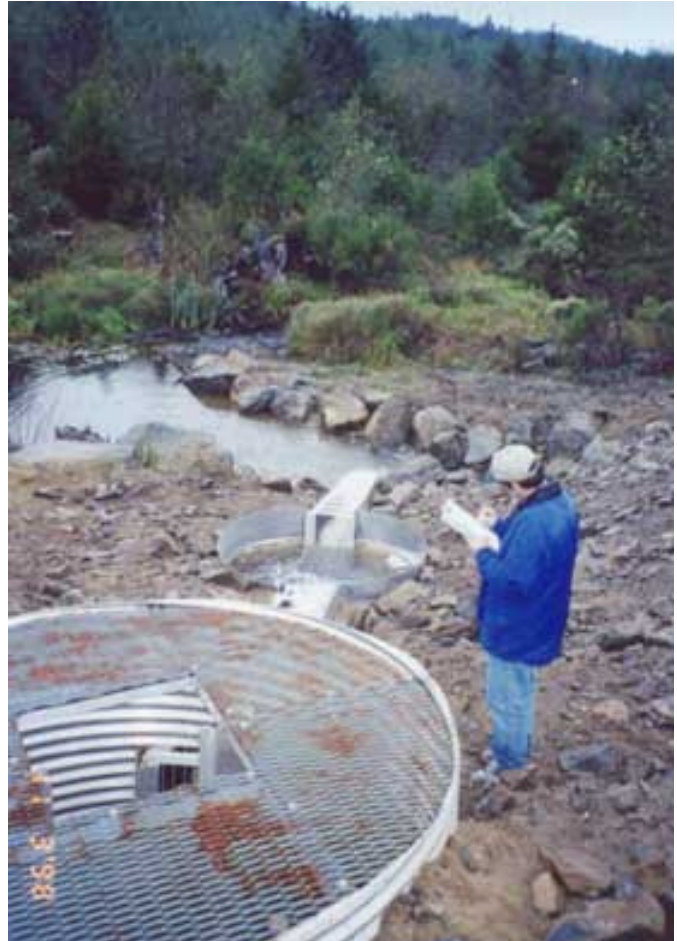
Looking downstream at resting risers and chutes, 11/03/98

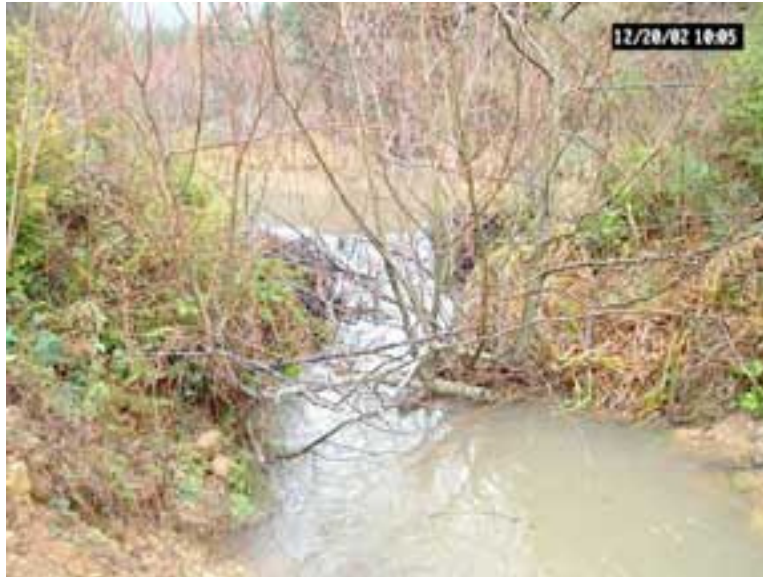
Biological Surveys: No surveys have been undertaken, though one adult Coho was observed in the channel in January 2003, trying to negotiate the beaver dam. Juvenile Coho were also observed in the channel in the spring of 2003.

Looking upstream from the new channel at the beaver pond, 12/20/02

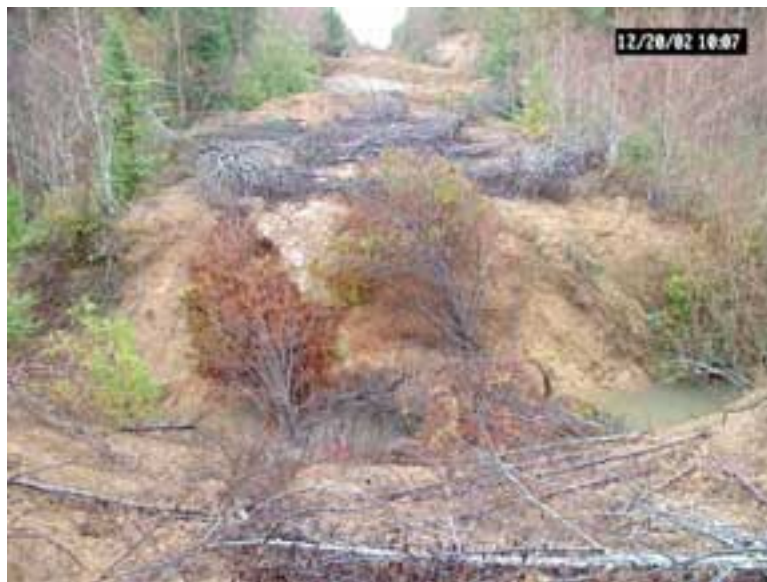
In the spring of 2002, a crossing on North Fork Boulder Creek was identified through the Councils' Road Inventory program as a fish barrier culvert, in addition to a sediment issue. The road was built on a north-south property line, and as a result, it indiscriminately crossed a 100'+ wide wet meadow floodplain, and the North Fork, through the construction of a 30' berm. The culvert was undersized, and had been dammed by beaver in the past, which caused it to overtop and erode the berm. In the summer of 2002 the crossing was pulled as part of a sediment abatement project (see photos pg 60). The quantity of fill that was removed was limited by costs. The result was the creation of a narrow, incised channel where the culvert had existed, that ties two reaches of the wet meadow together. Shore Pine with rootwad and limbs were placed in the channel to create cover and complex channel hydraulics. At the upstream end of the newly formed channel the beaver dam still exists, and is impounding an acre, or more, of pond.

Looking from the south at the excavated channel and placed trees, 12/20/02
