**2000 – 2001 Monitoring Report**

# **Riparian Improvement Project Effectiveness**

## **South Coast/Lower Rogue Watersheds**

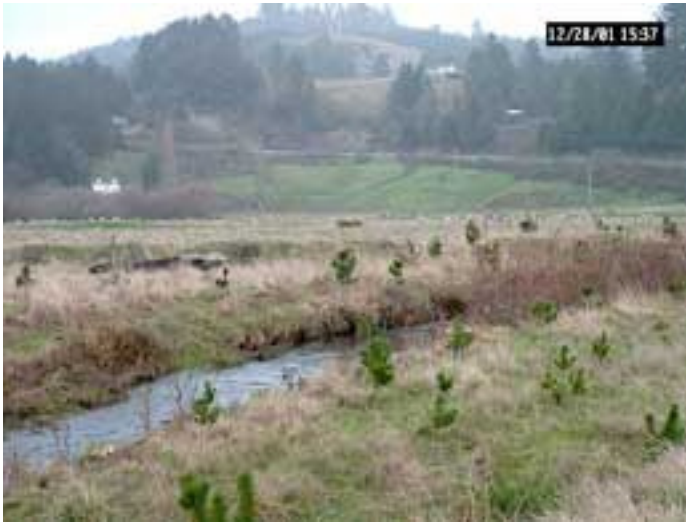
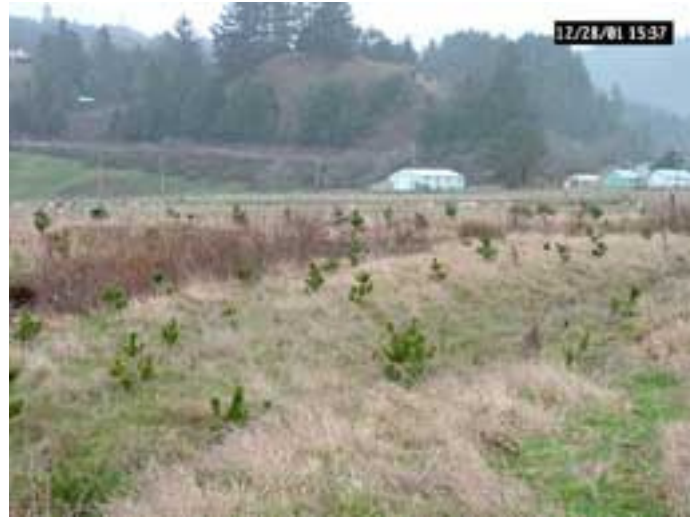
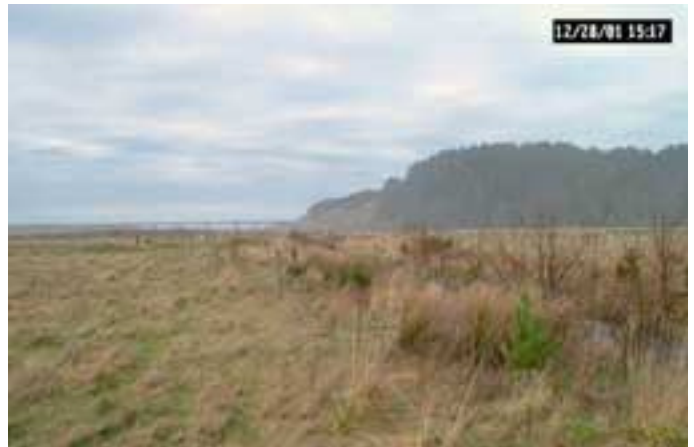
**Plate 3**

Willow cuttings were purchased for 1996, but willows have since been propagated from species near the planting site. Many of the past willow plantings were associated with bioengineering projects (covered in a separate monitoring report). Photo points for monitoring these types of plantings are preferable to accounting for individual cuttings. Willows can fully occupy a site after livestock exclusion without planting (Appendix A, Crook Creek and plate 3, bottom left).

Crook Creek, view from fence corner, toward house, 12/28/01

Crook Creek, view from fence corner toward barn, 12/28/01

Crook Creek view toward ocean from mid-reach, 12/28/01

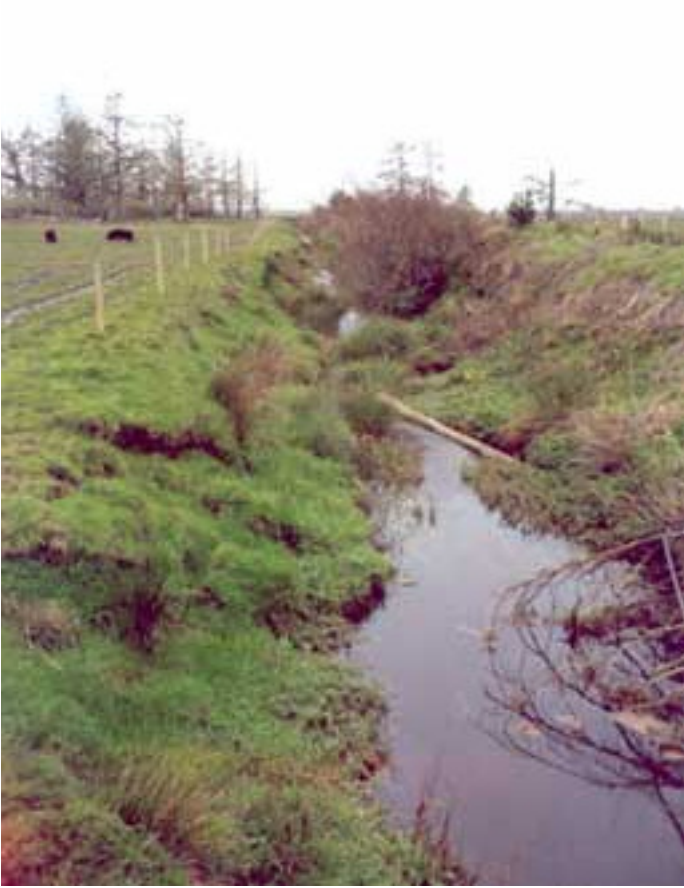
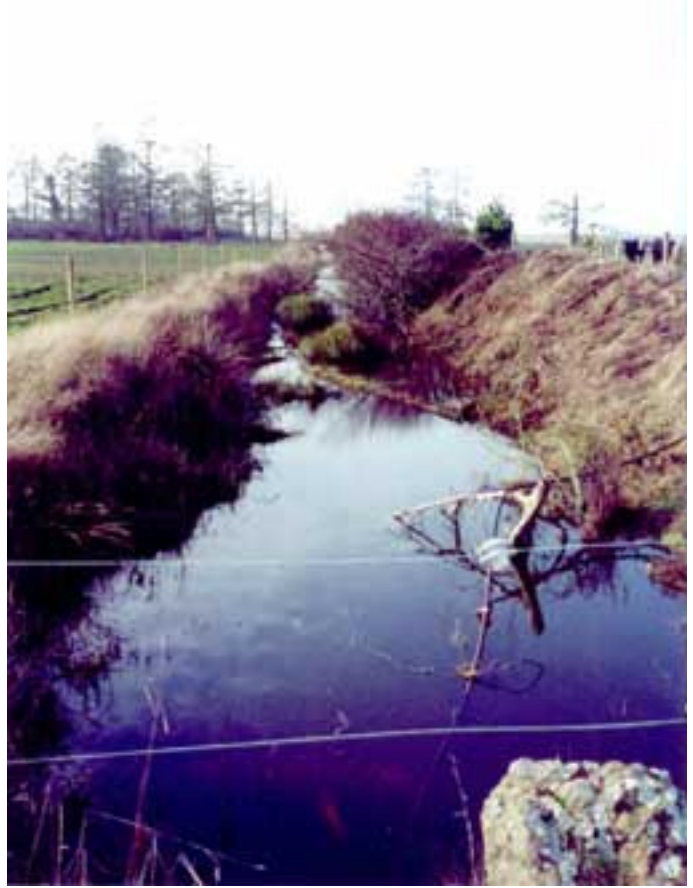
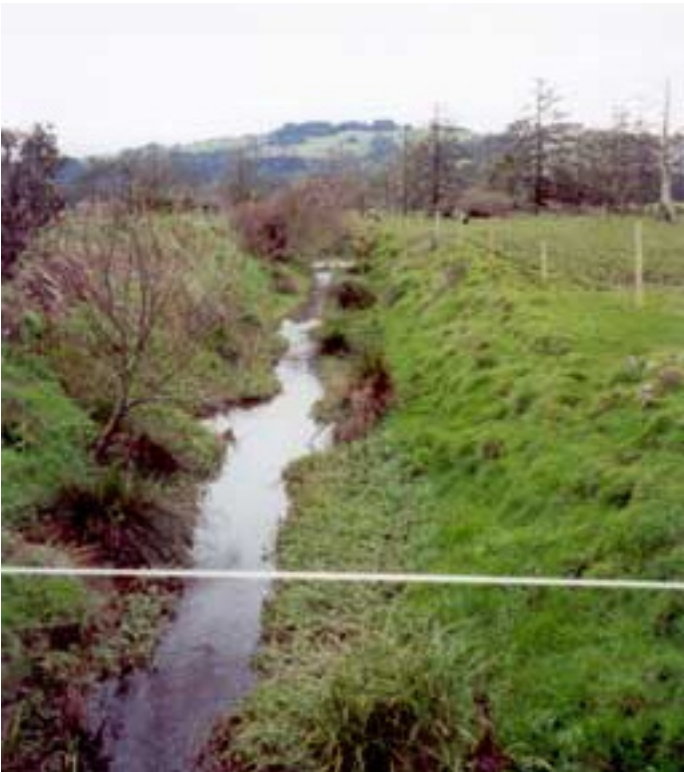
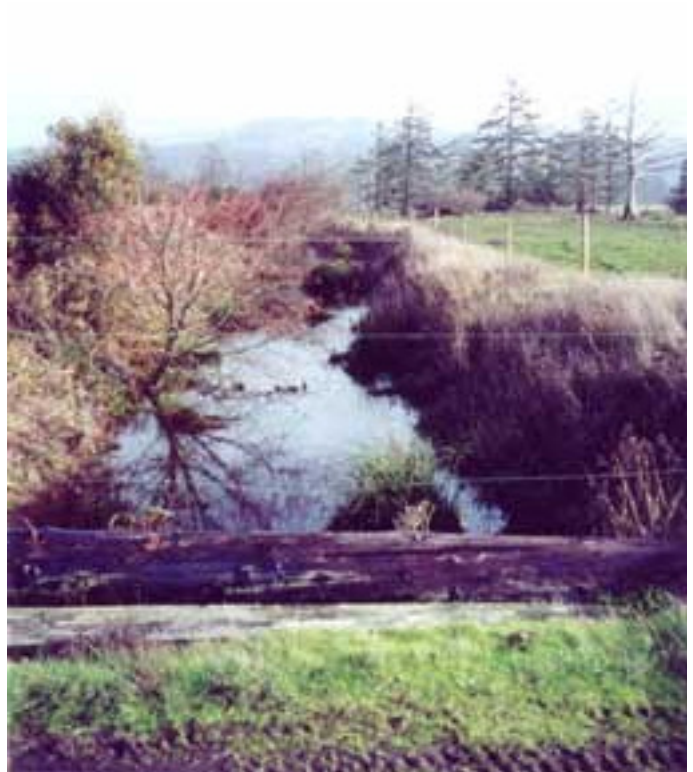
**Plate 5**

The response of grass and blackberry to livestock enclosure is dramatic (plates 5 and 6), and competition with conifers is a detrimental effect. It is also evident that grasses, herbs and shrubs can provide one of the key riparian functions of filtering surface water runoff from pastures within a few months.

South Langlois Creek, view to west, 03/15/00

South Langlois Creek, view to west, 12/15/00

South Langlois Creek, view to east, 03/15/00

South Langlois Creek, view to east, 12/15/00

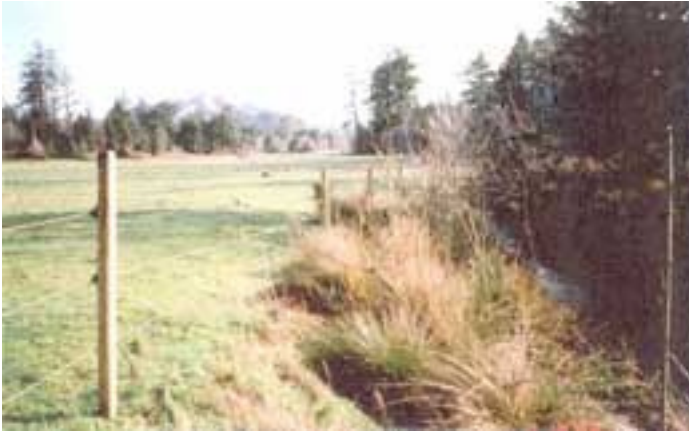
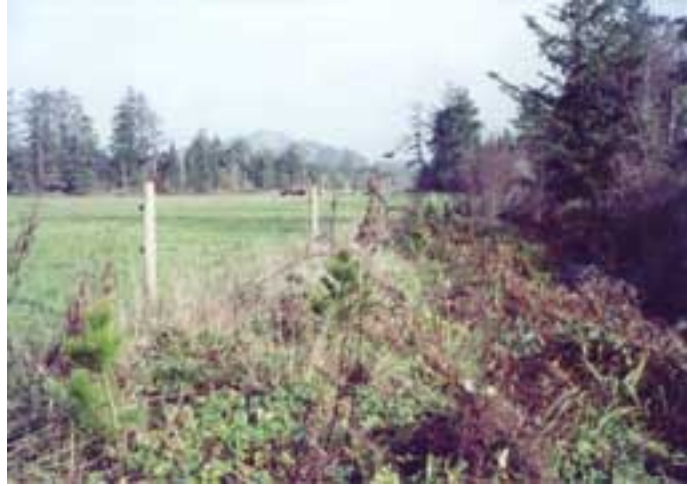
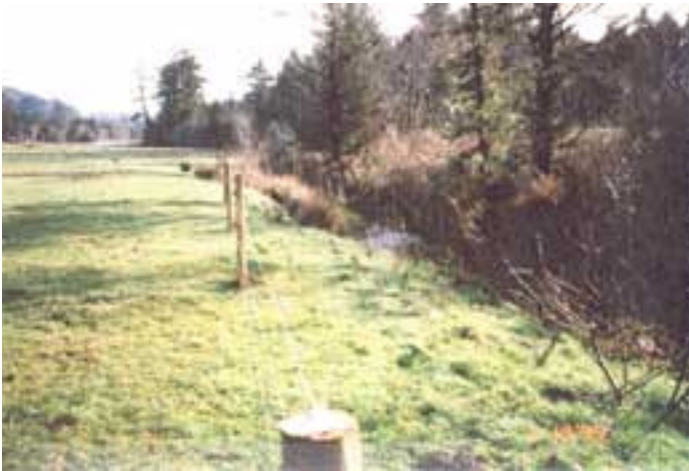
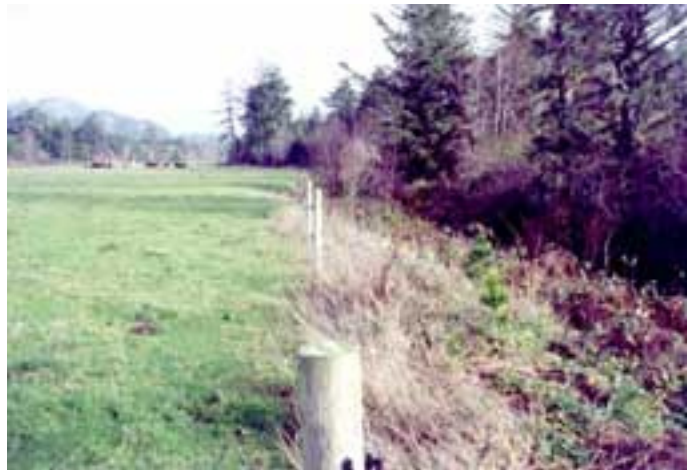
**Plate 6**

North Langlois Creek, 02/19/99

North Langlois Creek, 12/15/00

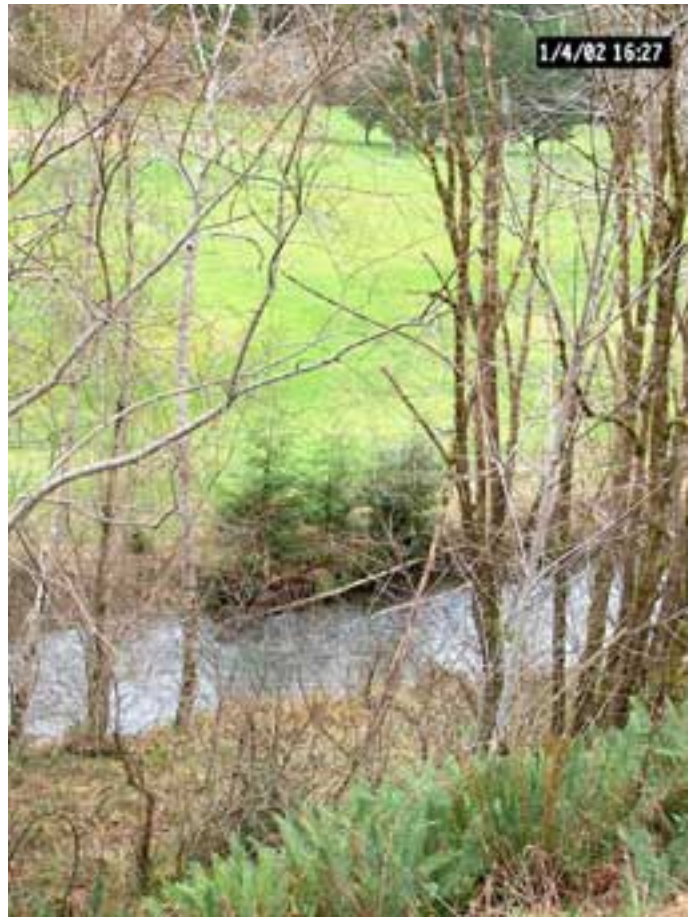
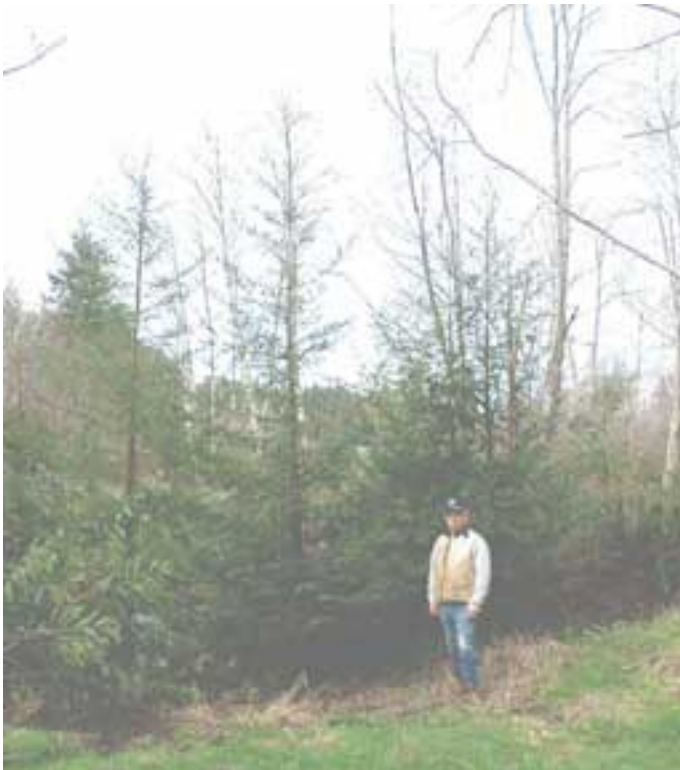
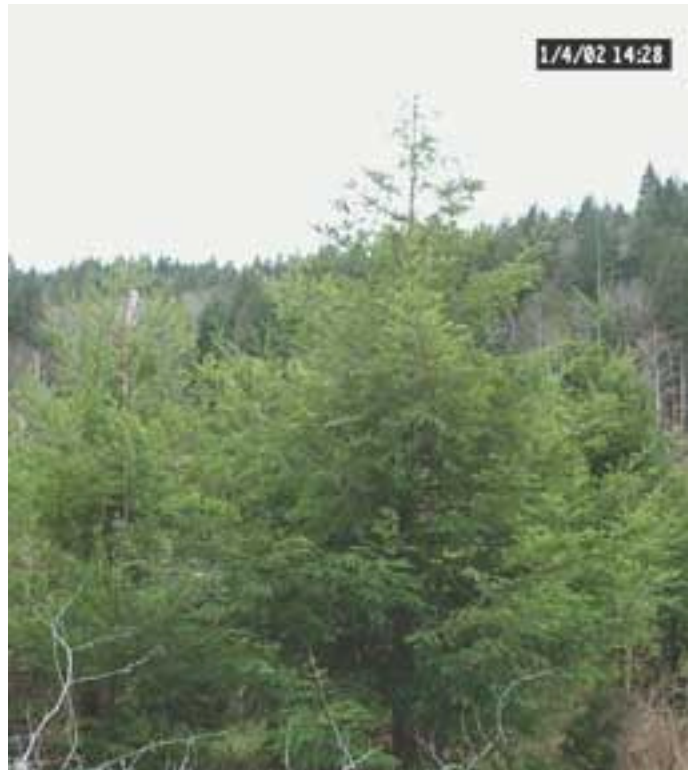
**Plate 7**

Coast redwoods were planted outside of their natural range, north of Chetco River to New River tributaries by landowner request. Where relatively protected from wind exposure, redwoods are growing vigorously, and are among the tallest of the early plantings (plate 7, bottom left). It is recognized that their long-term survival may be limited by extreme events of frost, drought or wind, or that their susceptibility to disease may be greater outside of their natural range. Already, it appears that redwoods may be somewhat more susceptible to wind damage than other seedlings, especially when planted in pasture with no understory shrub cover to help stabilize their roots. Considering the former range of coast redwood within the Pacific Northwest, these trees are rather close to their natural range.

Cedar Ck (EC-06), 01/04/02, Doug-fir & Sitka spruce Cedar Ck (EC-09), 01/04/02, surviving conifer on under alder upstream reach

Cedar Ck (ED-07),01/04/02, 15-20' redwood & Cedar Ck (EC-07), 01/04/02, irrigated redwood, 20-25' willow approx 18'

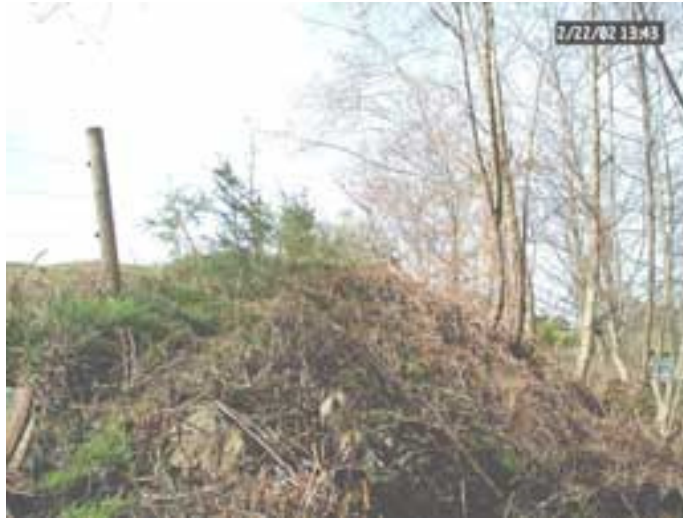
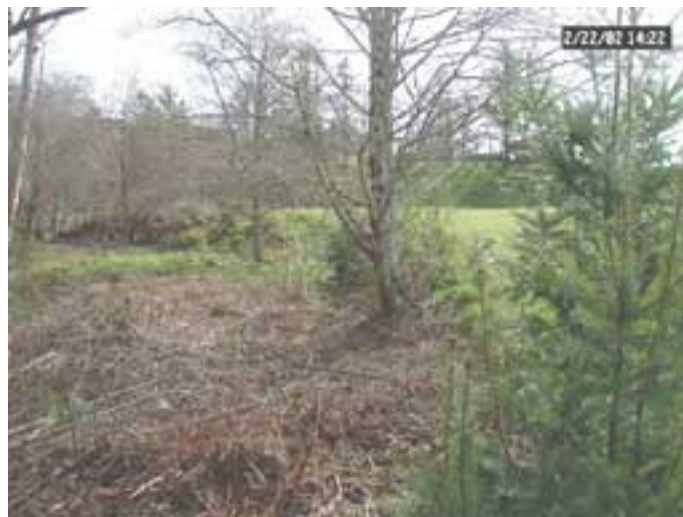
**Plate 9**

Willow Creek, FL-05, 02/22/02, Douglas-fir growing along fence line above slope newly cleared of blackberries

As above, newly cleared area replanted

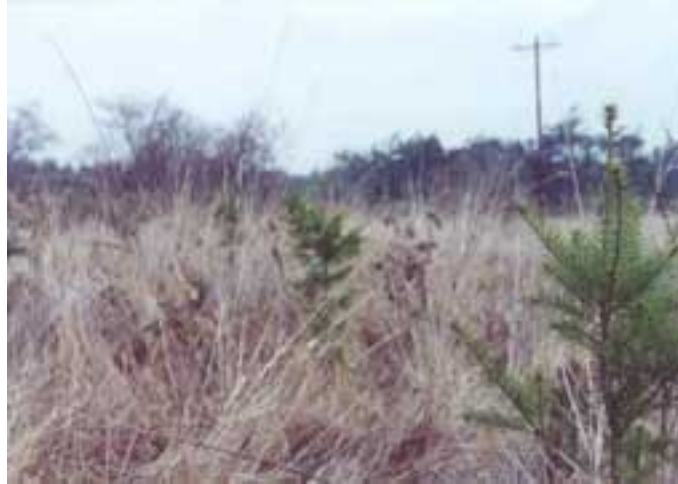
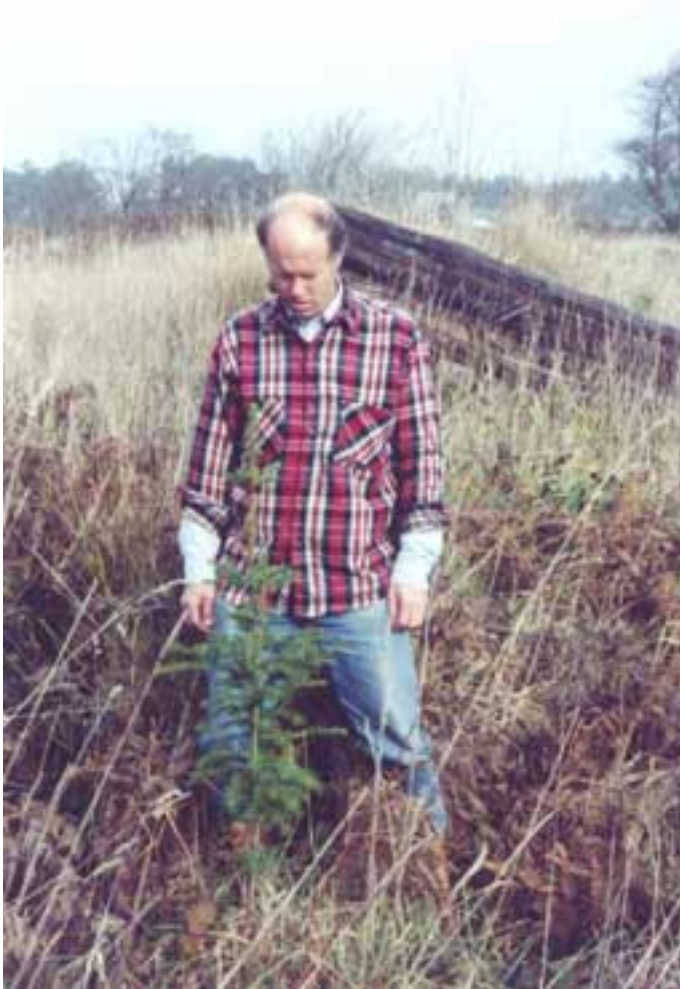
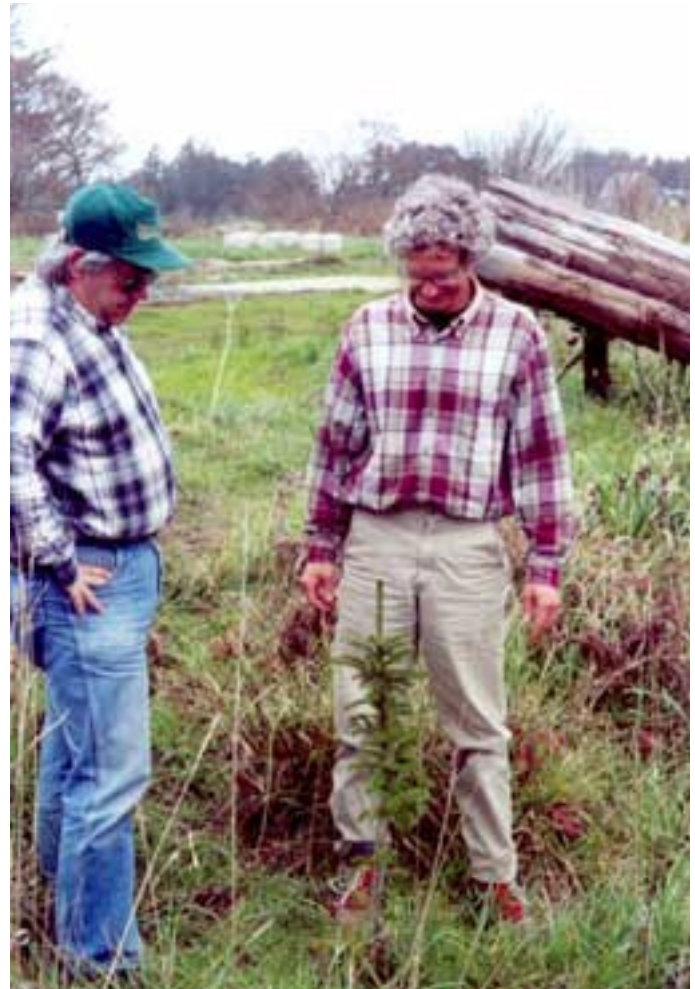
**Plate 12**

Species vary in their rate of root development and growth. For example, sitka spruce has been observed to lag behind other trees in the first few years, but growth accelerates after the root system develops (plates 12 and 13). Spruce is not doing as well as we'd hoped in the "blow zone" at the downstream end of Floras, Elk, and Pistol Rivers. Hay bales were placed at one site to provide wind protection, but the spruce tips got brown when they grew above the barrier. More willows are being planted to provide cover for the spruce.

Tributary to Fourmile Creek, 12/15/00

Tributary to Fourmile Creek, 03/15/00

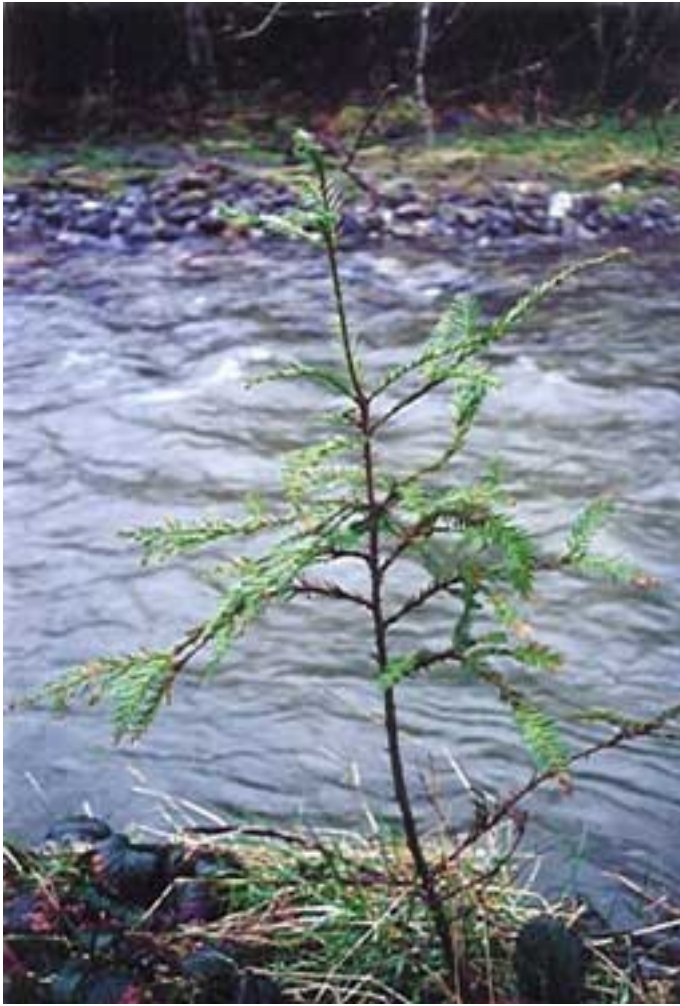
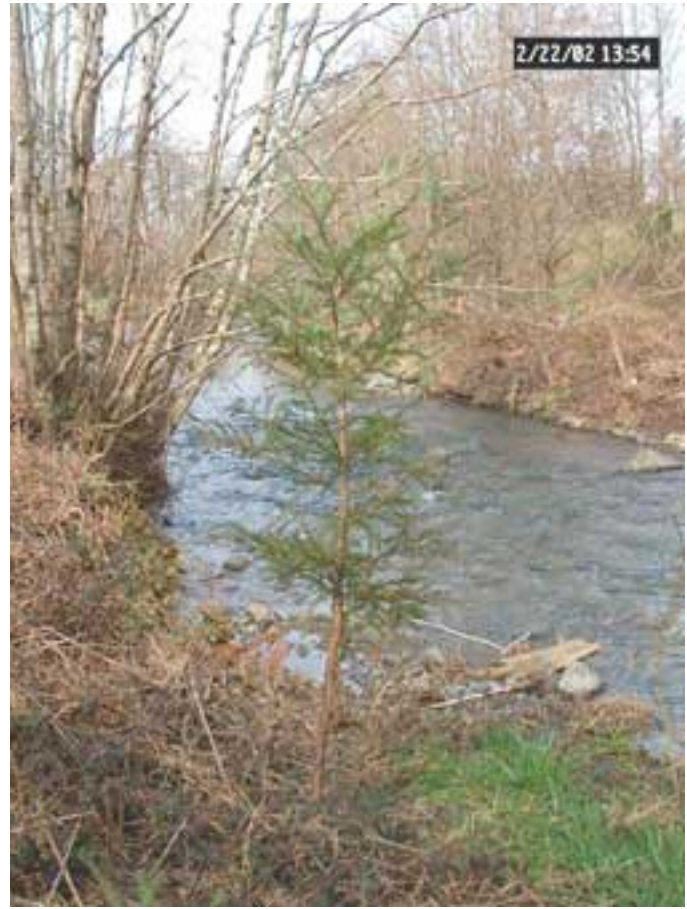
Plate 14

Willow Creek, FL-05, 02/02/99, matches with one of the

Willow Creek, FL-05, 02/22/02, coast redwood two photos on page, uncertain which one

FL-05, coast redwood bent over and damaged from high flow, silt deposited at base

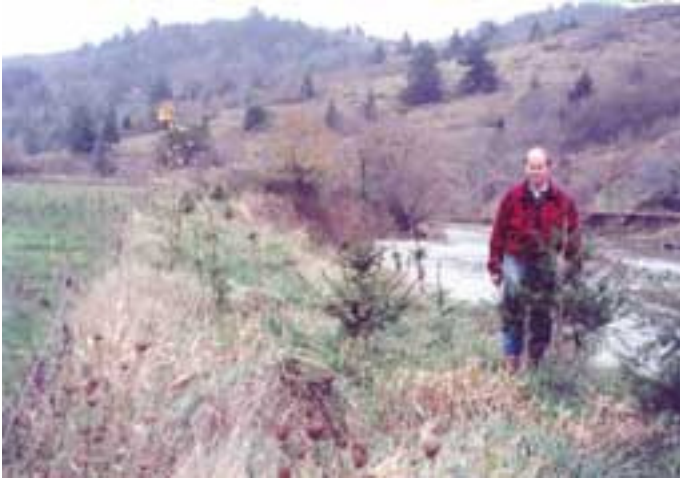
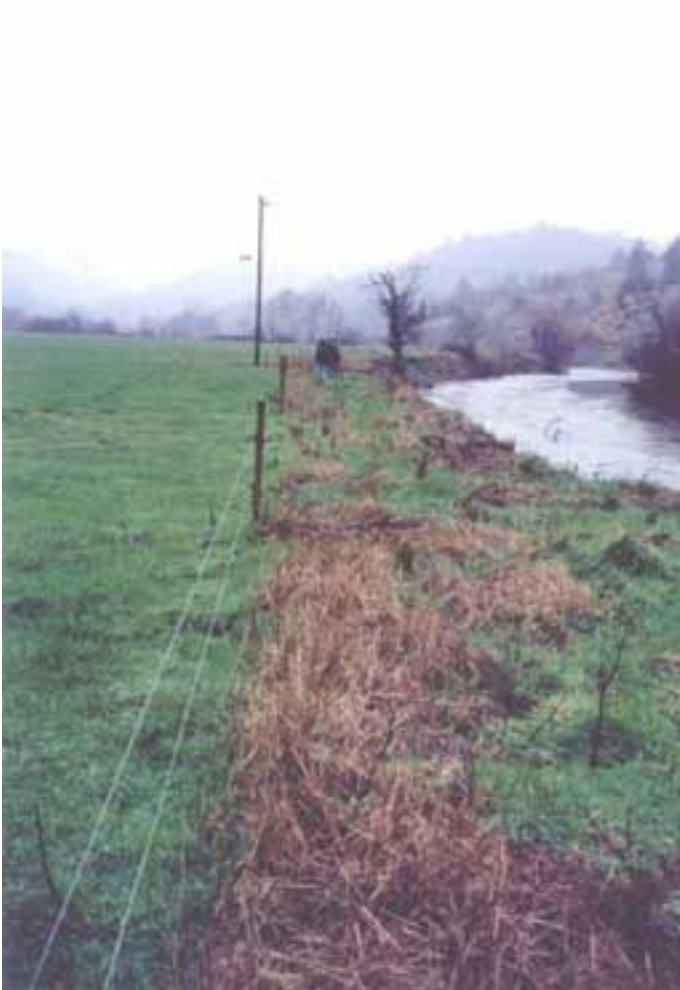
**Plate 15**

Electric fence requires maintenance of vegetation and debris along the fence line. Although many electric fences have been installed and are working well, landowners also report problems leading to animals within the riparian zone. Continued vigilance and maintenance of electric fence or woven wire is required to exclude lambs and small sheep from the riparian area. Larger animals can maintain vegetation along the fence line where the bottom electric wire is raised (plate 15, bottom left).

Chronic bank erosion makes fence maintenance an ongoing problem for landowners (plate 15, bottom right). Negotiations over wider setbacks can be difficult with landowners that already are volunteering to forego the use of part of their land. To decrease mortality from livestock browsing and reduce fencing costs where soil, vegetation, and channel conditions indicate that the fenced riparian setback is likely to be eroded, additional discussion will be needed. Narrower setbacks could be traded along inside bends and wider setbacks along the outside bend and downstream to anticipate channel migration. Although funds are generally unavailable for bank stabilization, providing structures that incorporate wood, planting willows and installing rock vanes and weirs are preferable to rip rap bank protection (plate 16). Sloping of banks to reduce erosion also creates a mineral soil planting site that is easier to revegetate (plate 17, top and bottom right), unless the exposed soils are droughty.

Floras Creek, 12/00, view upstream

Floras Creek, 02/99

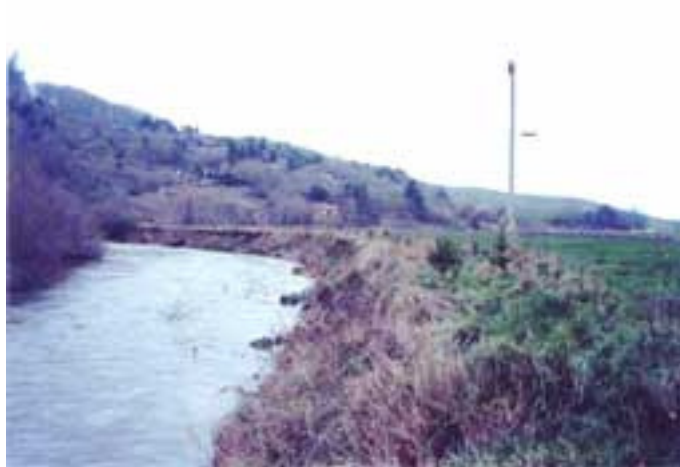
Floras Creek, 12/15/00, note rock vanes for bank stabilization, view downstream

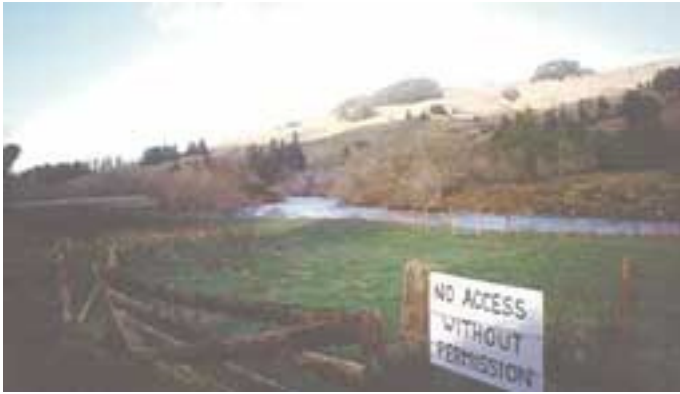
**Plate 17**

FL-04, summer '96 after fence construction, note gate nr river

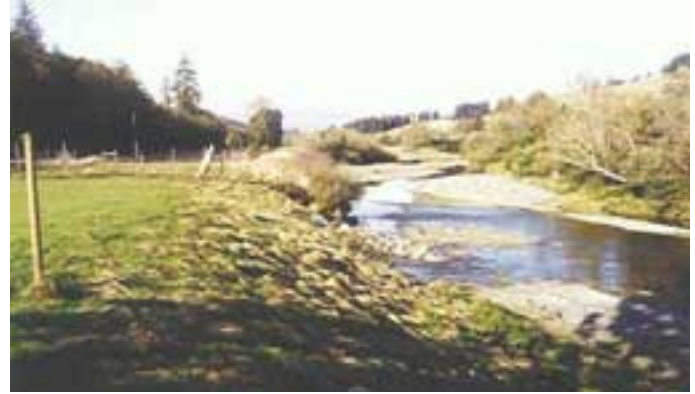
FL-04, October '98 after bioeng project, view downstream

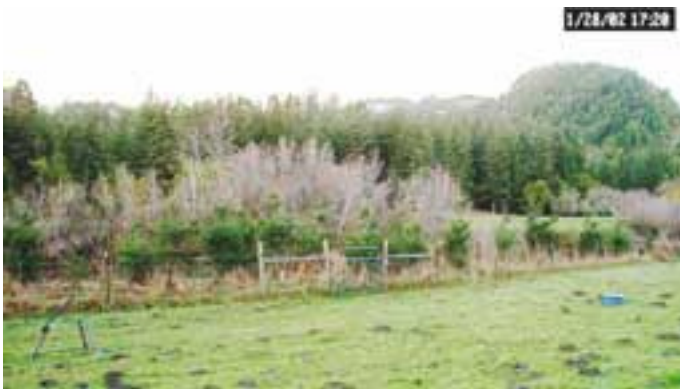
FL-04, 01/28/02, STA 7.16-10.96 east end, same gate as above

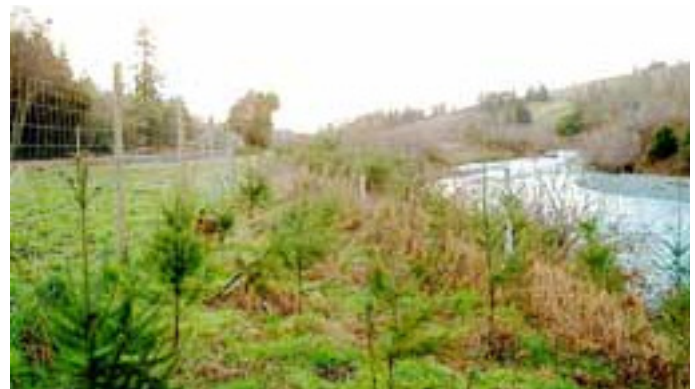
FL-04, 01/28/02, STA 5.75-7.16, view similar to above

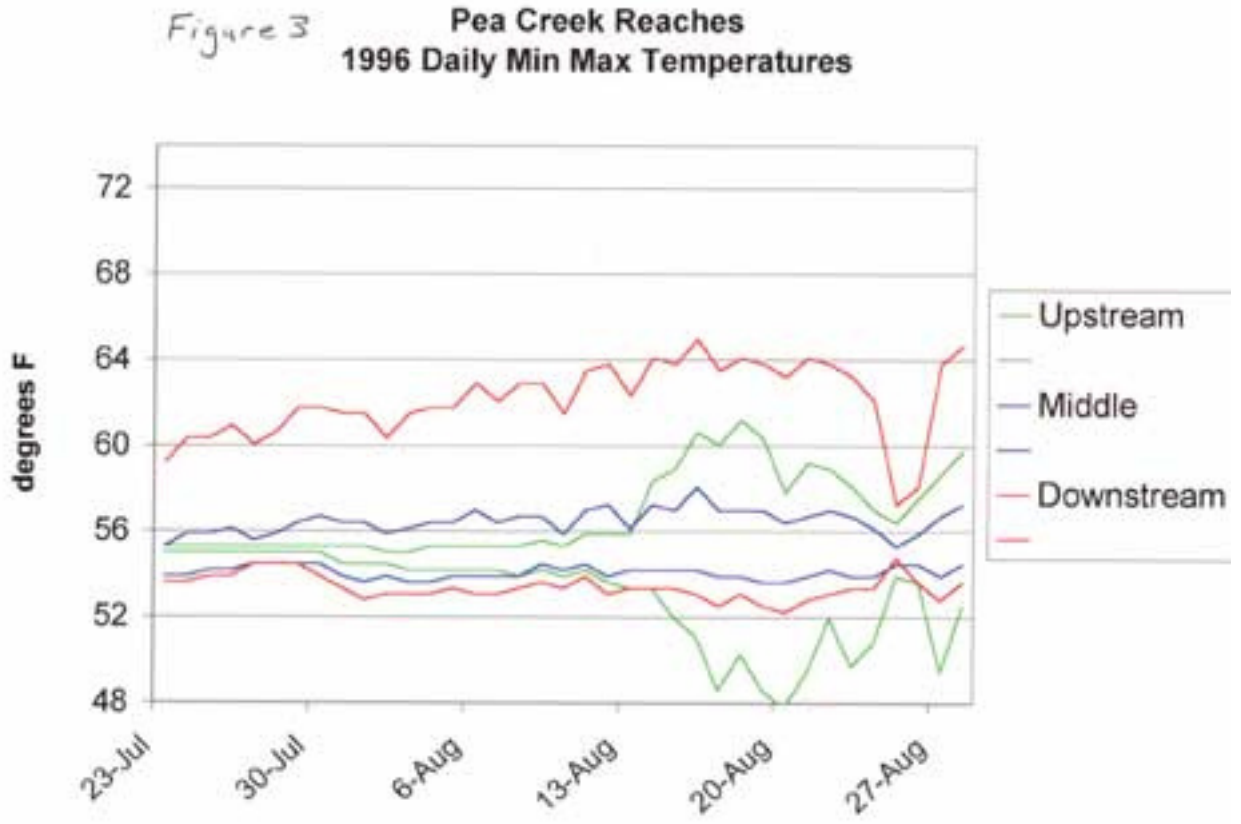
Figure 3

Results from 1996 are shown on figure 3, with minimum and maximum temperatures for each day connected as a single line. Minimum temperatures at the upstream site are well below the ranges typically found on South Coast streams, and are interpreted as evidence that the thermometer was exposed to air temperatures.

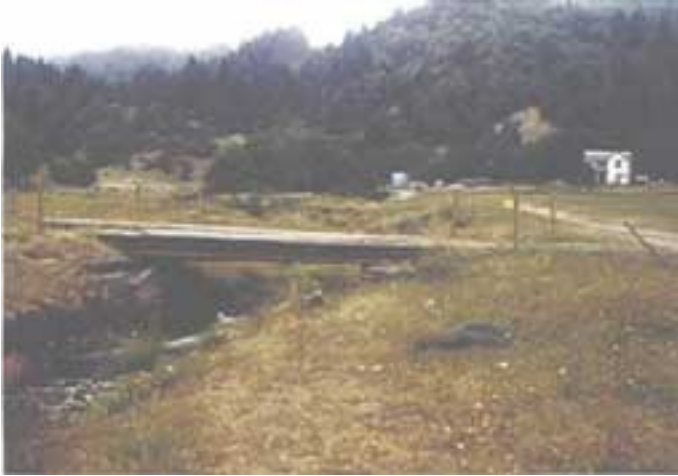
**Figure 4**

Photo points illustrate growth in riparian vegetation from 1995 to 2001 (figure 4). Although shade has not yet been measured systematically, as of January 2001 an estimated 40% of the reach was covered, 40% exposed, and 20% mixed. Overhanging and nearstream willows provide most of the shade. Conifers shade the stream only during the earliest and latest parts of the day, even though many measured 8-12 feet in height as of 2001. The channel also appears to have narrowed, deepened, and increased in sinuosity as a result of willows building streambanks. Progressive changes in the average 7-day maximum value at the mouth of Pea Creek document a dramatic reduction from 70.1 F in 1995 to 60.0 F in 2001 (figure 5). Note that 1997 temperatures include only the first half of the summer, so that the 7-day maximum is at least as high as the reported value. Table 1 documents the progressive decline of diurnal temperatures from 16.3 to 7.4 degrees F.

Pea Creek view to the north, summer '95

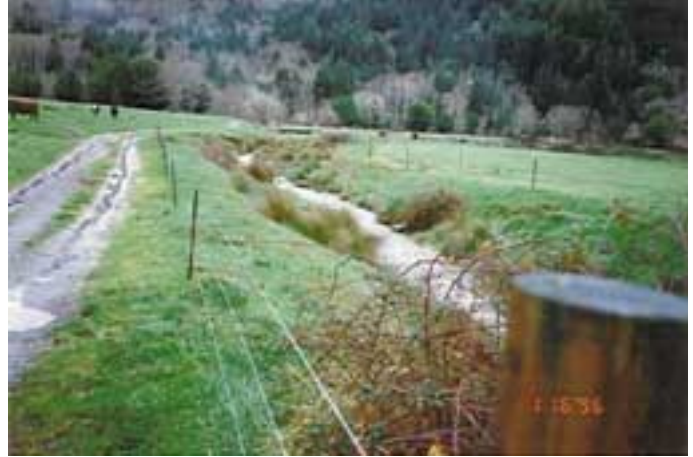
Pea Creek, view to south, 01/16/96

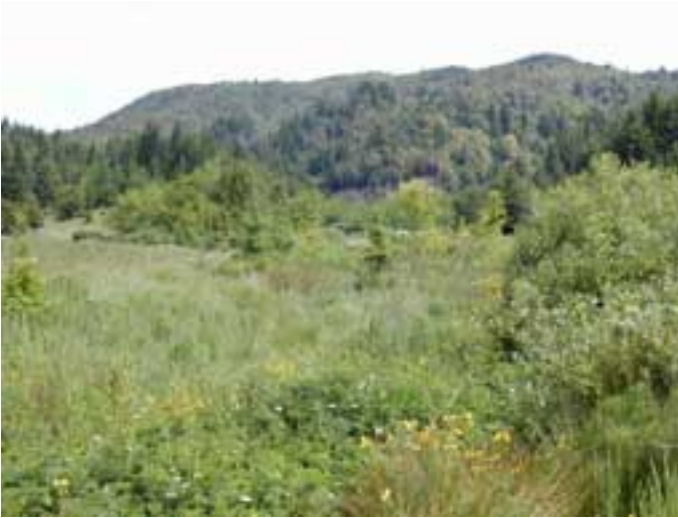
Pea Creek, view similar to above, 06/04/01, small gate middle of both photos

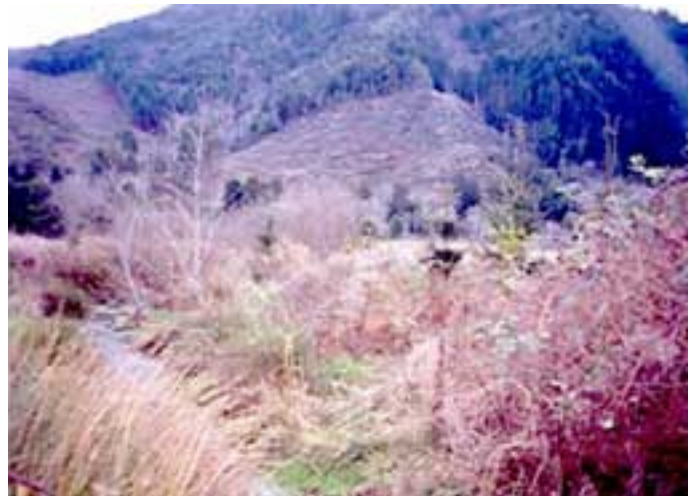
Pea Creek, similar view as above, 01/12/00, conifers in visible in distance visible on both, left-center

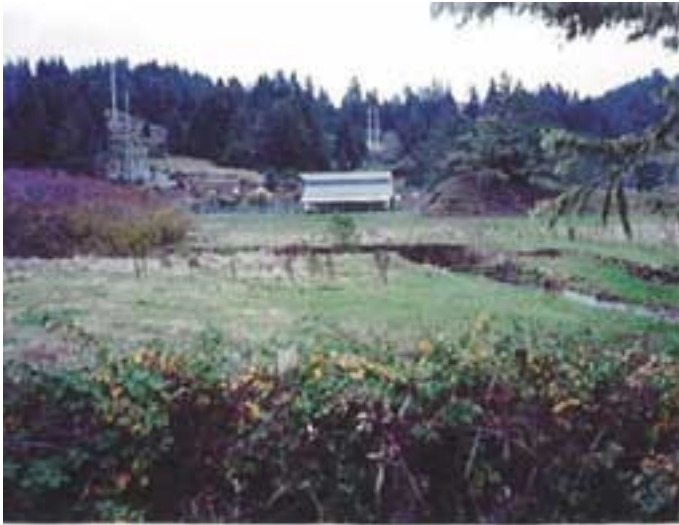
Figure 6 illustrates locations of the temperature monitoring sites. The multi-year record began in 1998 at the downstream-most site under the cattle bridge. Control and experimental/treatment reaches were not established until 2001. The upstream control reach of 425 feet is in unfenced pasture and the downstream treatment reach of 385 feet is fenced and includes some pre-existing riparian vegetation (figure 7).

Crook Creek, 11/01/01, view upstream, control reach

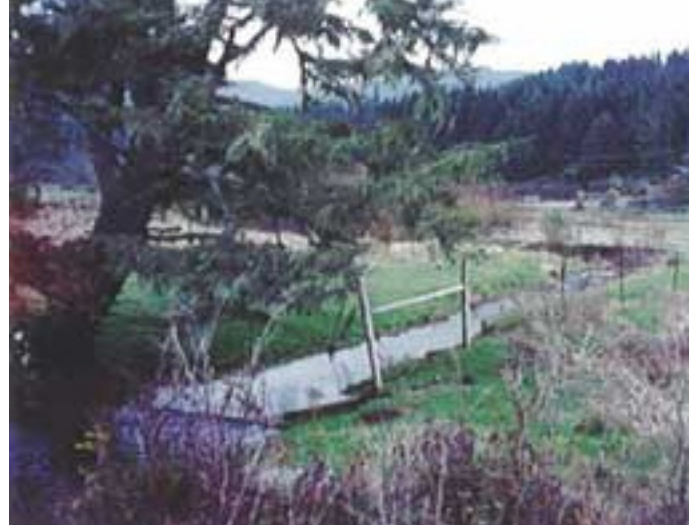
Crook Creek, 11/01/01, view upstream, control reach

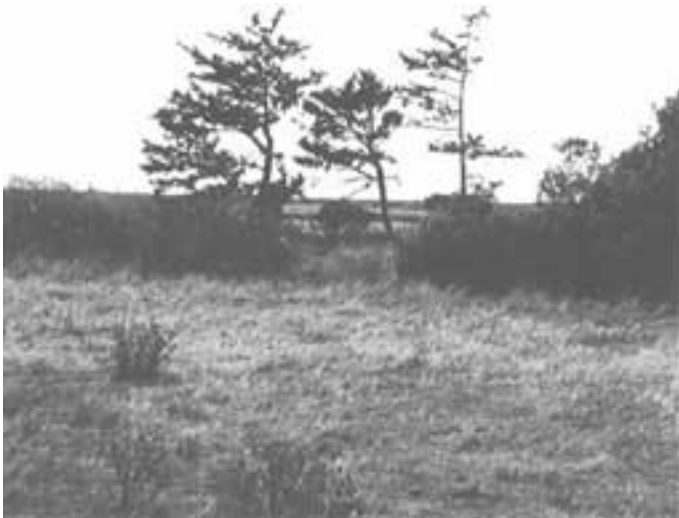
Crook Creek, 11/01/01, view downstream, experimental (fencing planting) reach reach;

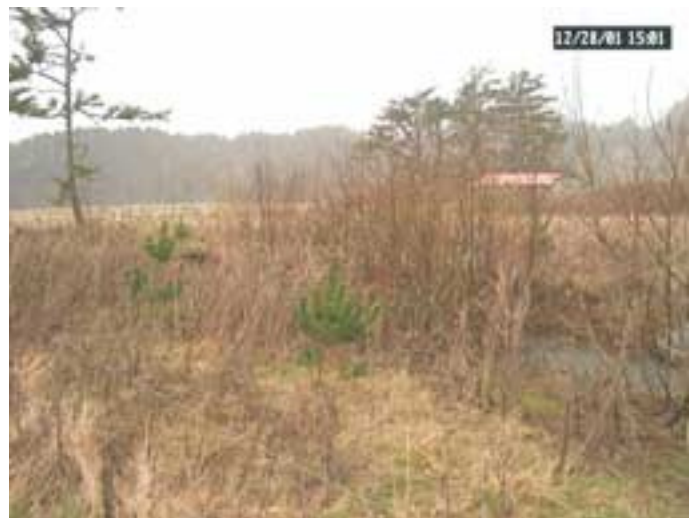
Crook Creek, 12/28/01, view downstream, along experimental and shore pines and willows visible

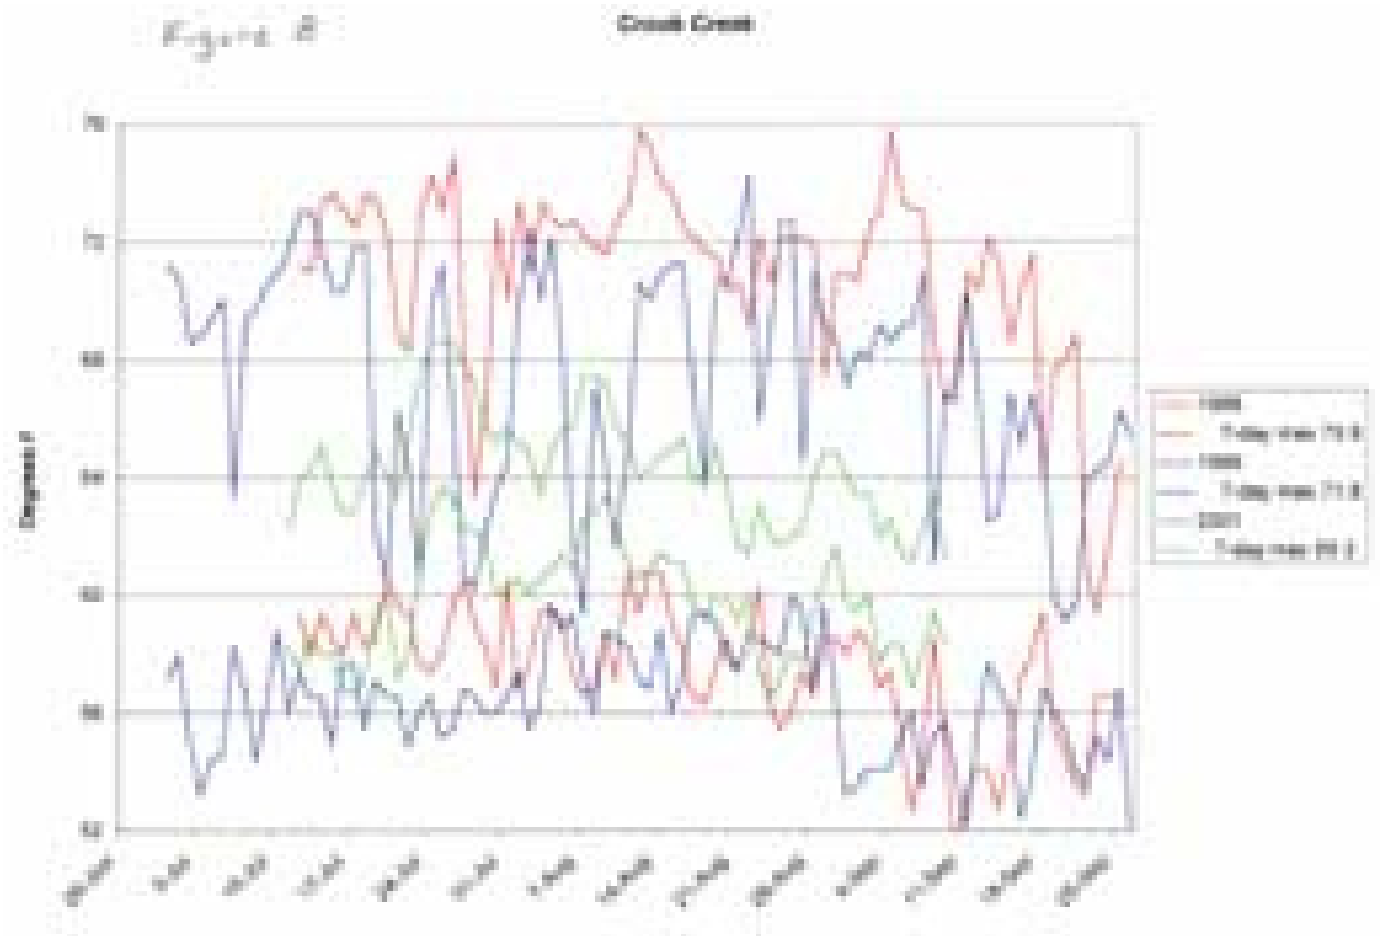
The average 7-day maximum value at the cattle bridge on Crook Creek documents a progressive reduction from 73.9 F in 1998 to 69.3 F in 2001 (figure 8). Diurnal fluctuations are also

declining, from 14.4 to 10.3 degrees F (table 2). Figure 8 illustrates a warming of daily minimum temperatures. More insulation from the cooler night air temperatures could be provided by an increase in vegetation or water depth or both.

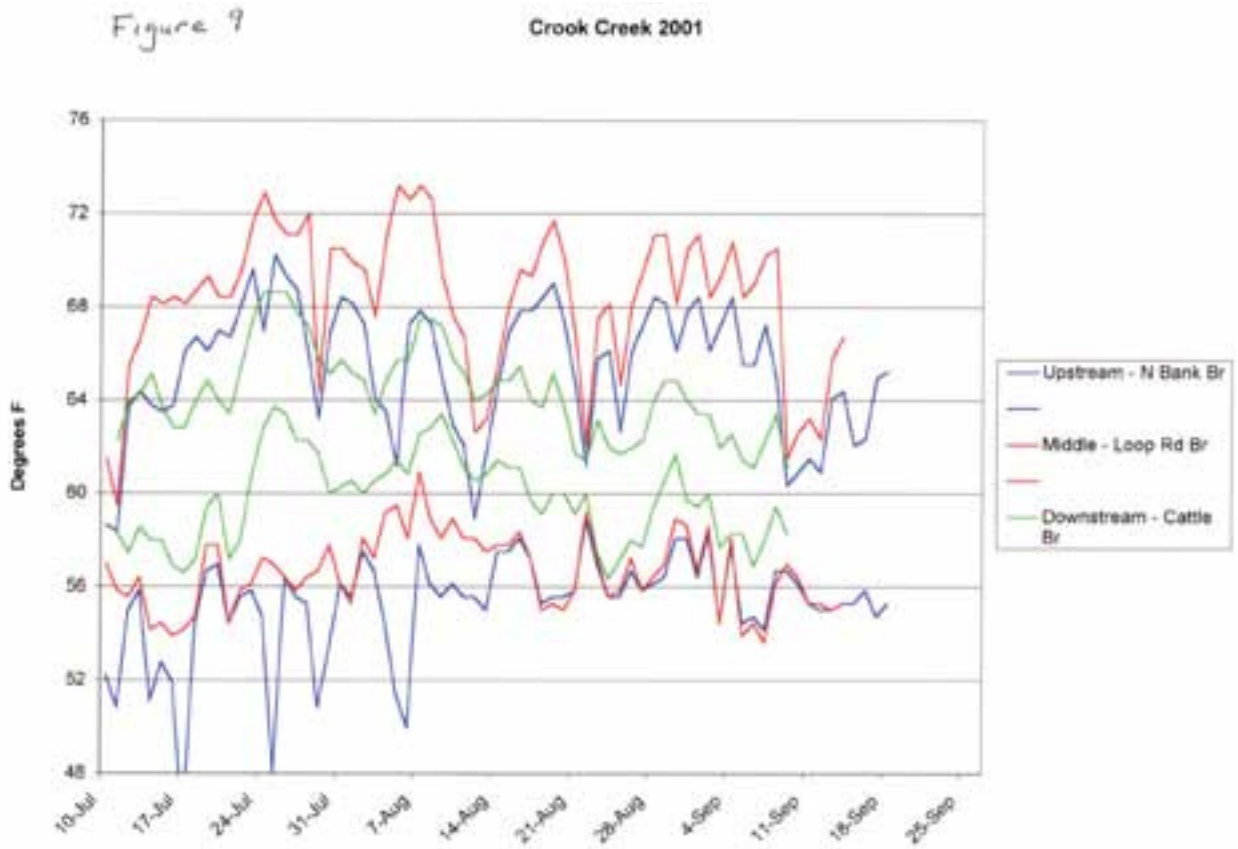
Figure 9

Results from 2001 are shown on figure 9, with minimum and maximum temperatures for each day connected as a single line. Prior to the mid-season audit on August 13th, the upstream site had been exposed to air temperatures and the thermometer at the middle site had been moved. Data after August 13th are valid, but no average 7-day maximum value was calculated. The diurnal variation shows heating in the control reach, and cooling in the treatment reach.
