PROJECT COMPLETION REPORT
CLOVER CREEK RIPARIAN RESTORATION
OWEB Project # 99-304

Glen Brady
Umpqua Basin Watershed Council
December 11, 2001

Clover Creek Riparian Restoration

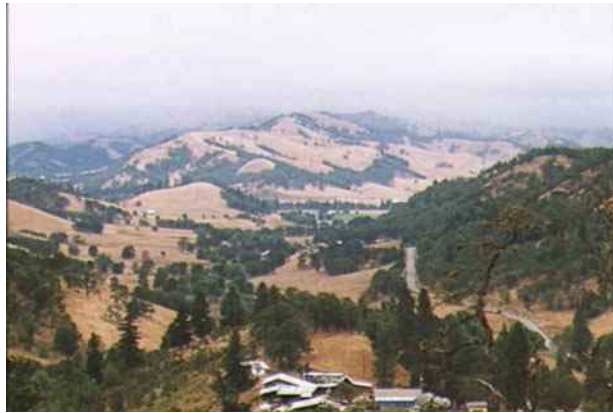
Figure 1
View of Clover Creek from the headwaters of the watershed

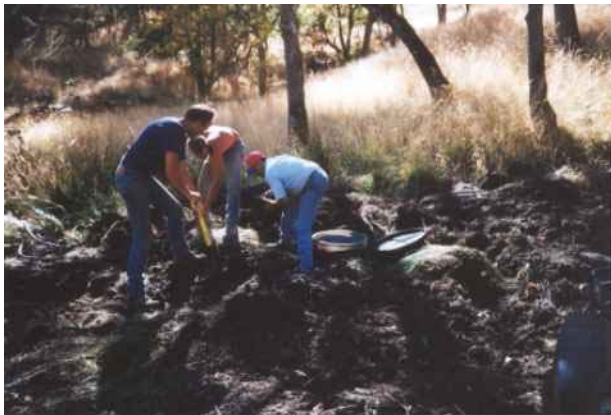
Figure 4
Sandbergs and Serge driving posts for Johnston fence near Kahn property line. Cathy is operating the post pounder, George is holding the post, Serge is watching, and Missy is supervising.
