Upper Chewaucan Watershed Assessment

**A Guide for Sustaining a
Healthy Watershed for Future Generations**

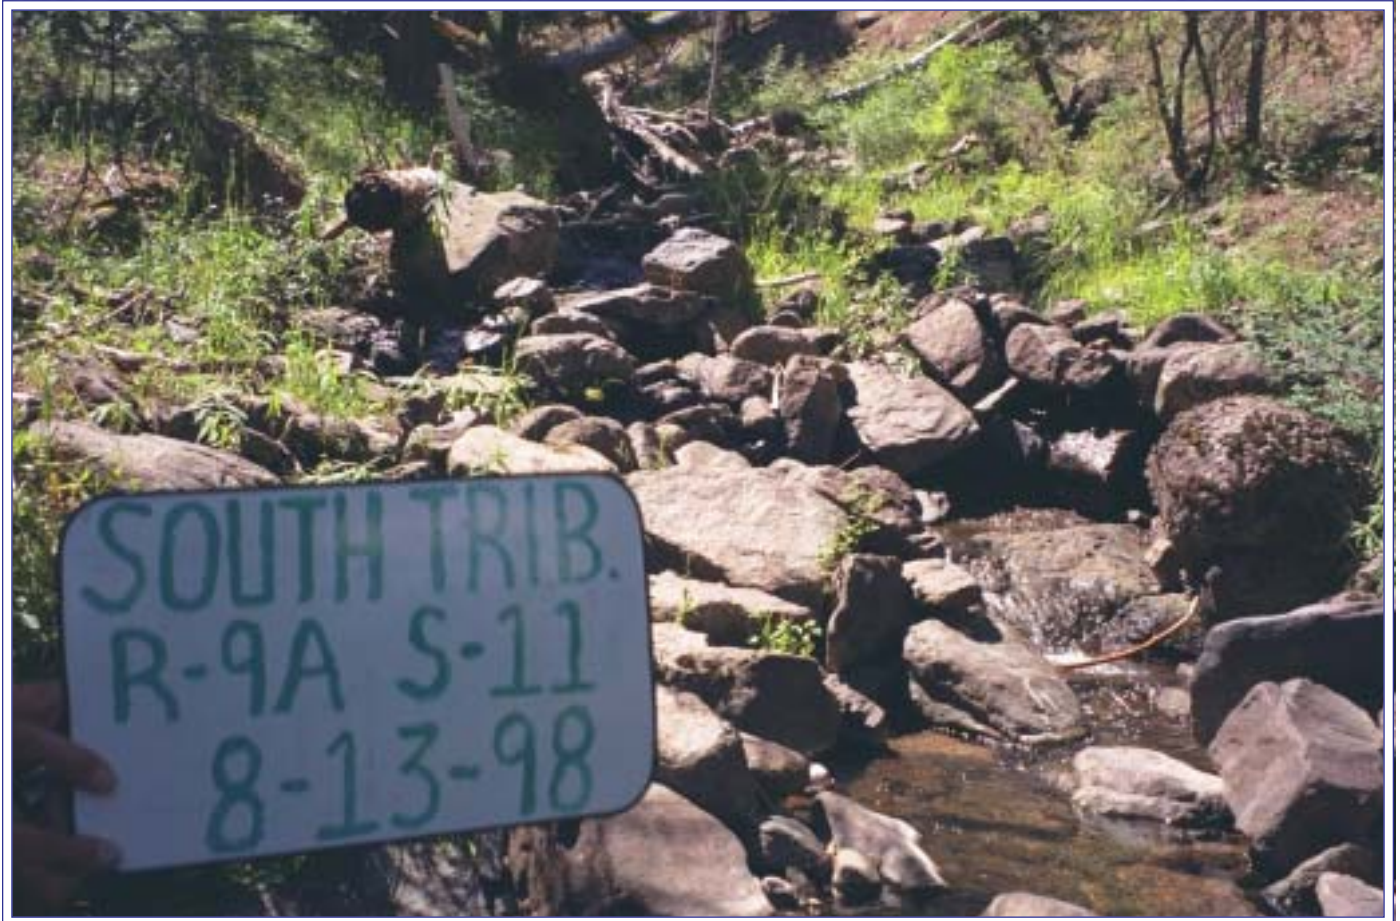
Morphological Description of Rosgen A3 Stream Type

Rosgen A stream types are characterized by steep gradients (between 4 and 10%), with deeply incised channels, and entrenchment ratios <1.4 . They have low width/depth ratios (<12) and low sinuosity (<1.2). Local landform and geology dictates channel stability. The A3 channel types, found in the Chewaucan Watershed, are characterized by a high sensitivity to disturbance, very high stream bank erosion potential, and vegetation having a negligible influence in determining channel stability. Overall, these channels exhibit high sediment supply and transport potential. Large woody debris plays a significant role in determining frequency of step pools which provides fish habitat and overall channel stability.

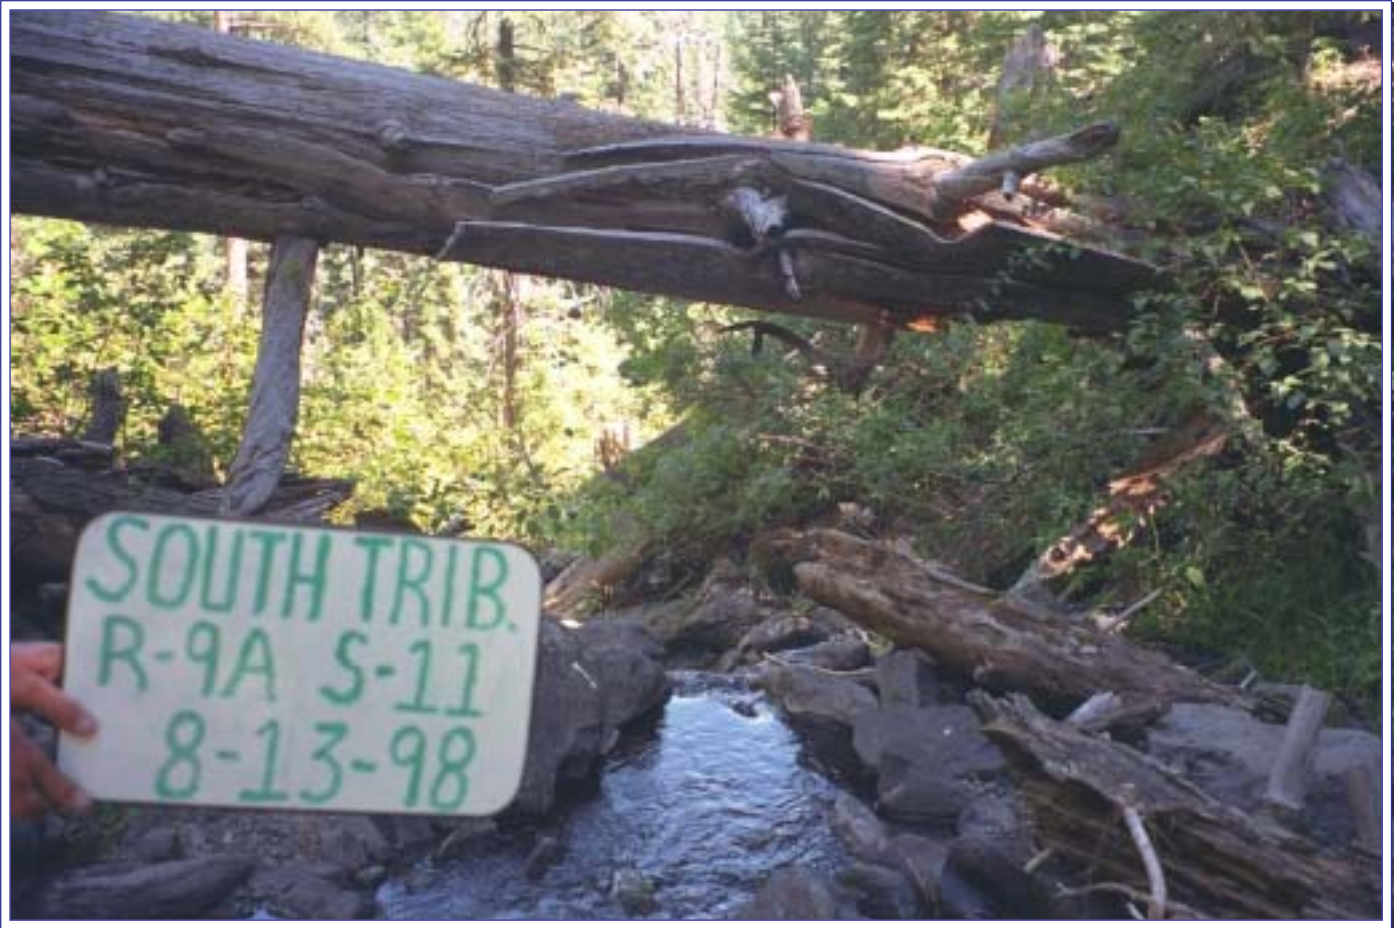
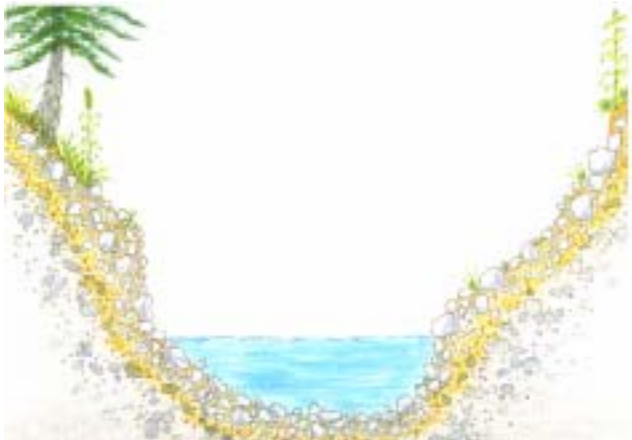
Rosgen A3 Stream Type

Delineative Criteria (A3)

Landform/soils: Steep narrow depositional slopes typical of glacial moraines and debris slides associated with unconsolidated, heterogenous and non-cohesive materials.

Sinuosity: < 1.2

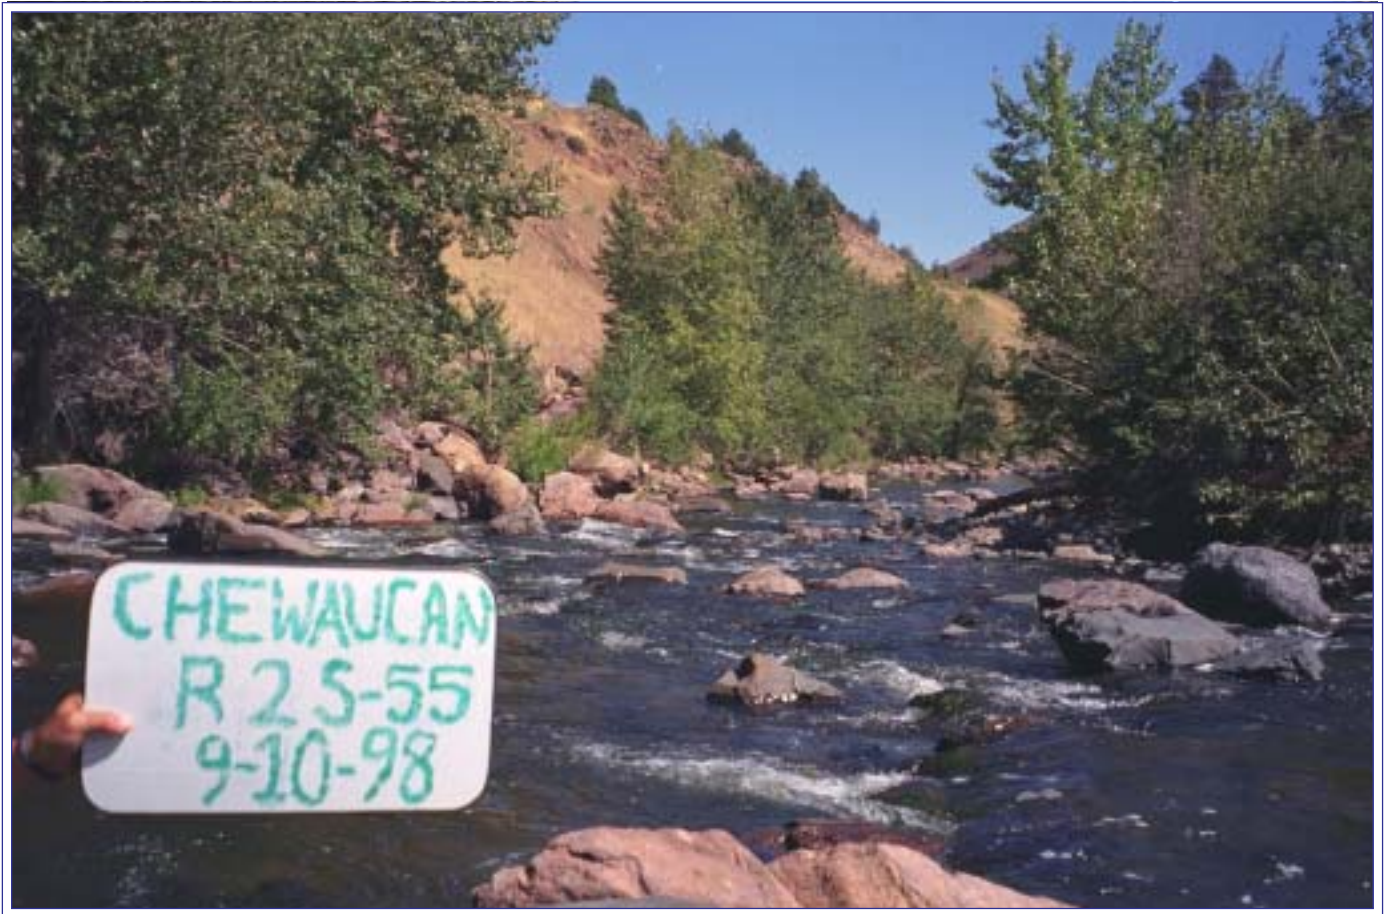
Morphological Description of Rosgen B3 Stream Type

Rosgen B stream types are moderately steep (between 2 and 4%), with rapids and riffles common and scour pools irregularly spaced. These stream types are moderately entrenched (1.4-2.2), with moderate width-to-depth ratios (>12) and sinuosity (>1.2). They are found within iV_i type valleys, usually in forested systems, with substrates ranging from gravel (B3) to cobble (B4). Vegetation has a moderate influence in determining channel stability. These channel types are characterized by low to moderate sensitivity to disturbance and low streambank erosion. Fish habitat is often associated with large woody debris which contributes to scour pool formation and cover.

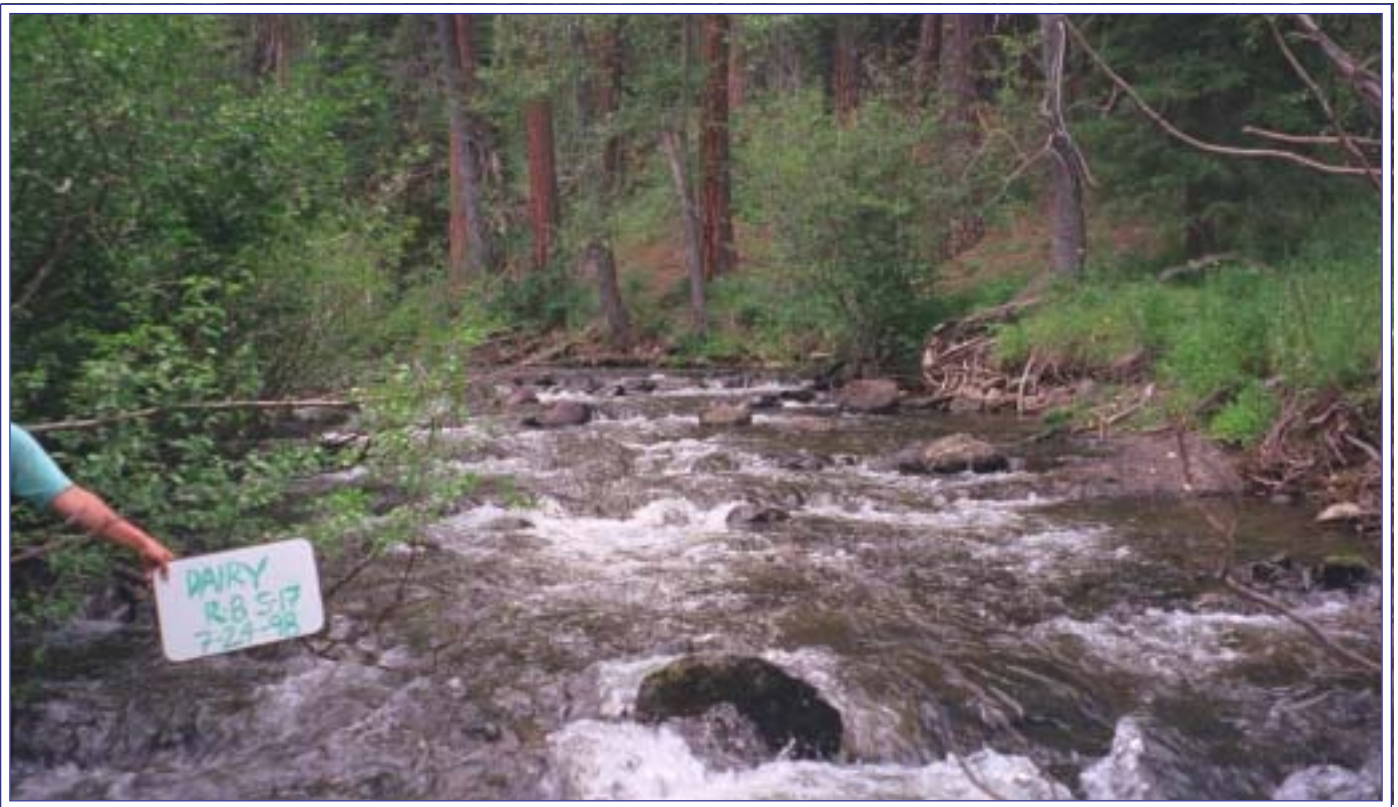
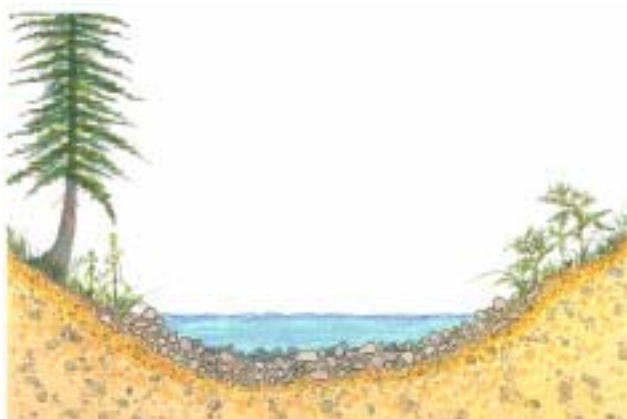
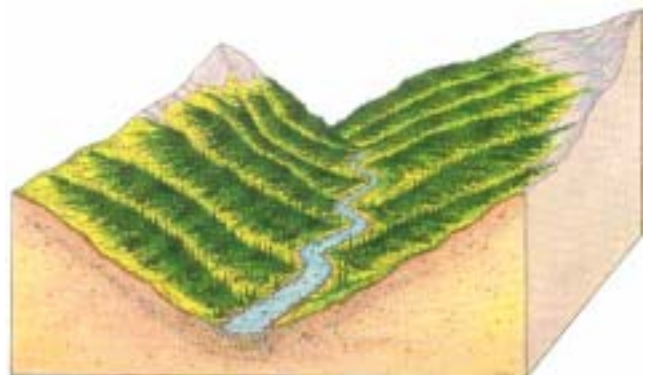
Rosgen B3 Stream Type

Delineative Criteria (B3)

Landform/soils: Narrow, moderately steep colluvial valley with gentle side slopes. Soils are colluvium and/or alluvium. Often in fault line valleys or on well vegetated alluvial fans.

Sinuosity: >1.2

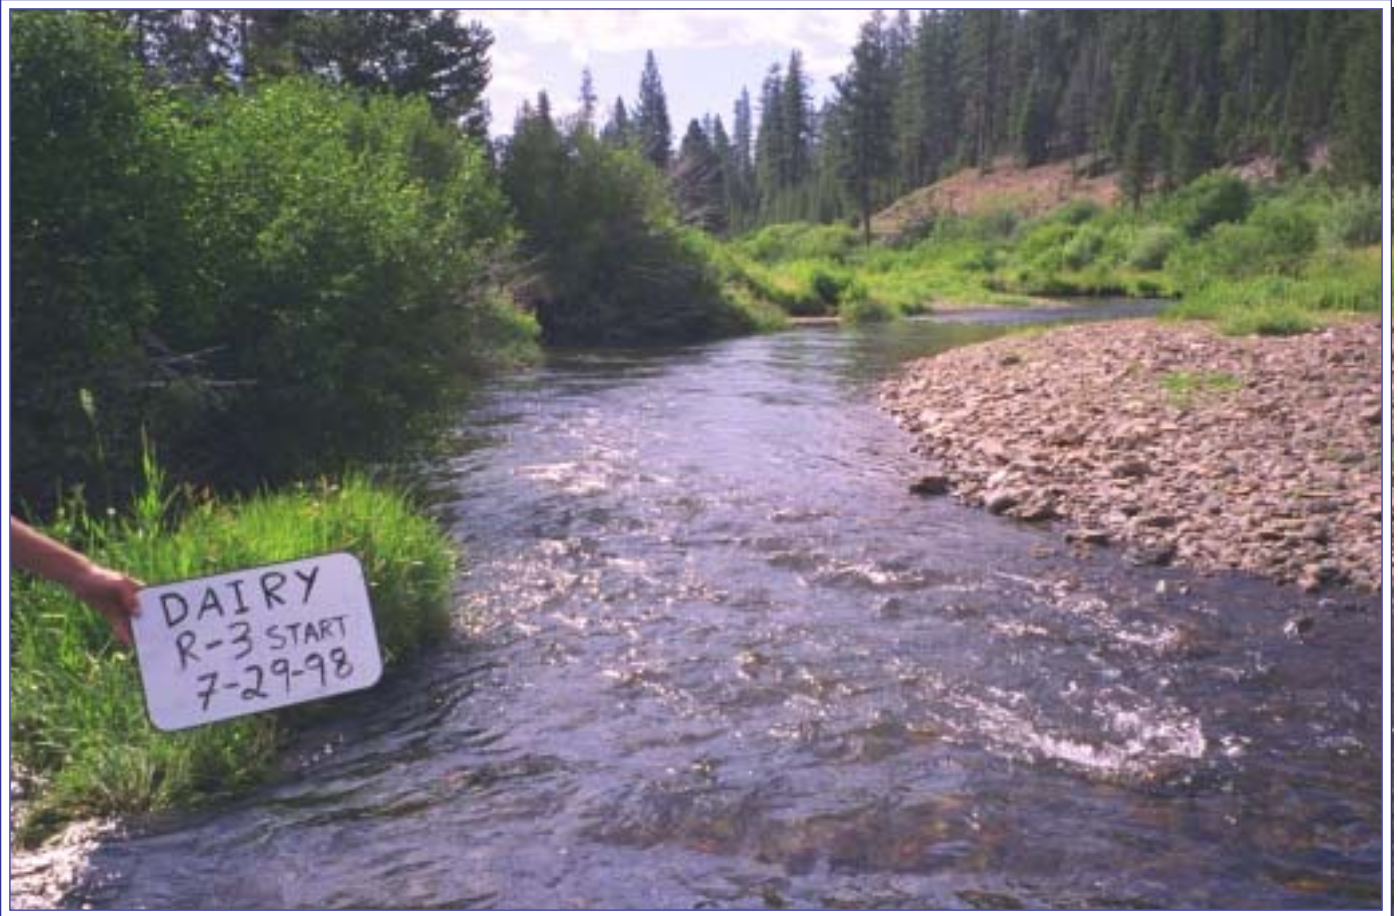
Morphological Description of Rosgen C4 Stream Type

Rosgen C streams types are lower gradient streams which are slightly entrenched (>2.2), have moderate to high (>12) width-to-depth ratios, high sinuosity values (>1.4), and are characterized by riffle/pool sequences. Streams within the watershed are often found in low gradient alluvial valleys with substrates dominated by gravel (C4). Channels have characteristic point bars and broad, well defined floodplains. Vegetation has a very high influence in determining channel stability, and when vegetation is disturbed and removed, these channel types are highly sensitive to both lateral (bank) and vertical (downcutting) erosion. Natural sediment supply is moderate to high except in those areas where stream banks are well vegetated. These streams are highly sensitive to changes in sediment and stream flow.

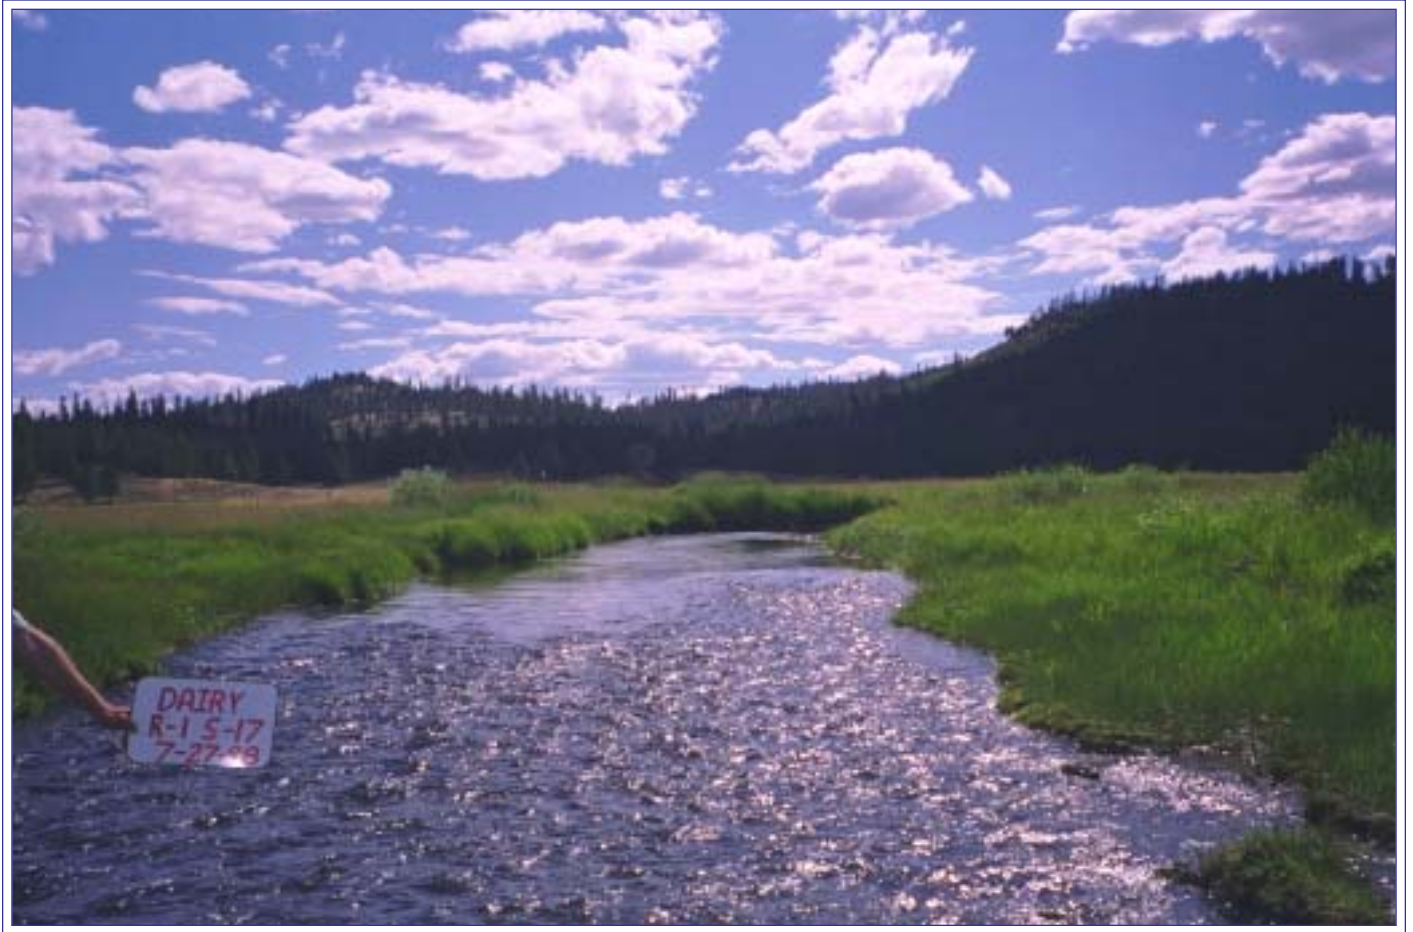
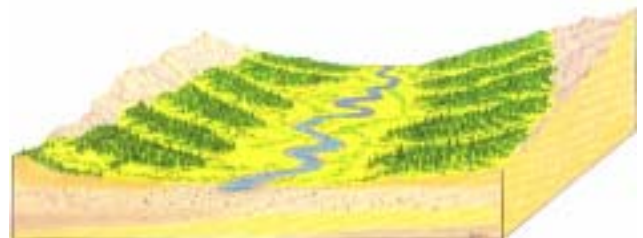
Rosgen C4 Stream Type

Delineative Criteria (C4)

Landform/soils: Broad, gentle gradient alluvial valleys and river deltas. Soils are alluvium.

Sinuosity: > 1.4

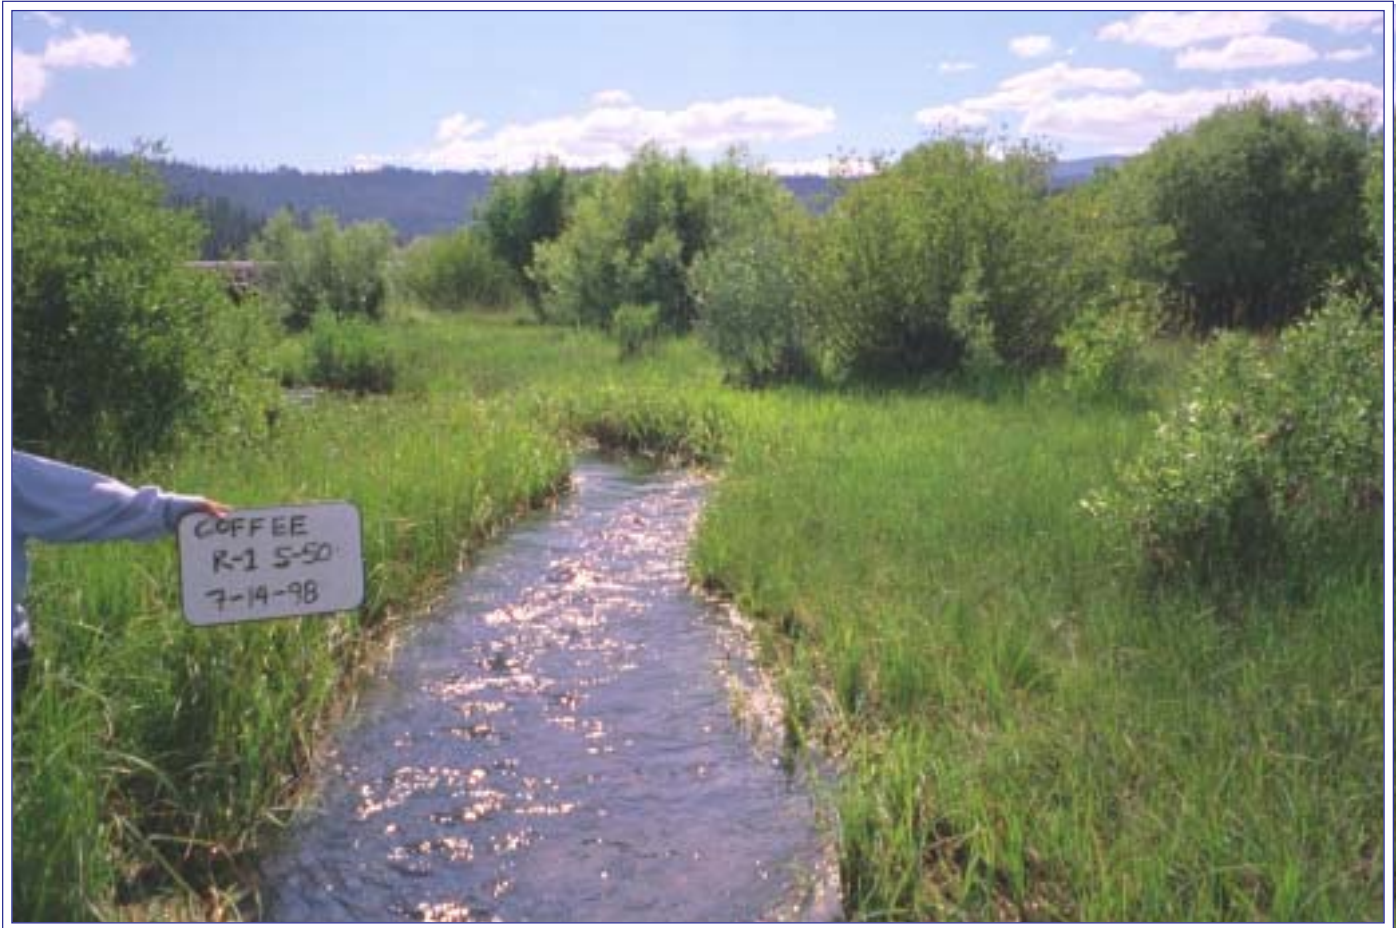
Morphological Description of Rosgen E Stream Type

Rosgen E stream types are low-gradient streams (<2%, but can reach 4%) which are slightly entrenched (>2.2) with low width-to-depth ratios (<12), and high sinuosity (>1.5), with riffle/pool sequences and well developed floodplains. In the Chewaucan Watershed, channel substrate is dominated by gravel (E4) and to a lesser degree cobble (E3). Valleys are usually wide and gently sloped. Vegetation has a very high influence on channel stability. When it is lacking, these channel types are highly sensitive to disturbance which may result in increased levels of streambank erosion and downcutting. These streams are highly sensitive to changes in sediment and stream flow. The E stream type provides excellent fish habitat through undercut banks, clean spawning gravels, and numerous deep pools.

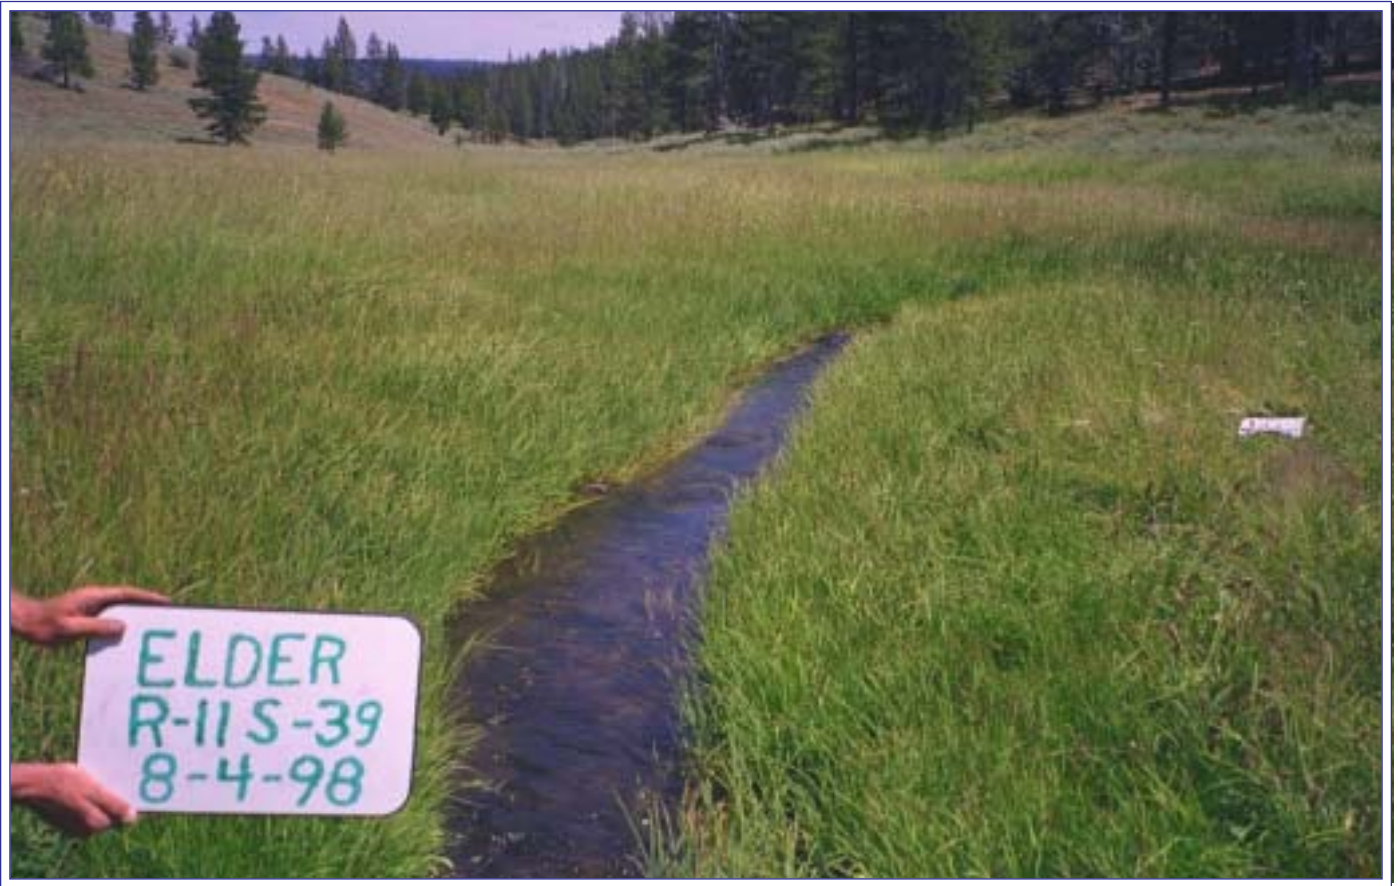
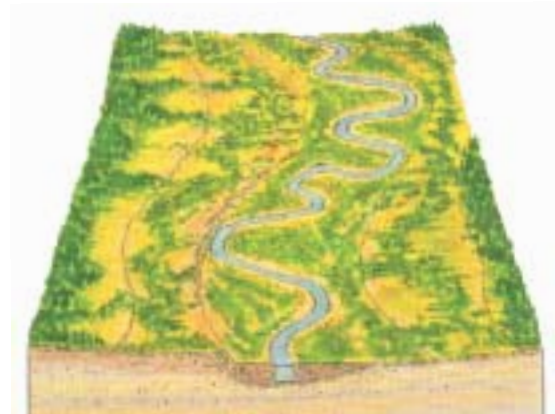
Rosgen E Stream Type

Delineative Criteria (E4)

- Landform/soils:** Gentle slopes in broad riverine or lacustrine valleys and river deltas.
- Channel Materials:** Gravel dominated bed with smaller accumulations of sand and occasional cobble. Streambanks composed of sandy/gravel mixture with dense root mat.
- Slope Range:** < 0.02
- Entrenchment ratio:** > 2.2
- Width/depth Ratio:** < 12
- Sinuosity:** > 1.5
