Stream Restoration Plan

Middle Fork Lake Creek at Lake Creek Lodge

August 2005

Louis Wasniewski
Assistant Forest Hydrologist
Deschutes National Forest
Bend, Oregon

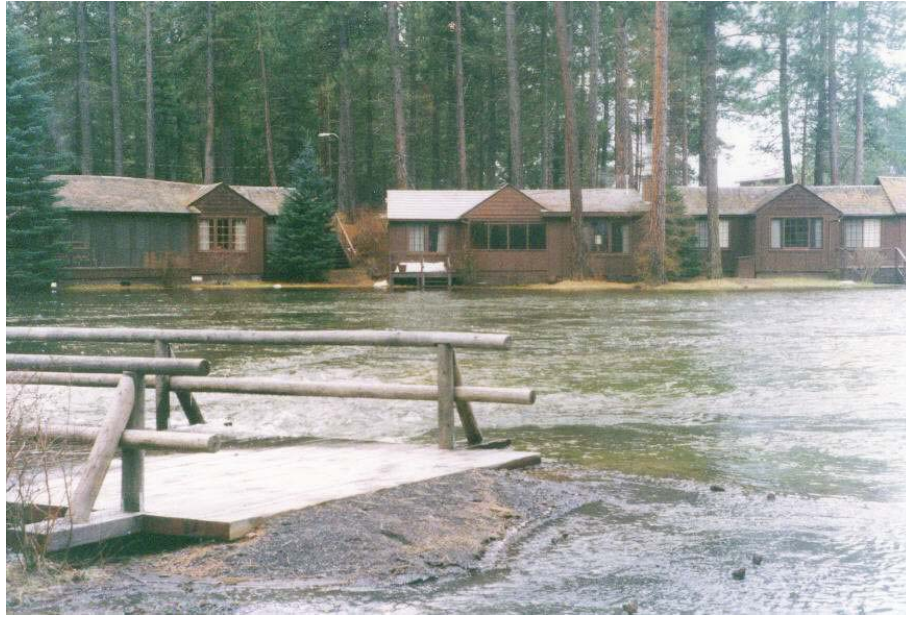
Photograph 1: 1996 flood at Lake Creek Lodge. Photo provided by Lake Creek Lodge.

The largest flow on record at the gauge was 589 cfs that occurred on February 10, 1996 as a result of a warm weather and a rain on snow event. This same flooding also occurred at Lake Creek Lodge where the floodplain was accessed, however, no water had entered the cabins. Pictures during the flood were taken by the lodge and were very useful in several areas of the design (Photograph 1).

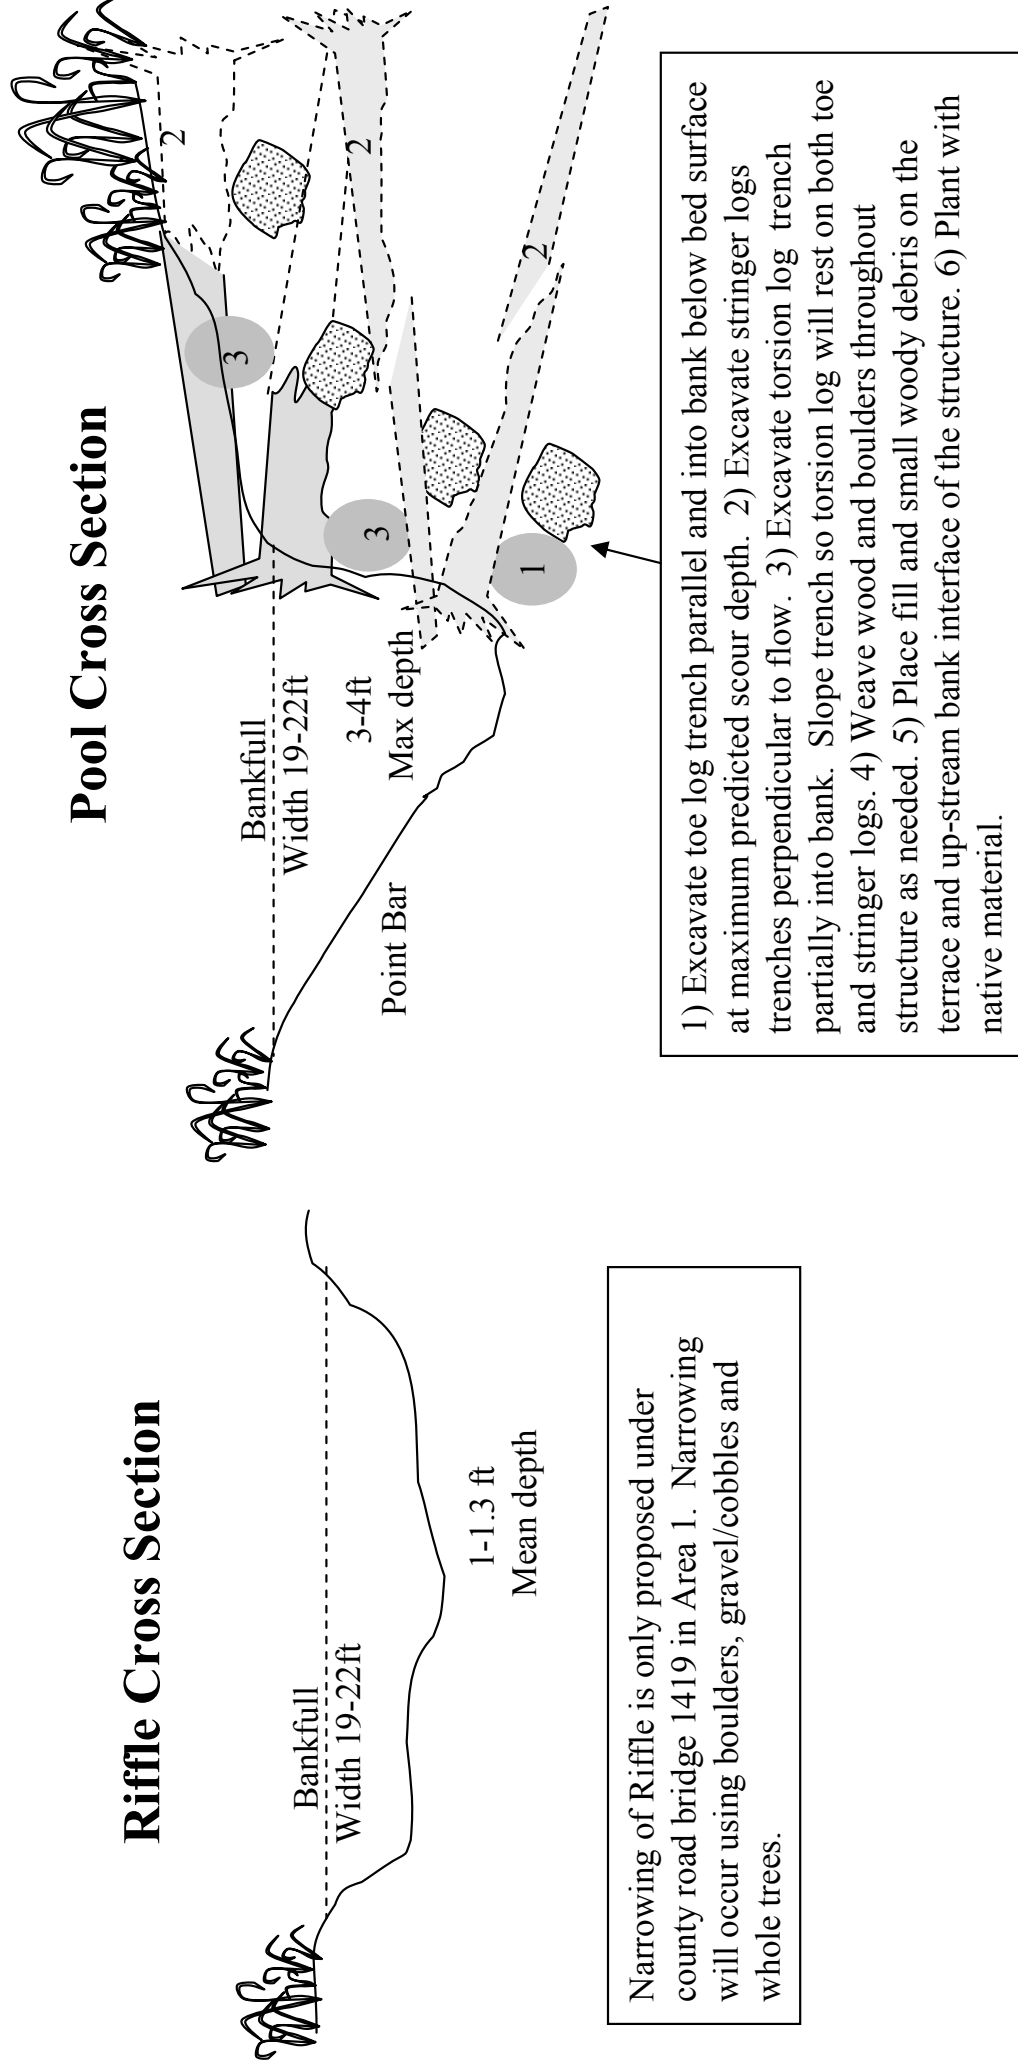
Figure 6. Typical Riffle and Pool Cross Sections

Narrowing of Riffle is only proposed under county road bridge 1419 in Area 1. Narrowing will occur using boulders, gravel/cobbles and whole trees.

Area 1 is located under the 1419 county road bridge and extends downstream through the first meander (Figure 5). This area is further divided into two sites: site 1 is under the bridge and site 2 is the first meander. Under bridge the channel maintains a riffle feature that is wide and shallow, having a width of 36 feet that is 180% wider than the average reference width of 20 feet. To create a narrower and deeper channel and improve fish habitat and still maintain flood capacity the channel would be narrowed to approximately 20-25 feet. The existing cross sectional area is 41.9 ft² and a mean depth of 1.2 ft. By changing the bankfull width to 20 or 25 feet the cross sectional area would be 27.6 or 30.4 ft², respectively. This is much closer in the reference condition range of 21 to 24 ft² (Figure 6)

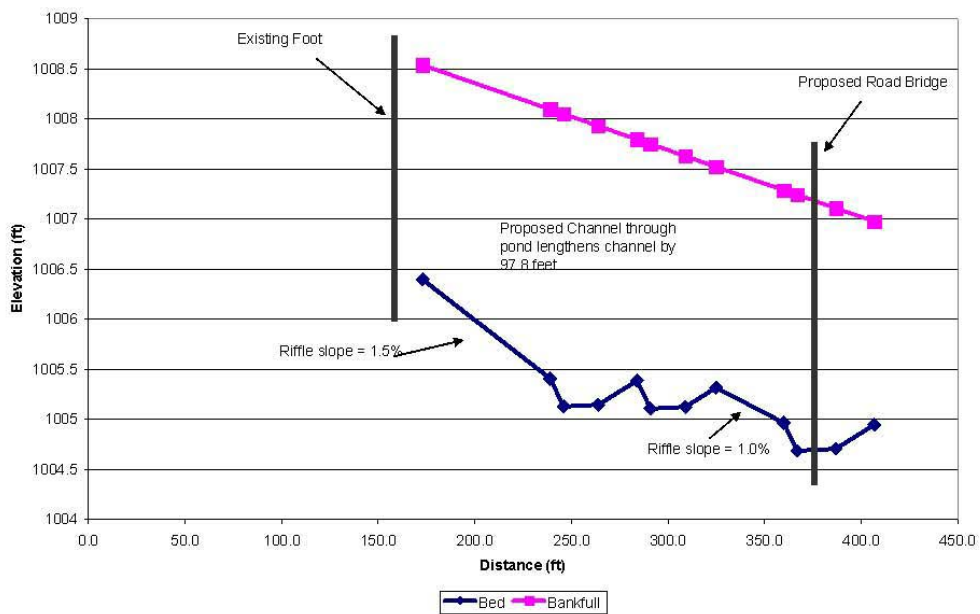
Lake Creek Proposed Profile Through Pond
