PROJECT COMPLETION REPORT
BUCK FORK – N. MYRTLE CULVERT REPLACEMENT
OWEB Project # 99-511

Buck – North Myrtle Culvert Replacement

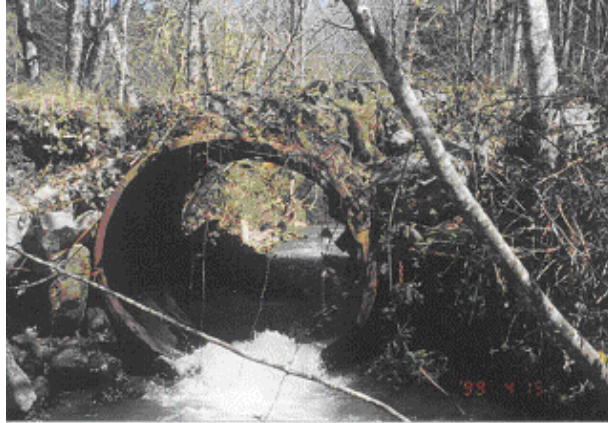
Figure 1
Pre-project view, Buck Fork Creek Culvert, outlet end

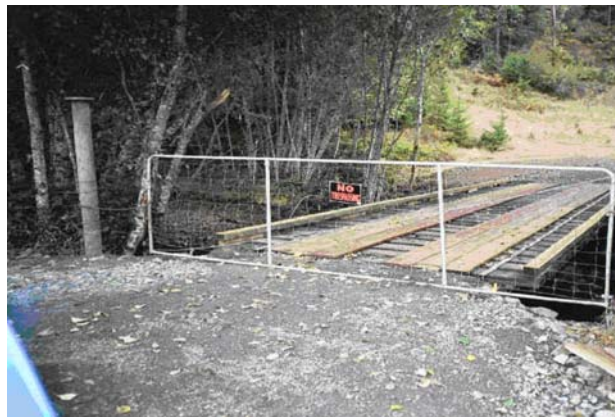
Figure 2
Post-project, Buck Fork Creek Bridge installed

This project has successfully eliminated the fish barrier caused by the water tank culvert.

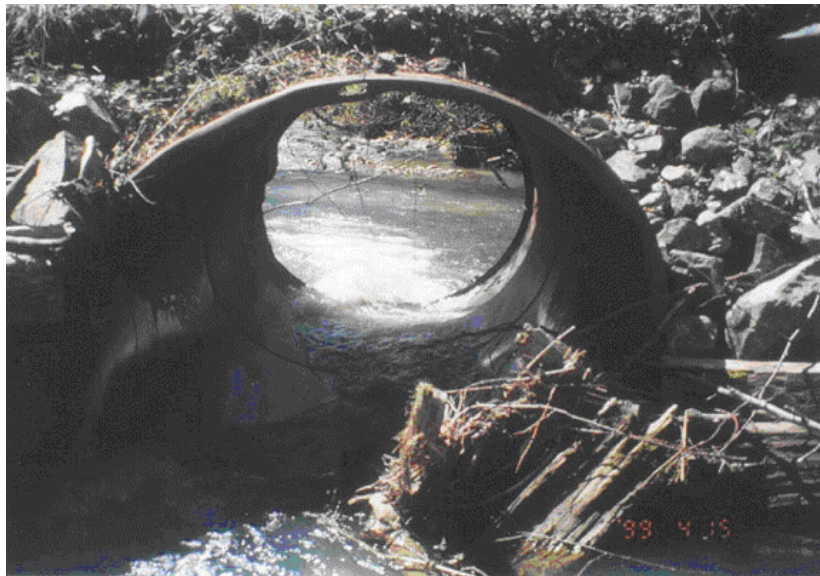
Figure 3
Pre-project, interior view of the old culvert

Work began on the project in early September to remove the water tank culvert in preparation for placing the railroad flatcar bridge. After placing a silt dam downstream of the work area, the contractor used a medium size track excavator (same as above) to dig out the fill on each side of the culvert and either stockpile it adjacent to the work area or had it hauled a short distance down the highway to a small stockpile area on the landowner's property. This material would later be retrieved and used on the project.

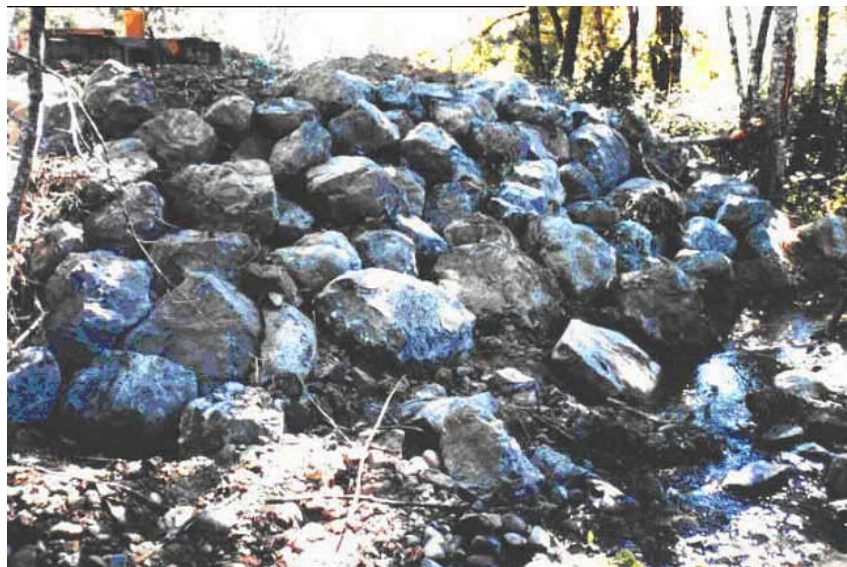
Figure 4
Riprap in place

Large rip rap rock (1,000 to 3,000 pound) were stacked at each bank of the stream under where the ends of the flatcar bridge would rest. Each rock was placed then tamped and/or moved around until it was firmly in place. Once all abutment rocks were in place the concrete forms were constructed so that the concrete would form a cap upon which the flatcar bridge would rest. Eye bolts were embedded in the concrete for bridge tie downs. The concrete was poured September 15, later than we really wanted, because of equipment breakdown and delays of the concrete pumping company. As soon as the concrete cured, we would be ready for the big moment!

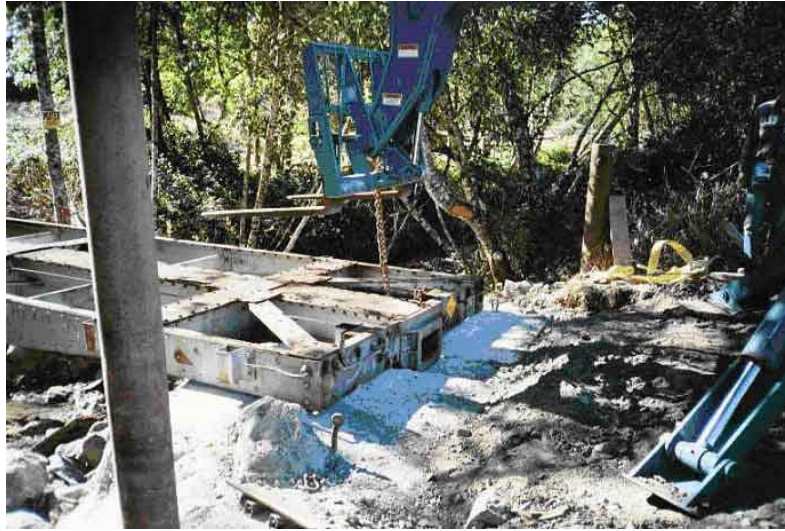
Figure 5
Bridge being lowered onto concrete footing

The flatcar bridge frame was pulled across the stream using the telescoping boom of the forklift with a heavy cable attached between them. As the bridge was inched across the cable was shortened keeping the bridge suspended well above the stream. The point of balance was finally reached just before the bridge reached the north abutment and the end came to a rest on the rip rap. From there it was a simple matter to lift the end of the bridge onto the abutment.

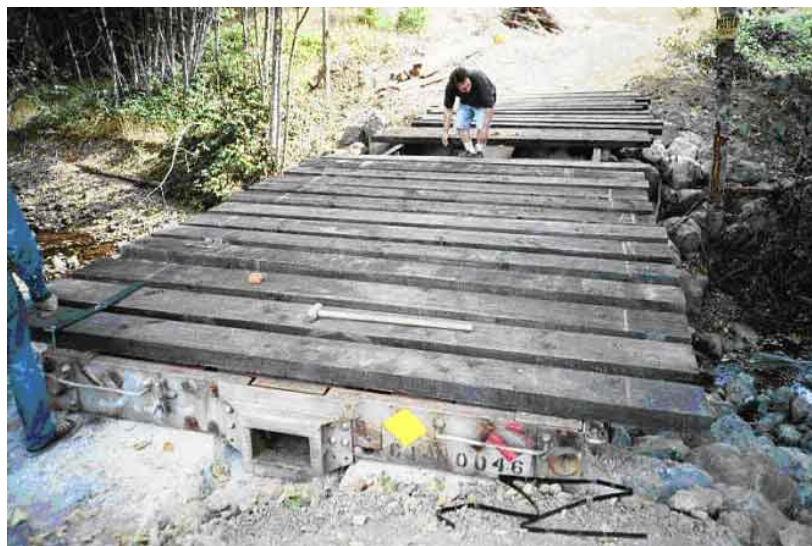
Figure 6
Putting on the new pressure treated planking

The bridge decking consisted of 4" x 12" x 12' long pressure treated planks and 2" x 12" x 20' long pressure treated runners. The planks were attached to the bridge frame with metal straps bolted through the original bolt holes and the runners were attached with spikes and lag bolts. The landowner helped the contractor install the decking by making modifications to the planks to fit the frame. Finally a bumper timber was installed on each side of the bridge.
