# 2003 Restoration Project Effectiveness Monitoring Report

## Fish Passage Improvement Projects

### Summary

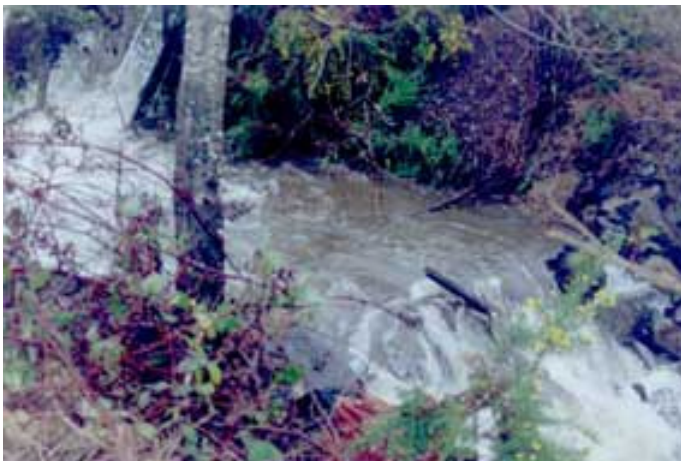
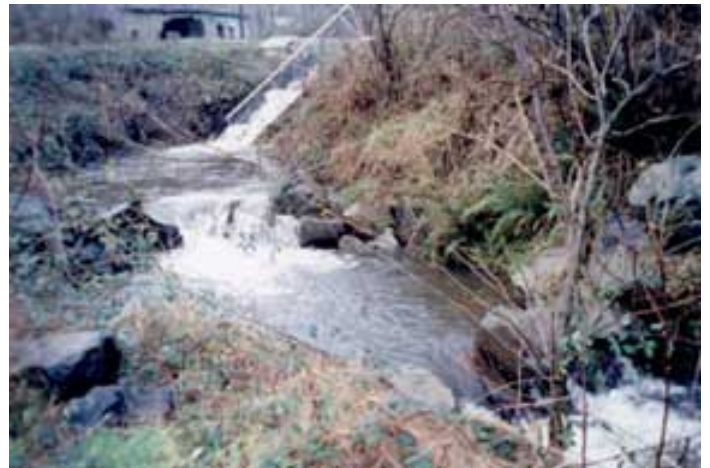
Boulder weir constructed to raise water level at fish ladder upstream, 11/96 View of original weir and first new downstream weir, 01/99

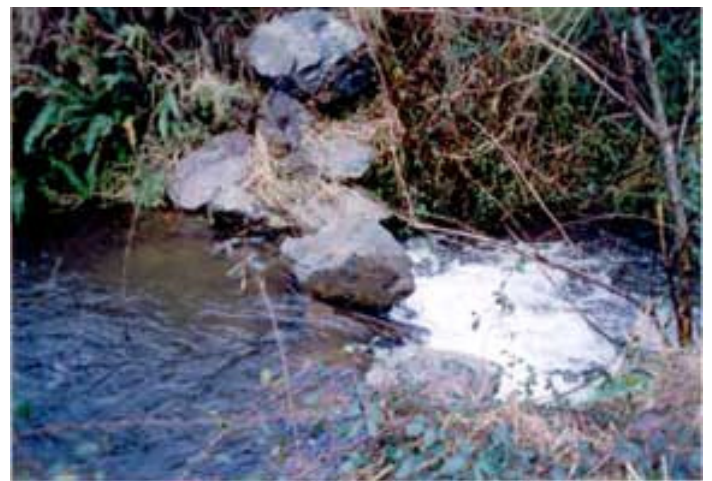
Original boulder weir with smaller step after more weirs installed, 01/99 Closeup of first new downstream weir, 01/99

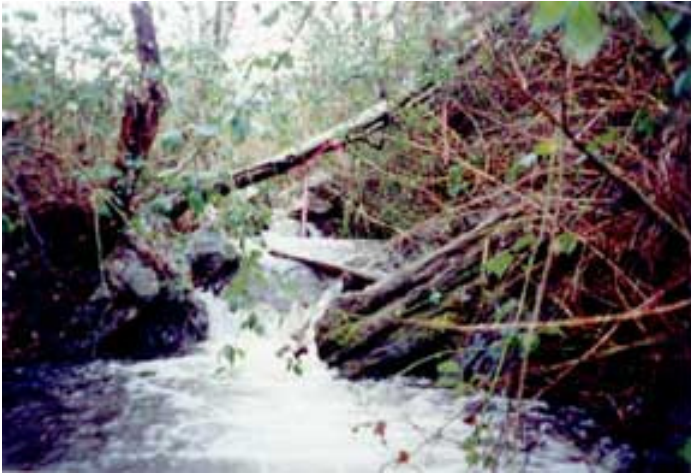
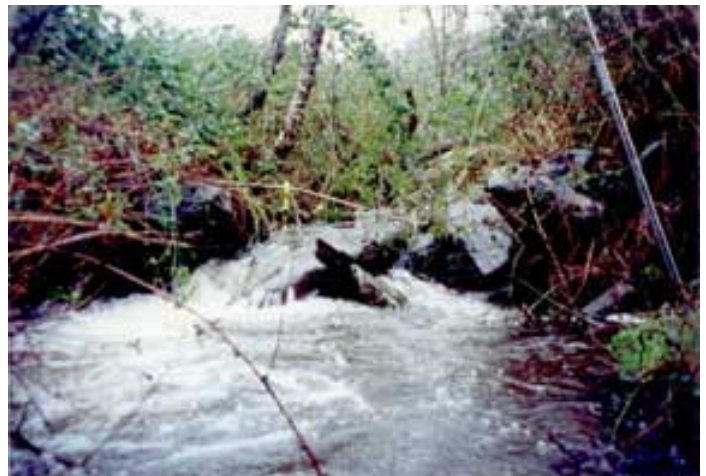
One of two downstream weirs showing jump height, 02/14/00 Other downstream weir showing jump height, 02/14/00

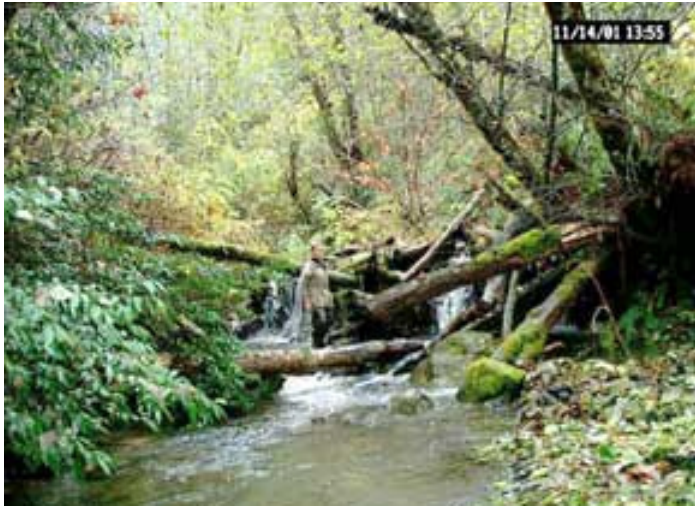
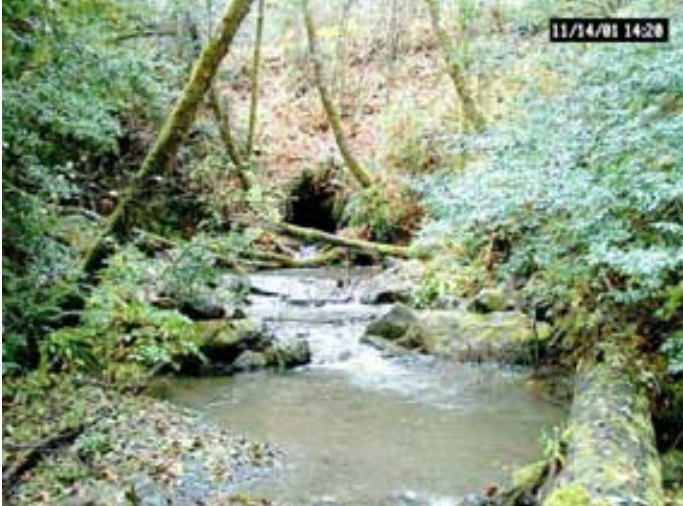
Looking upstream at the log jam 450' from the culvert, 11/14/01    Looking upstream at outlet and two jump pool weirs, 11/14/01

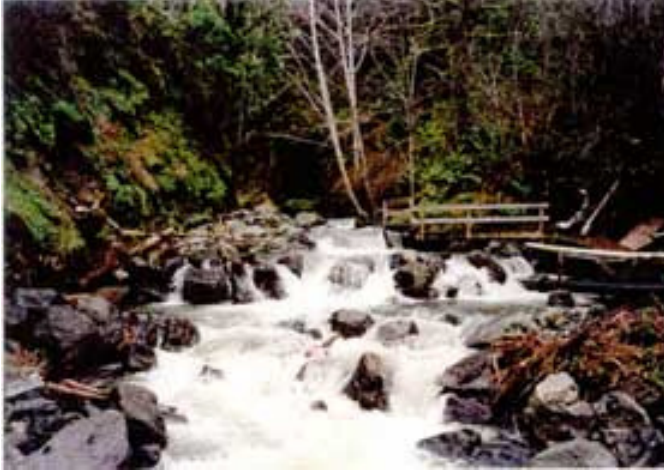
Steps formed by boulder weirs, 03/22/99

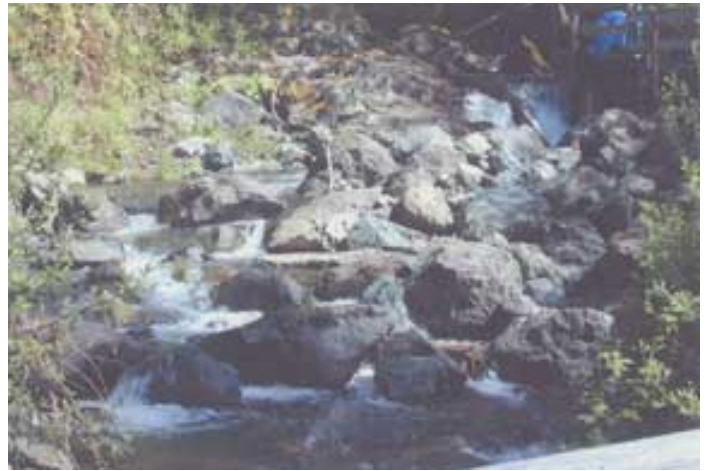
Boulders not performing as weirs, 04/01

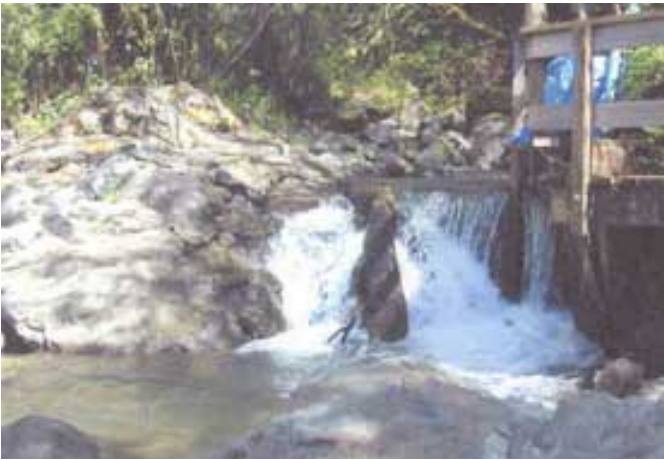
Front view of top jump over intake dam, 04/01

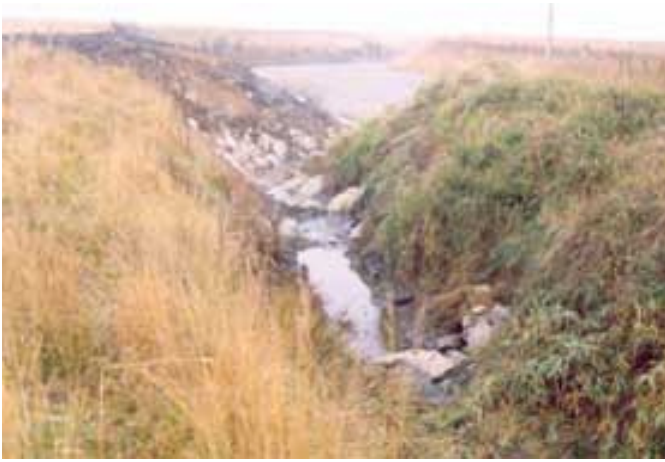
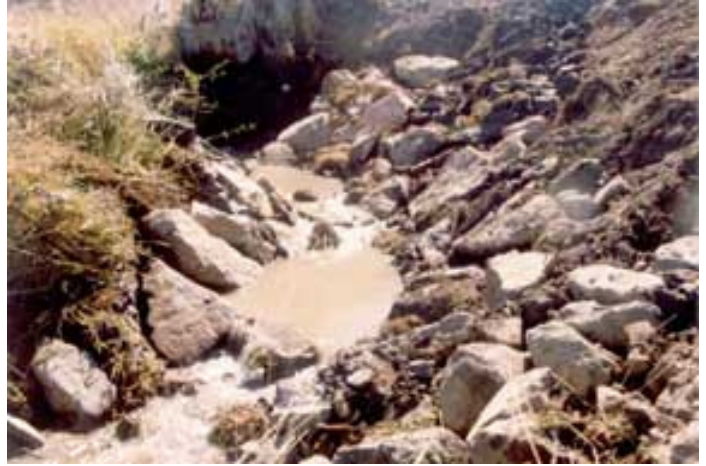
Weirs during construction, looking at Jenny Cr/Floras Cr confluence Weirs during construction, looking upstream from the mouth

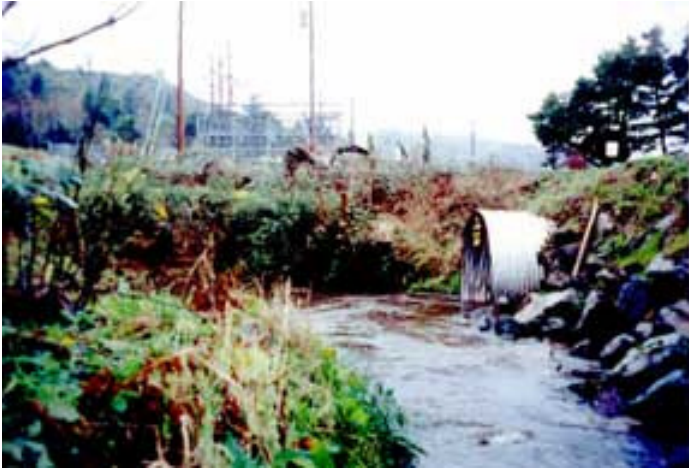
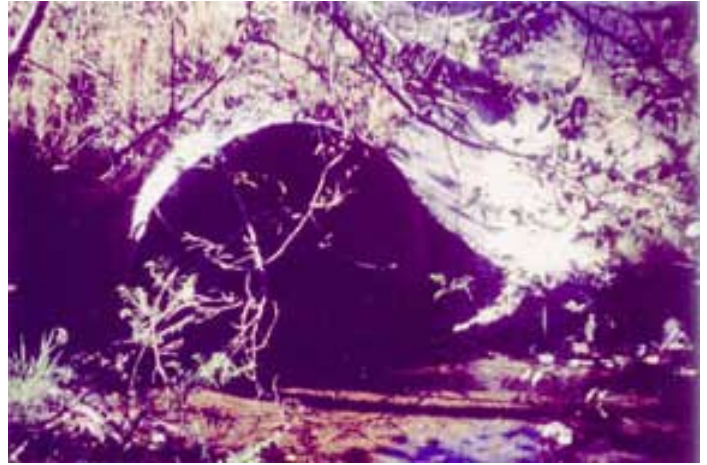
Inlet from upstream showing 90 degree turn, fire pond access, 02/14/00 Outlet, showing sand and silt-dominated substrate, 09/07/99

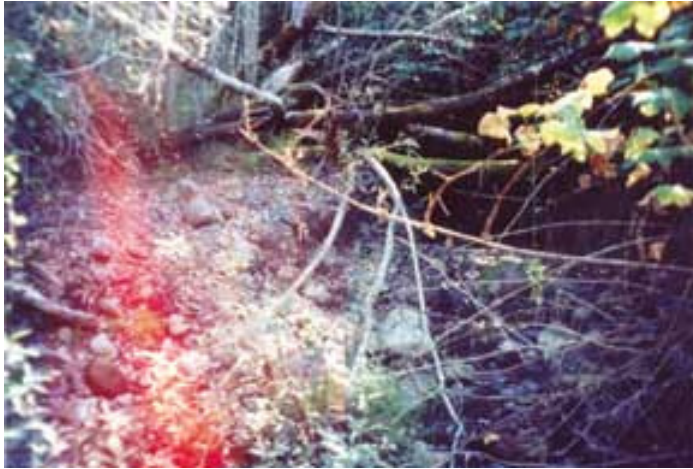
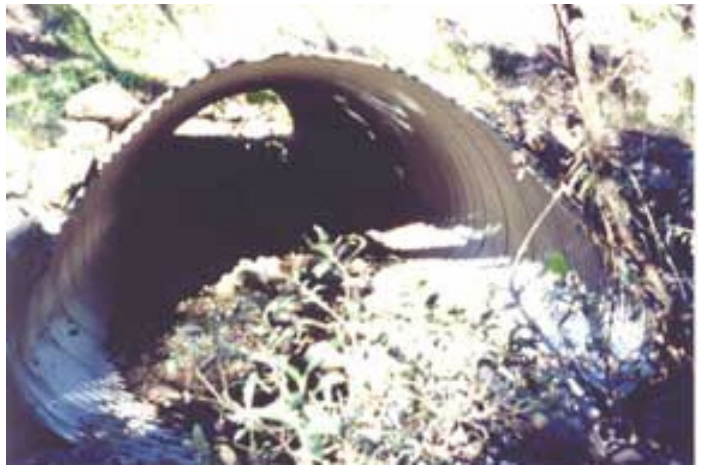
Looking upstream at headcut, where nick point migrated upstream. Looking downstream at mitered (beveled) inlet

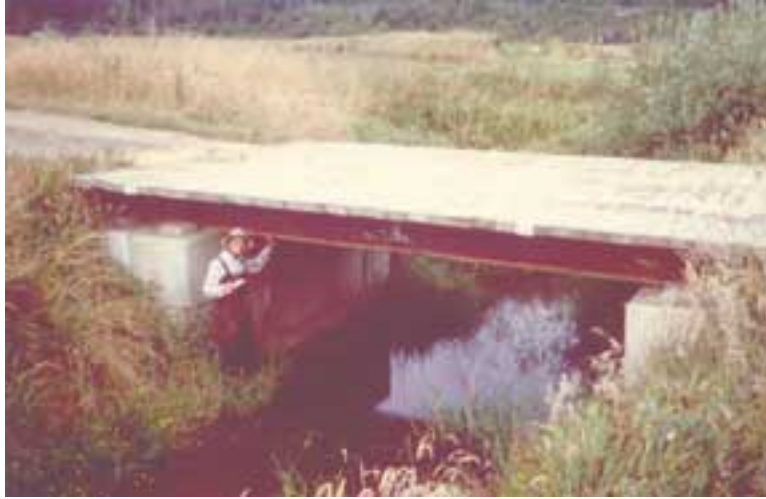
Looking downstream from above, 07/21/00

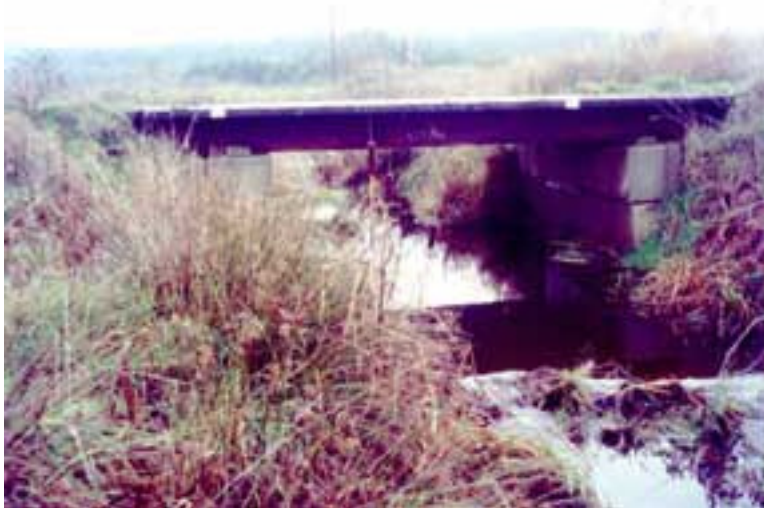
Looking upstream, 12/15/00

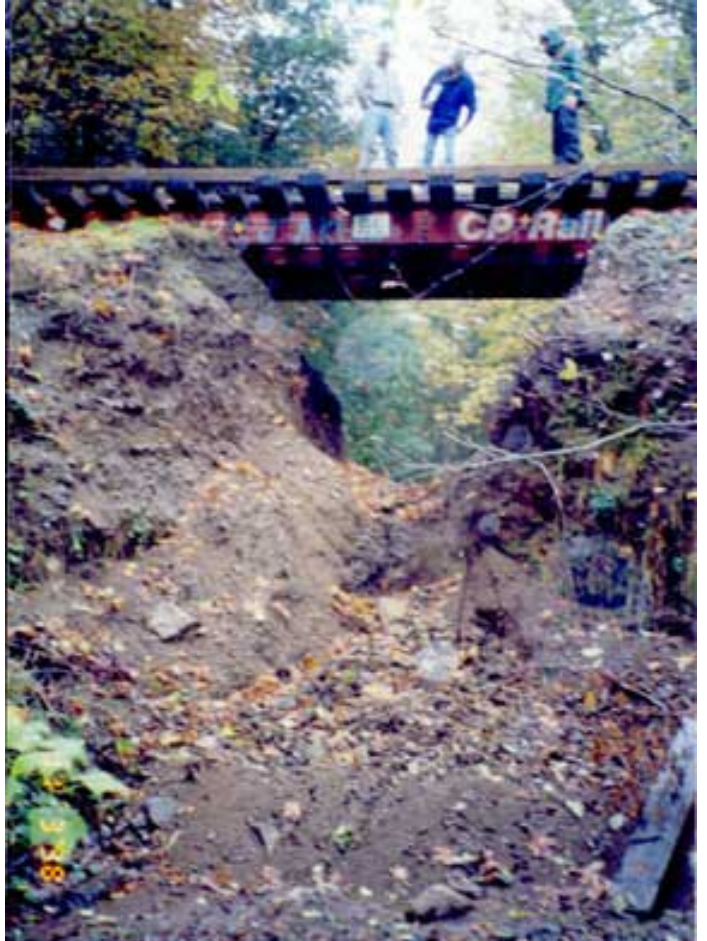
Outlet side after replacement but before first winter, 11/03/98

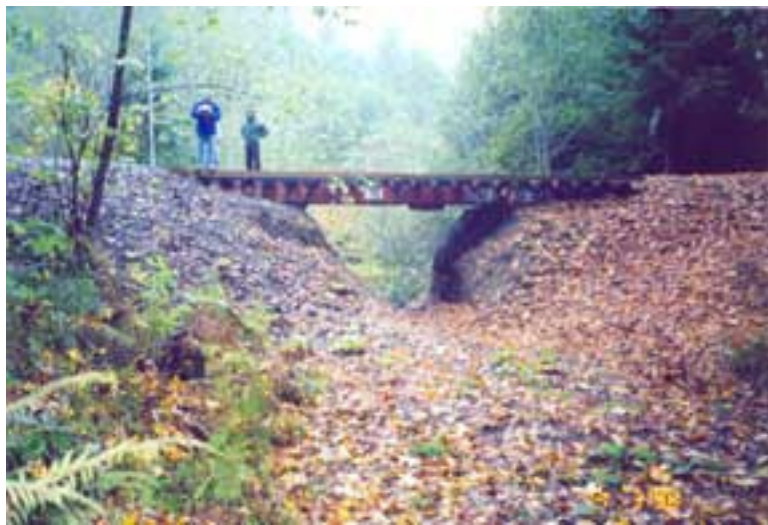
Inlet side after replacement but before first winter, 11/03/98

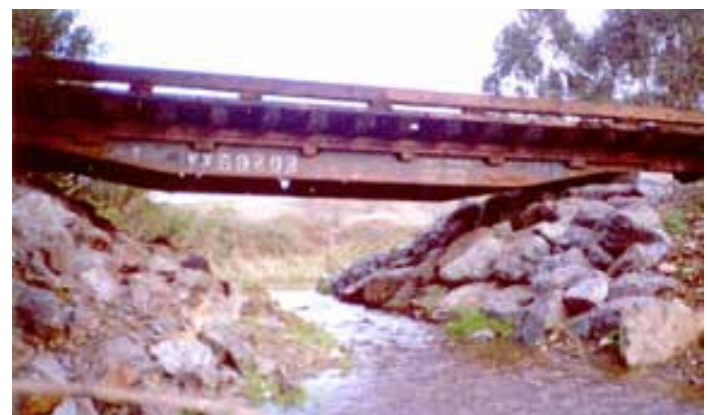
Looking downstream at the riffle formed under the bridge, 12/07/99

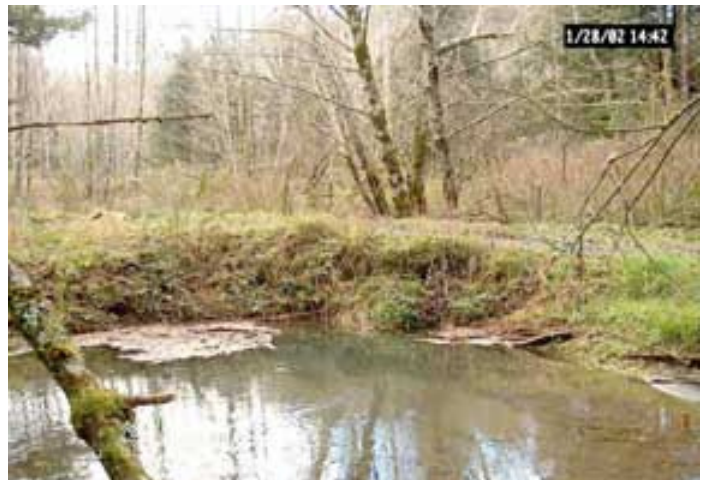
Looking at the former outlet of the upper crossing, 01/28/02

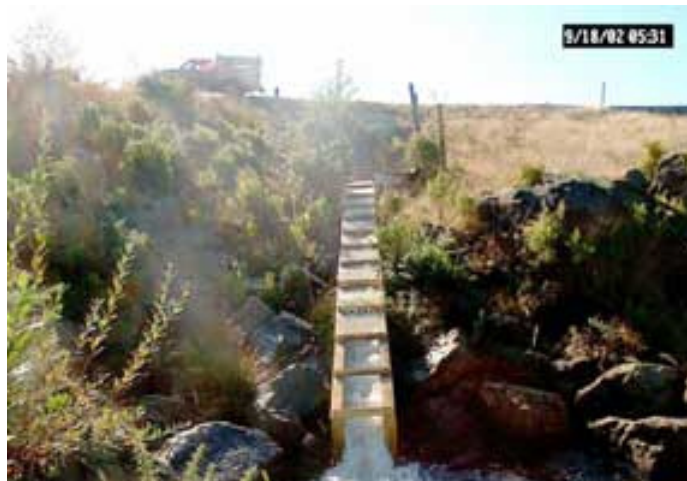
Steep Pass post screen placement, 09/18/02
